## VILLA SARACENO

#### Vol II- The Repair of the Buildings

Charlotte Haslam, 1994

**Repairs to Villa Saraceno**

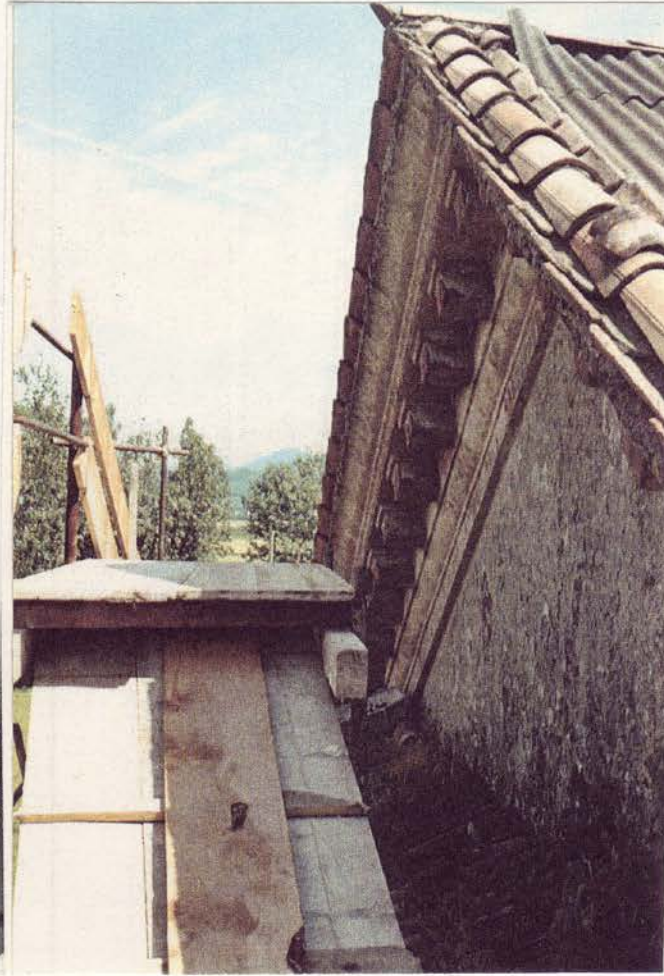
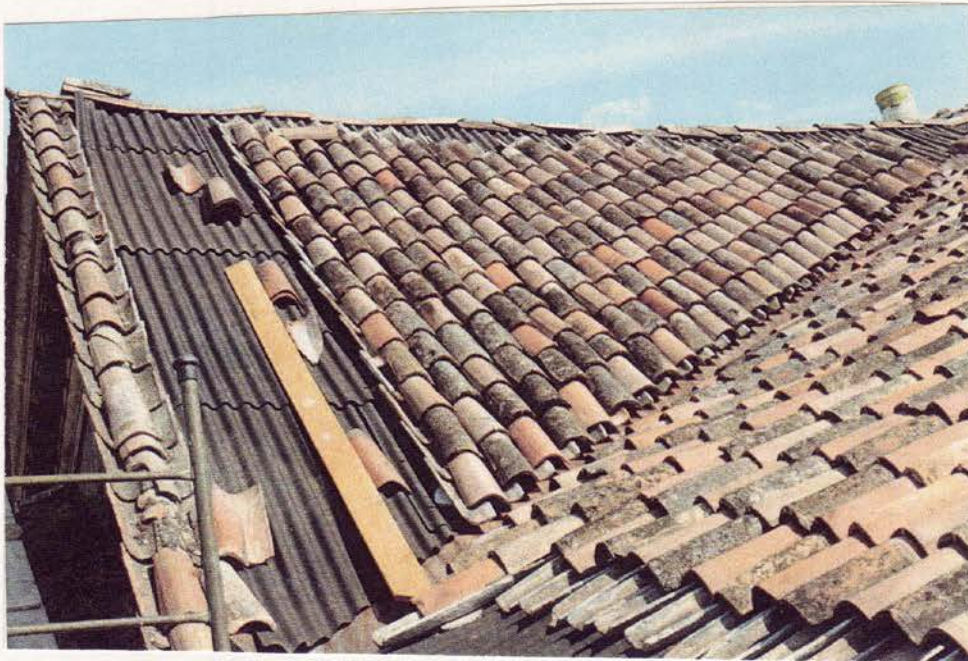
*North pediment: cornice and valley.*

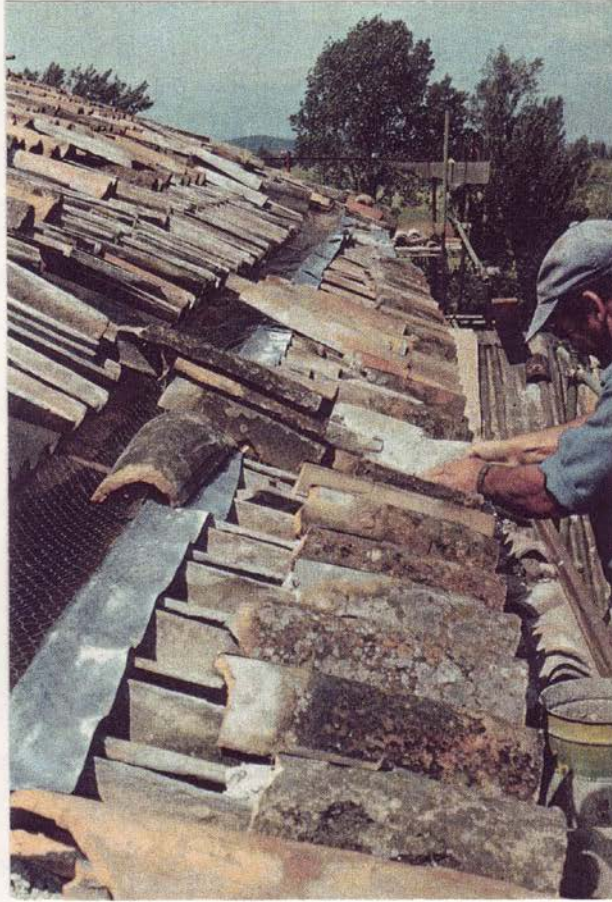
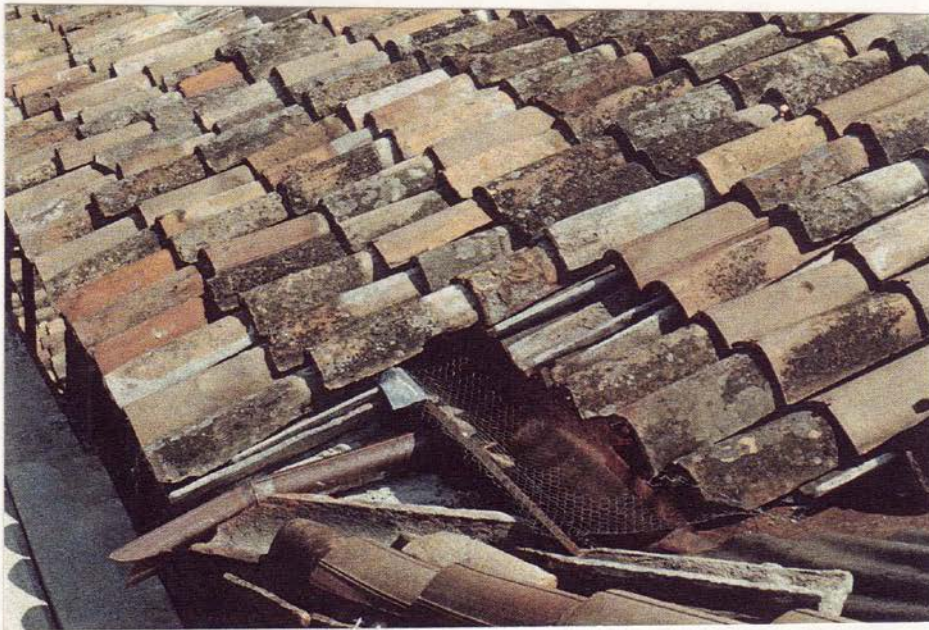
**Making the secret gutters and rain-water spouts.**

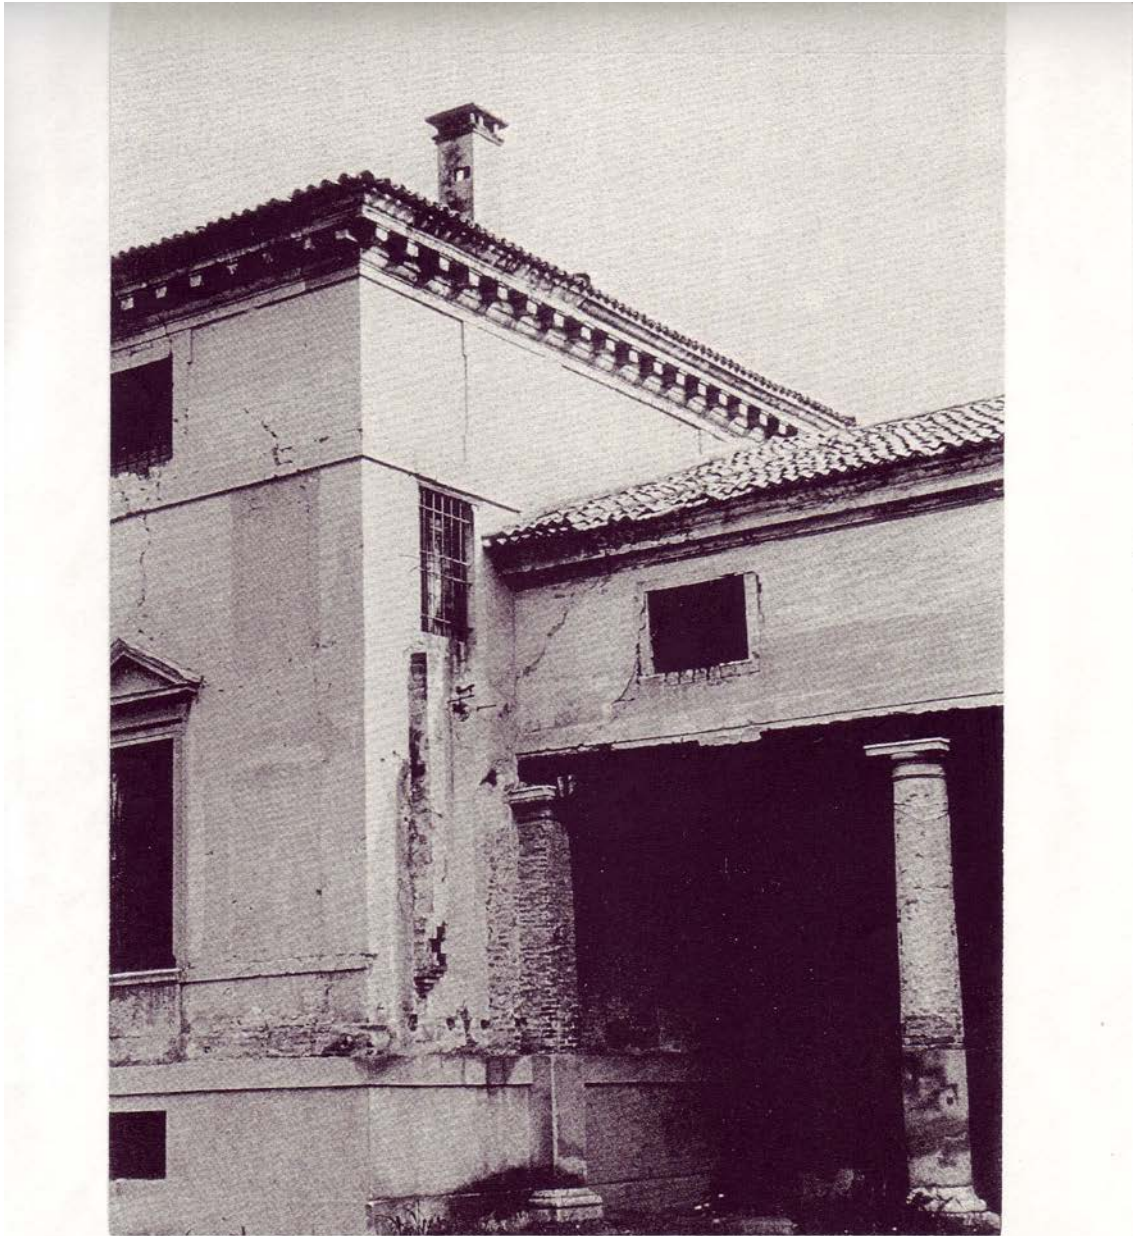
△  
The east wing main cornice had  
moved outwards, because the roof put △  
on after the fire of 1798 had no tie beams.

All the roof structures and coverings were repaired in 1990. The east granary defect was corrected by swinging up new tie-beams of pine brought from the Alps, and linking them to the existing trusses by new stone imposts in the angles and raking braces so as to reduce the thrust at the wall head. The villa house roof coverings were repaired first, and the opportunity was taken to remove the two later dormer windows in the south pediment hips and a chimney on the south-east corner. Secret gutters were installed like those at Palazzo delle Trombe, which discharged rainwater through copper spouts so as to avoid external gutters and down pipes. New chimneys were built like those at Villa Marcello Curti, which echo the rhythm of the facades below. The other roofs followed in sequence, with the *tezza* roof (which, being low, is the most visible) coming last. The existing system, using the existing components was repeated throughout; *pianelle* (flat tiles) planted on battens and visible from below, then timber bracing and insulation as necessary, then *coppi* (curved tiles, secured with clips).

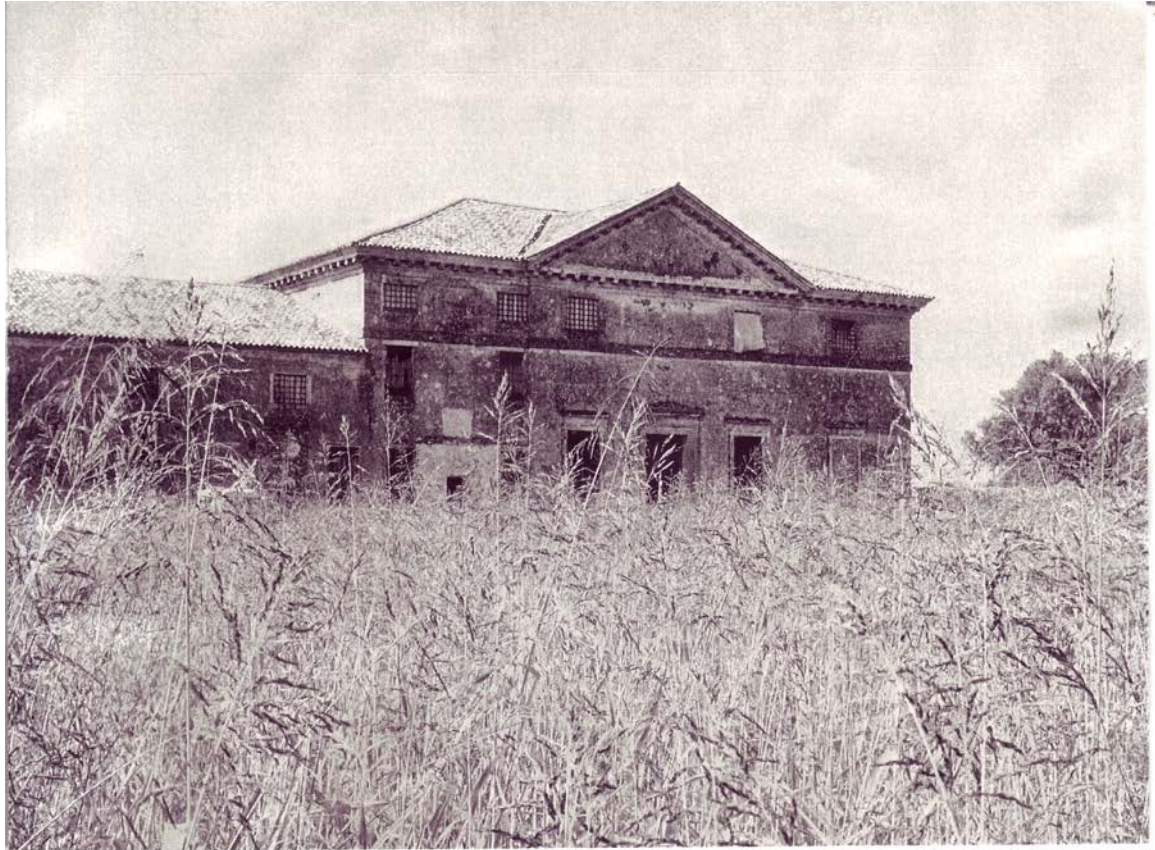
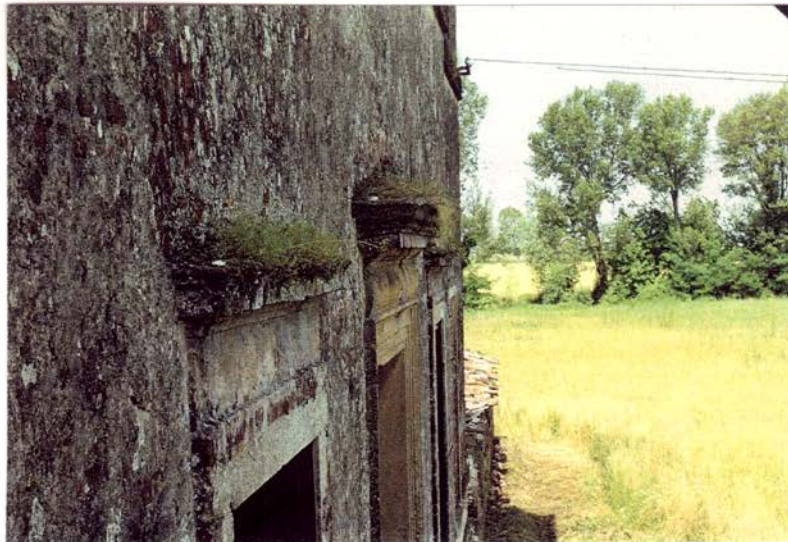
△ The north front before repairs; and a glimpse of its problems ▽

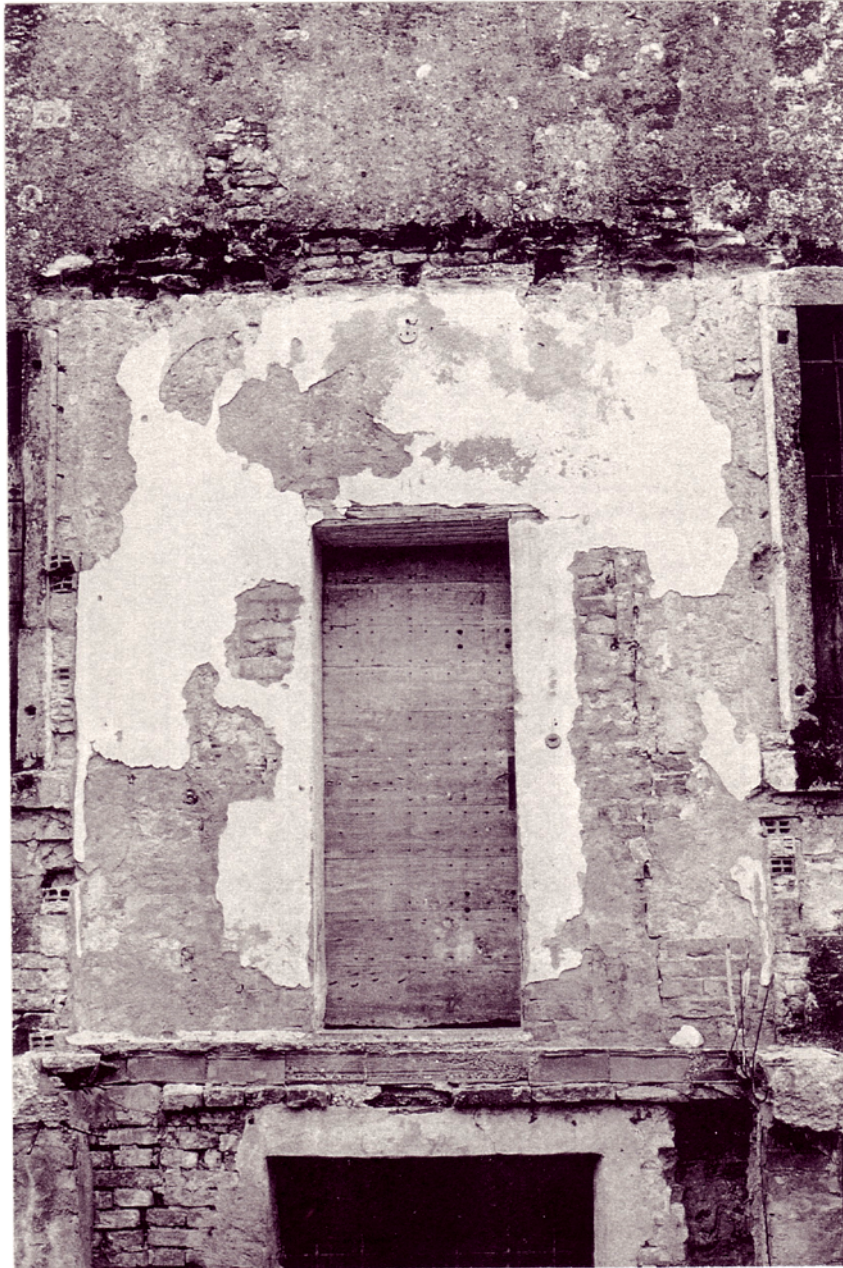
East window of north front after  
removal of pantry.

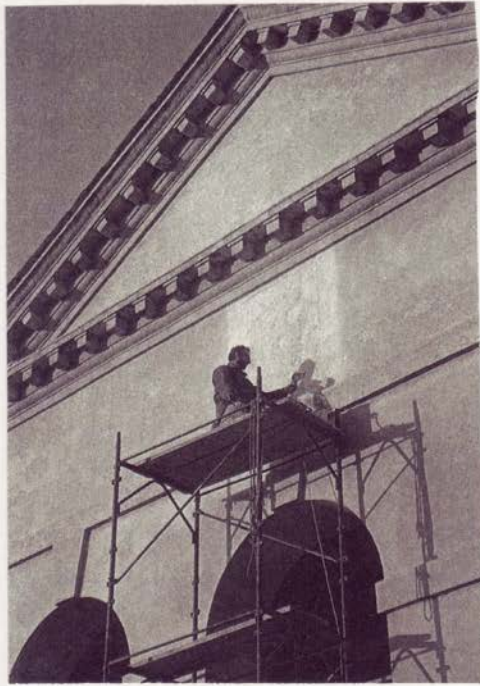
Suinore, the site foreman, uncovering the damaged cornice slab on the south front.

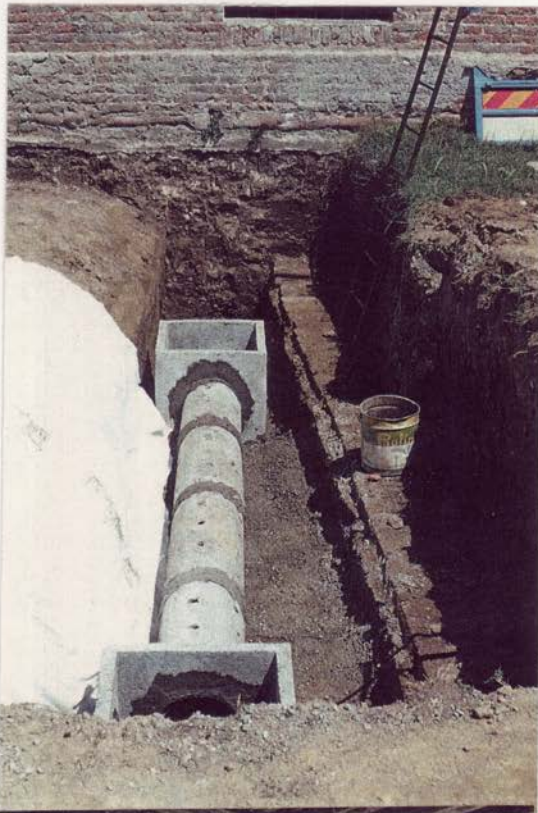
The original brick drain leading south from the cellar, with its replacement beside it.

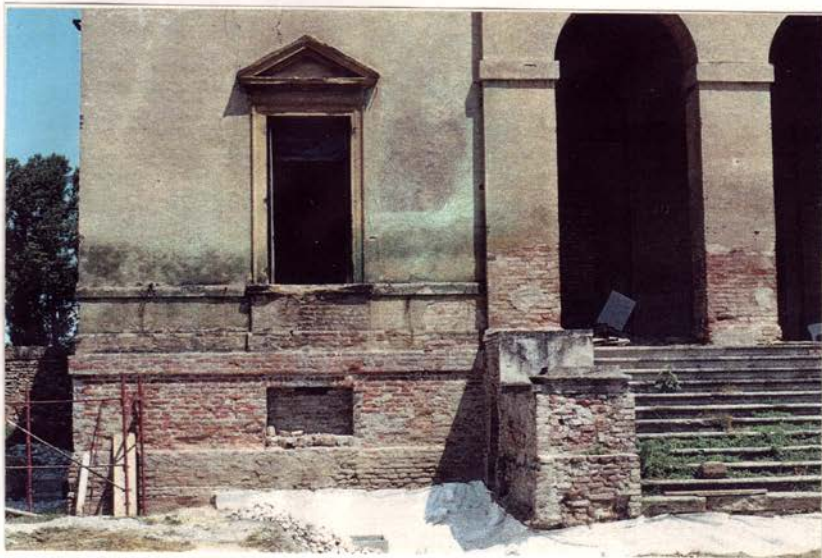
The south front had been damaged by the plinths being rendered in cement, and by copper stairs from spraying vines. The south steps prove to be an early-17<sup>th</sup> century project; the side walls were refaced in March 1994; and the stone-hogged stepped ramp is still to be installed.

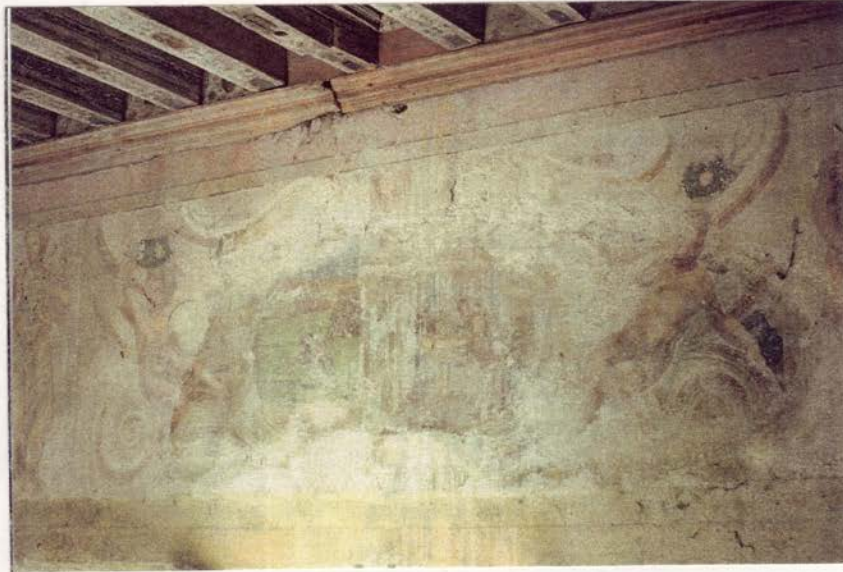
The sala frescoes before cleaning.

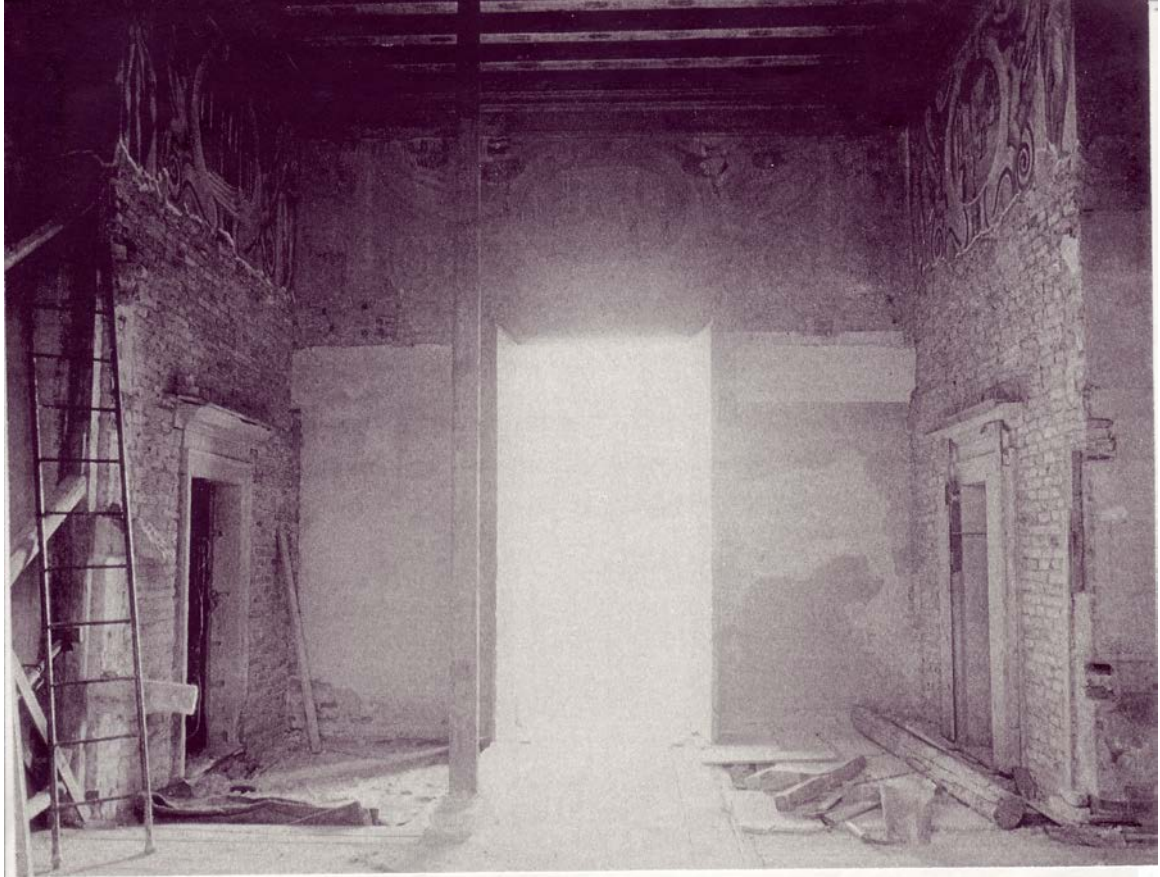
The sala entrance, looking south, after the reduction of the stanzine in 1991. The frescoes above the void were first cleaned and fixed as a precaution.

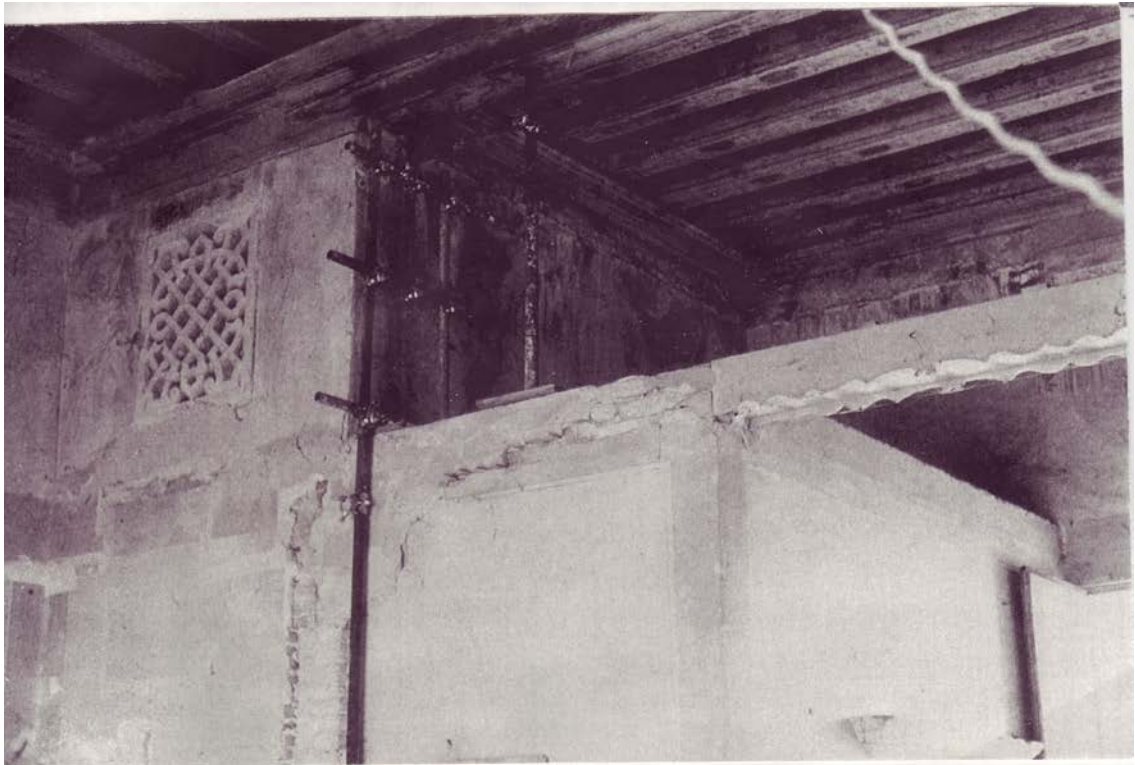
△  
The east stanzina as  
enlarged about 1890.  
The west stanzina,  
(above) just after the  
Levi statement; and  
(below) with old patches  
of intonaco and trials  
for new.

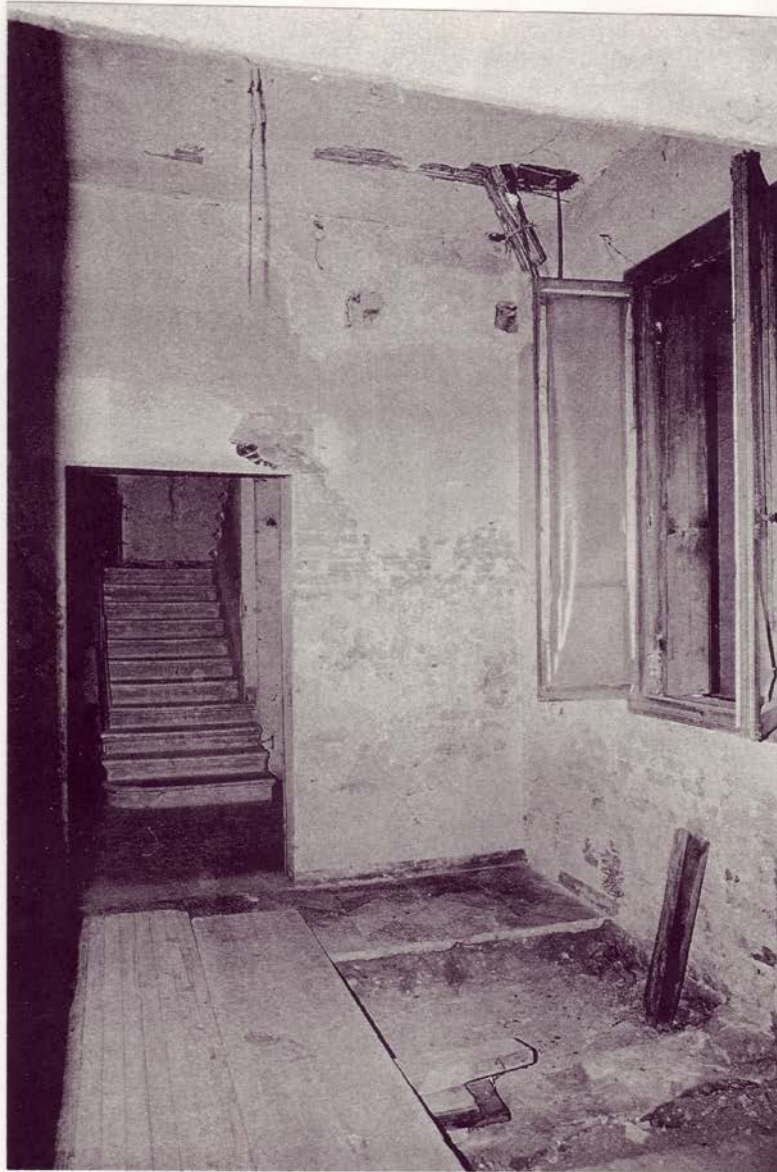
The east stanzina, with the mirdar  
to the loggia opened about 1890, and  
the door through to the stairs of 1890.  
Examination of the east wall revealed  
that three staircases came and went  
in this space.

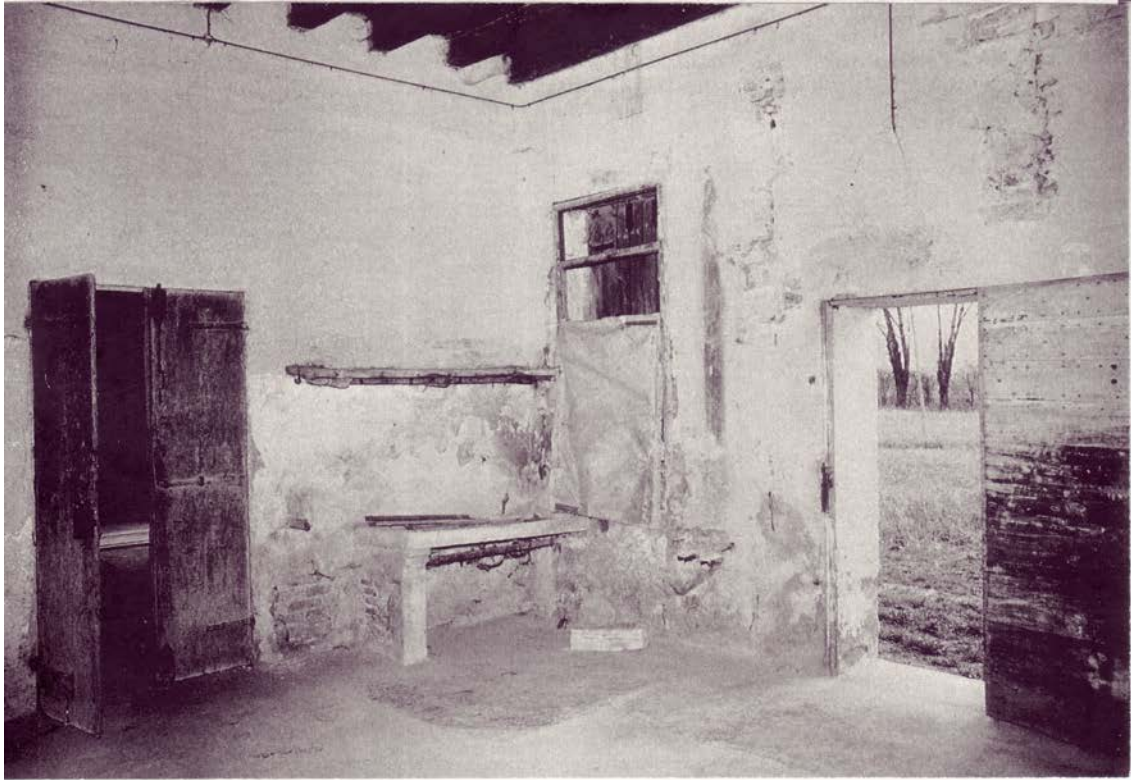
The north half of the cocina grande, after removal of the pantry which obstructed the site of Paredo's window.

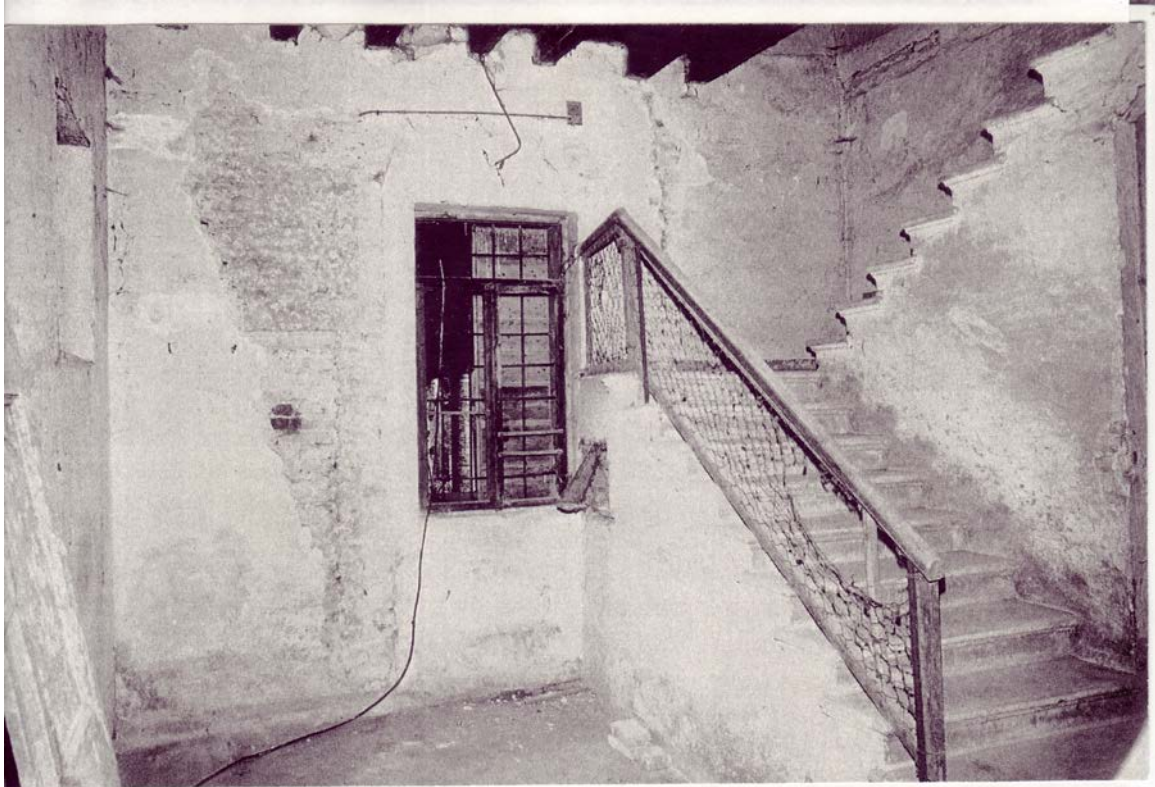
The south half of the cucina grande, before  
removal of the partition wall which divided  
Paredi's very tall fireplace in two.

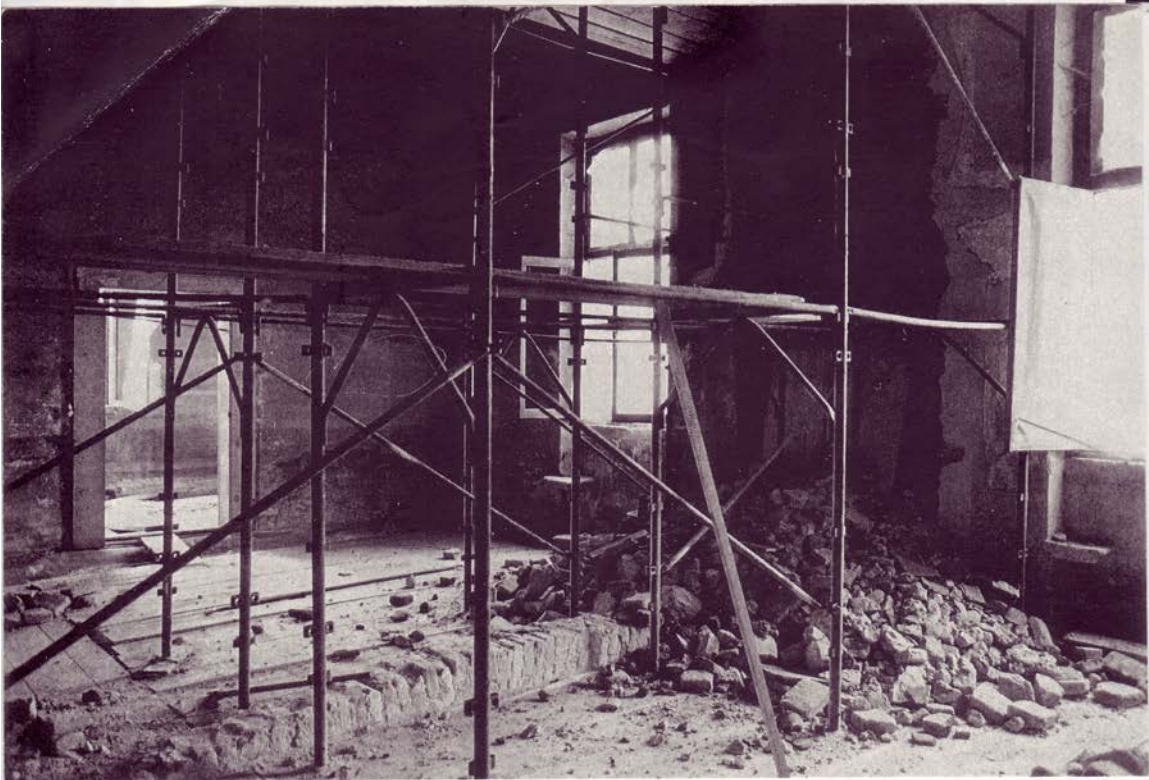
De stanza maggiore after demotion of the partition wall.

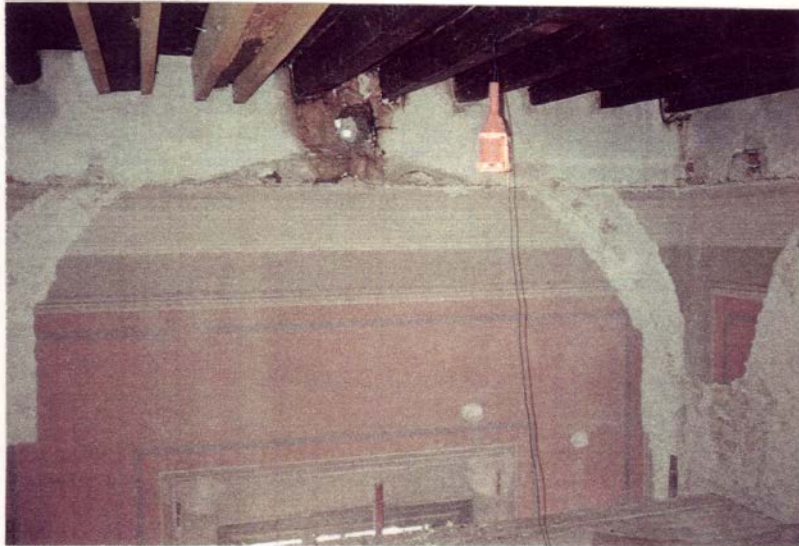
The profile of Palmedio's brick vault, after removal of the 19<sup>th</sup> century false ceiling revealed the fragments of fresco decoration beneath the crowns of the arches.

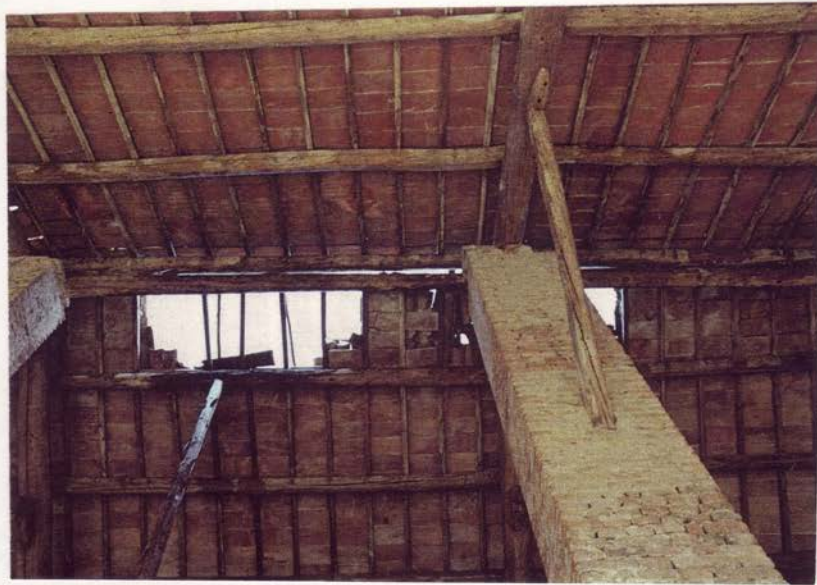
holes in the terra roof.

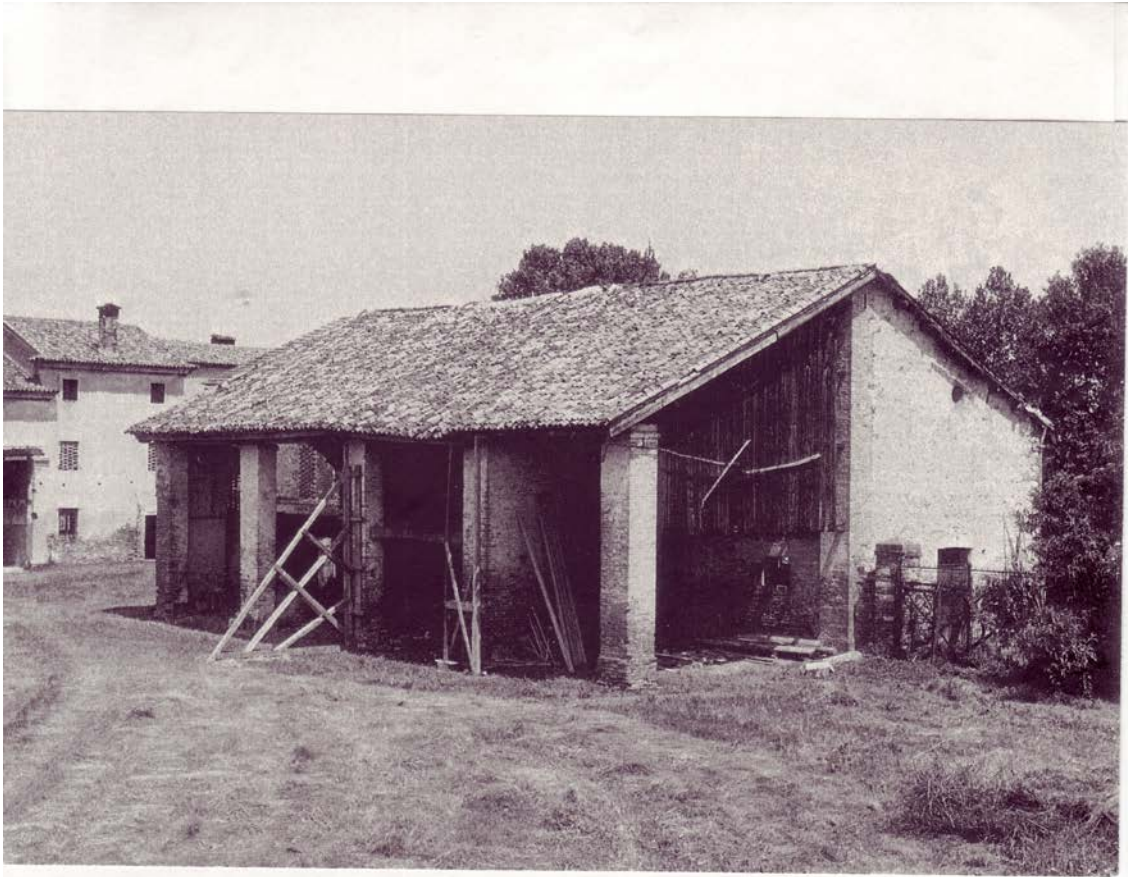
The *tezza* was close to collapse when the builders first came on site in 1989. The first thing they did was to shore and chock it all round. The medieval rear wall was winding, as brick structures without foundations always have been on this sandy soil. Two of the brick piers on the *corte* side were unsound; the roof timbers were therefore unstable and parts of the roof covering were falling in.

*The teza was shored up in 1989 and jacked straight in 1990*

The *tezza* was made secure, but has not been altered apart from having a rolled stone surface for cars laid in its loggia-like space.
