# The Landmark Trust

# OLD CAMPDEN HOUSE SITE HISTORY ALBUM

East Banqueting House & West Banqueting House

# **Volume I – RESTORATION OF THE BUILDINGS**

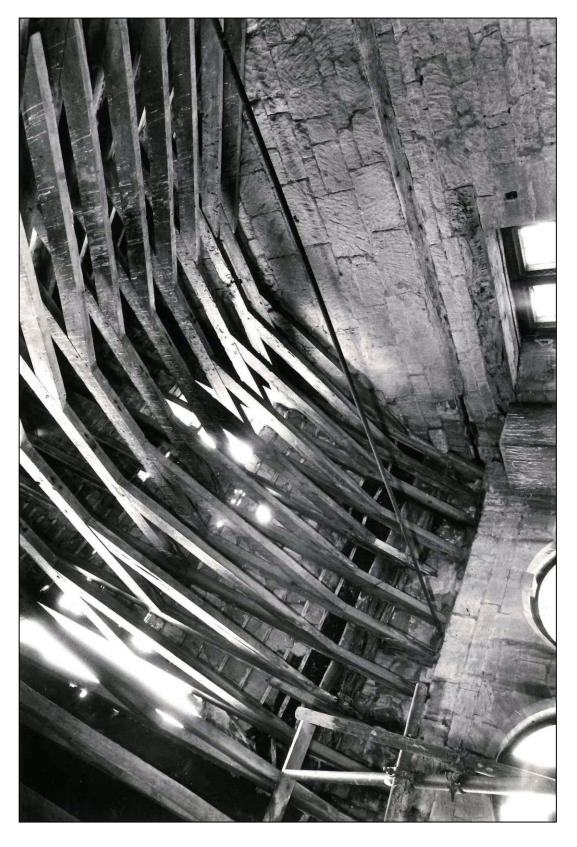
The roof had to be completely dismantled.

Once the roof had been secured and repaired, the covering of stone slates could go back. As many of the old slates were reused as possible, which in the end amounted to about half. These were made up with new from a quarry in the Cotswolds. Where the gables meet the main roof, there is no break in the slates, forming what is called a swept valley, a method traditional to stone-slate roofs.

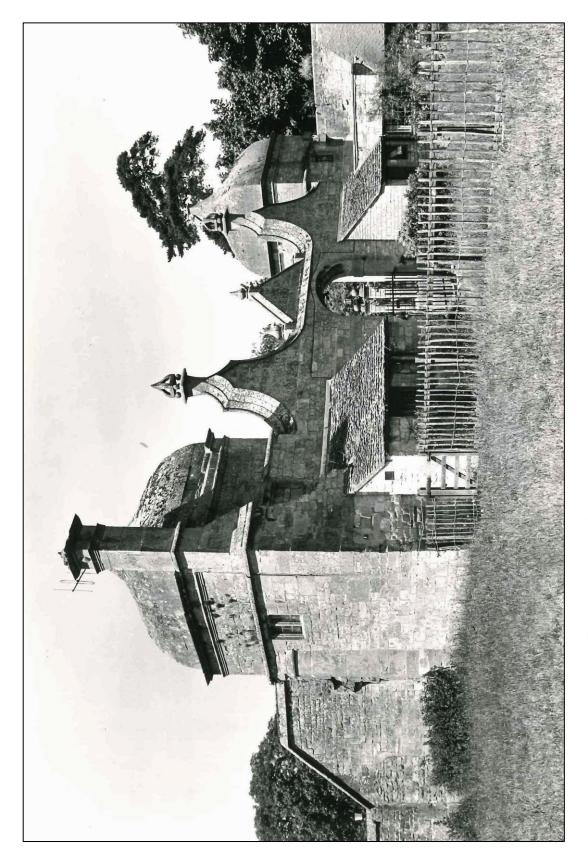
The lean-tos and the cottage to the right were removed.

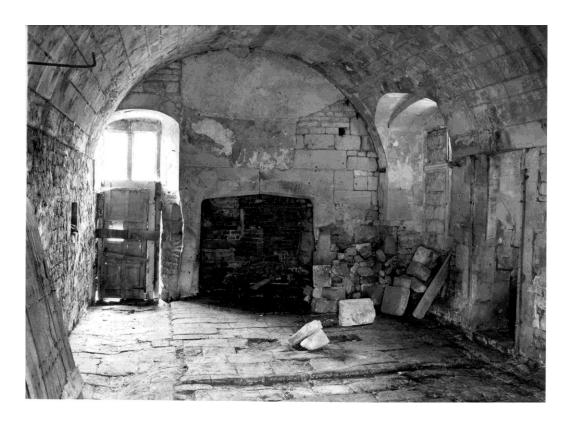
The lower level showing the partially blocked west window (to the right) before restoration.

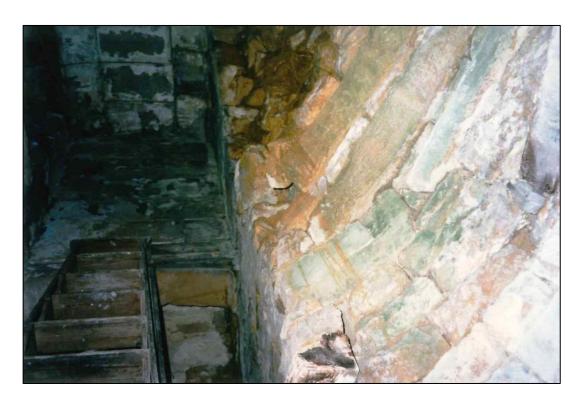
The collapsed staircase caused by water ingress.

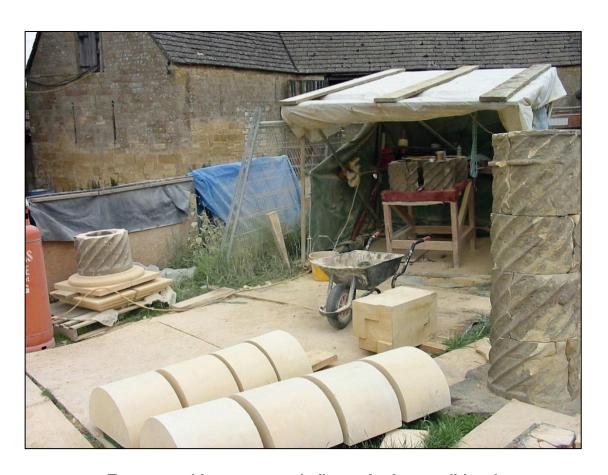
Two new chimneys were built on site in a traditional stonemason's bankers' shed, June 2002.

Also at roof level, two chimneys were found to be beyond repair and had to be replaced. The work was done on-site in a traditional stonemason's bankers' shed. The shafts were carved in two halves, each divided into several slices and the

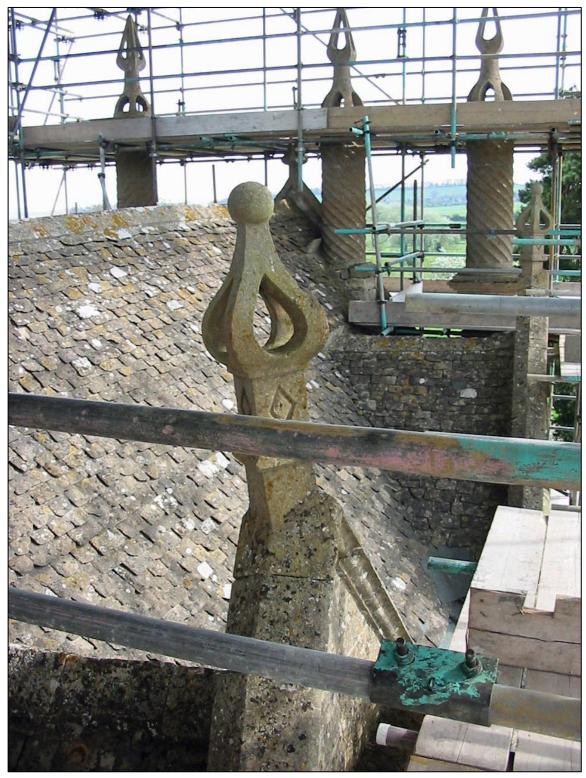
The east wall had also bowed significantly and rotted rafter feet above equally decaying wall-plates meant that the wall had come adrift from the roof by some 12-15cm. Metal tie beams had been inserted in the past and the wall seemed stable so, in contrast with the treatment of a similar problem at the East Banqueting House, we decided not to crank the wall back to vertical, simply replacing the metal ties. Quite how far out of true the wall has moved is easy to read from the boxed-out west cornice on the inside. The rafters were given new feet and we cast a new concrete tie beam to give them something to sit on.

The roof undergoing repair.

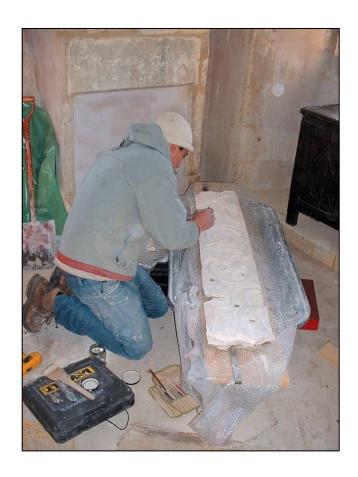
Piecing together fragments of the decorative frieze below the cornice on the first floor.

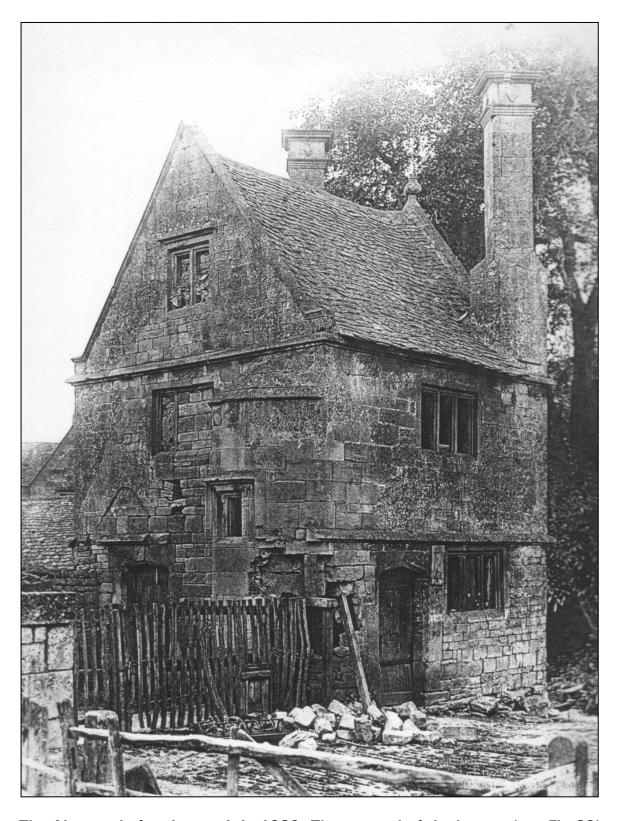
The Almonry before its repair in 1929. The removal of the lean-to (see Fig 29) has made the dangerous state of the stair turret alarmingly clear.

Under Griggs' instructions, in 1930 local builders Pyment and Sons undertook repairs to the stair turret. Pyment & Sons were the firm founded by the same Mr Pyment, builder and joiner, who had taken on the Silk Mill. (His firm is still in business today, under the same name although now in different ownership). According to sound SPAB principles, photos were taken before and after the repairs at Griggs' instigation.

The photos show that the stair turret at ground level was almost completely rebuilt and the first floor window on the south elevation was reinstated. The shadow of recently removed accreted buildings is also apparent, a removal that may have accounted for the dangerous state of the stair turret. The first floor window in the south elevation also appears to have been almost completely replaced. Griggs was correct that the stone would tone down naturally, though his repairs can still be identified today on the stair turret.

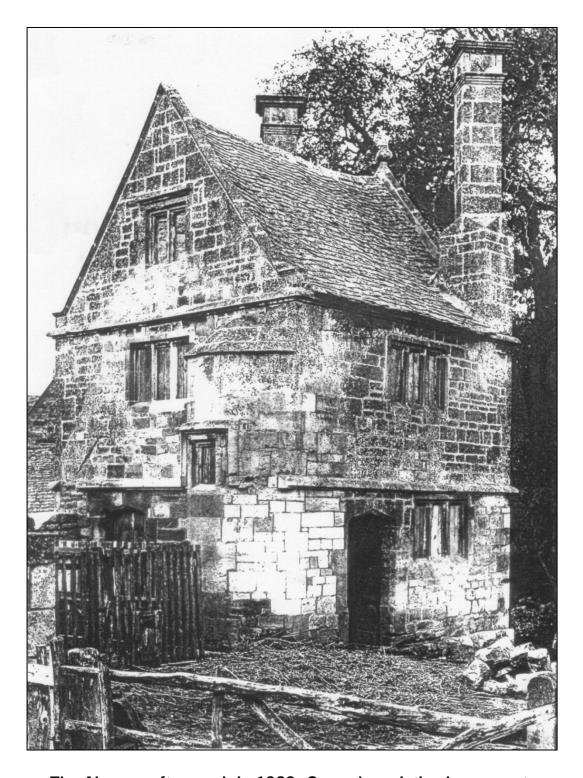
The Almonry after repair in 1929. General repointing is apparent, as is the almost complete restoration of the first floor window in the south elevation.

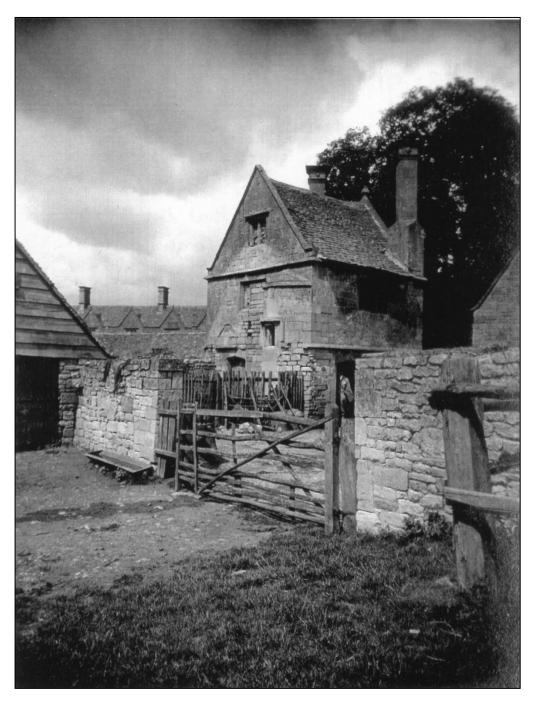
The Almonry apparently at an interim stage of the repairs, since the blocks in the stair turret appear to be unpointed. Perhaps the figure lurking in the doorway is Griggs himself. The line of the fence leading south from the Almonry is interesting: the wall in the foreground that it joins is almost certainly primary and the fence not only follows the line of a wall shown in the bird's eye views but the little court formed in front of the building makes sense of the three doors at ground/basement level.
