BRINKBURN MILL

History Album

Architect: Stewart Tod & Partners, Edinburgh

Work completed 1992

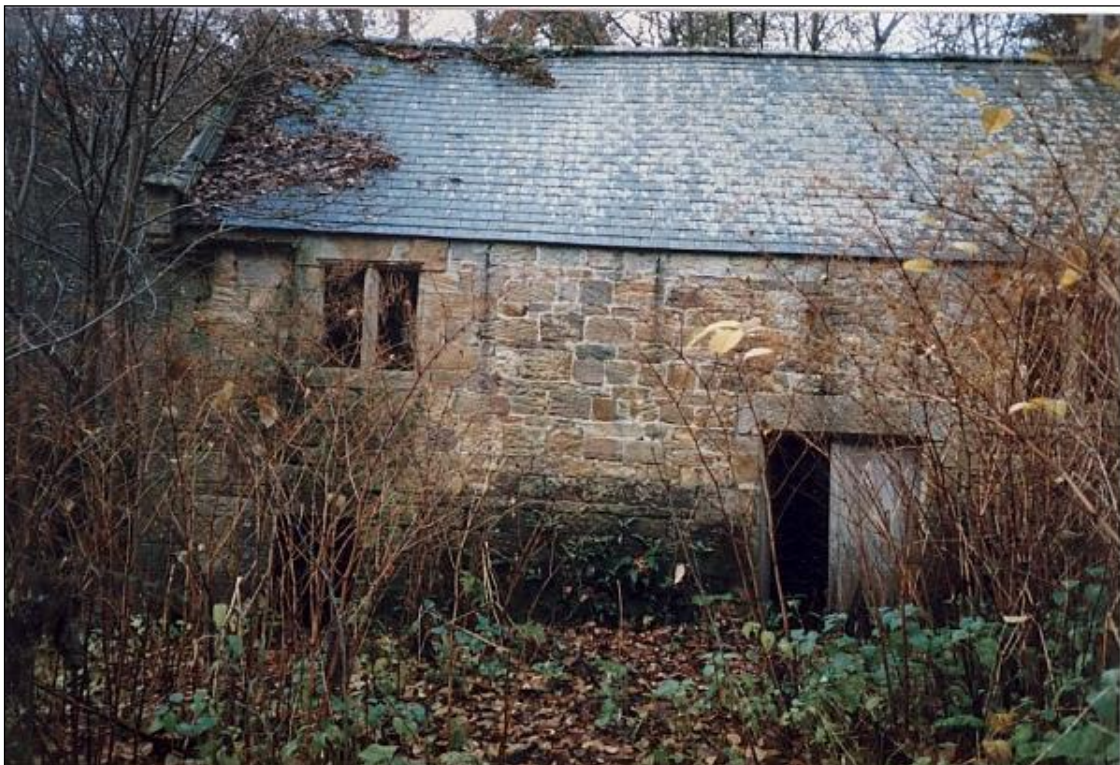
The east front. The paving was earthed up.

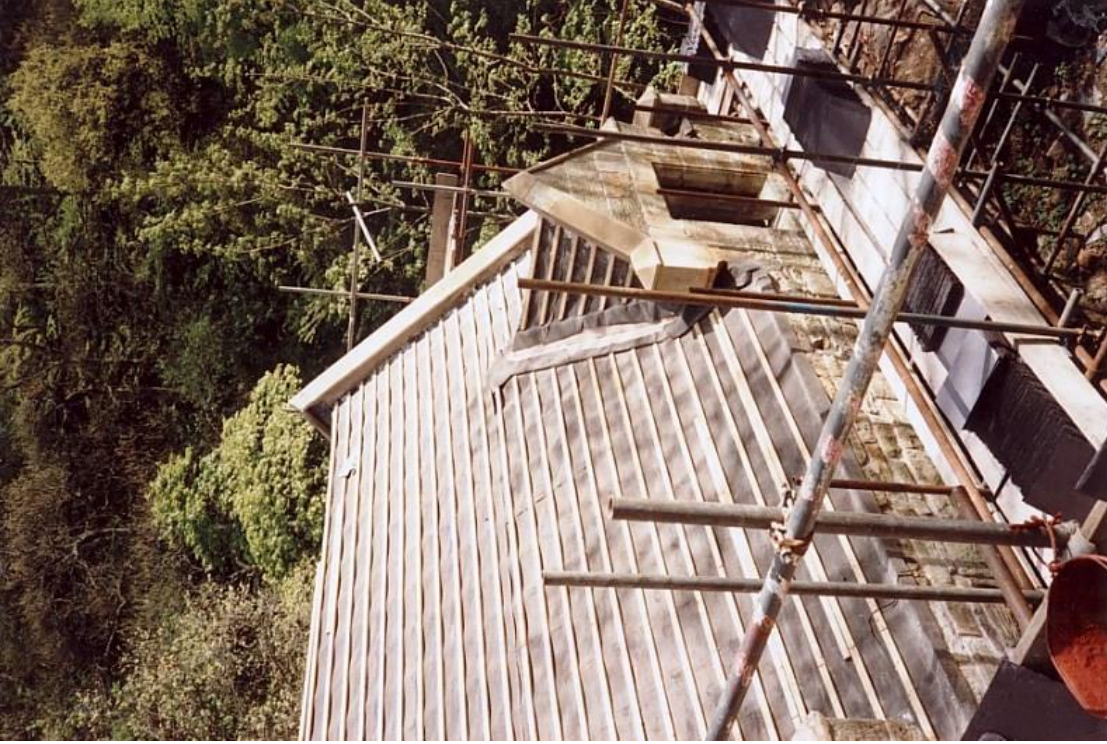
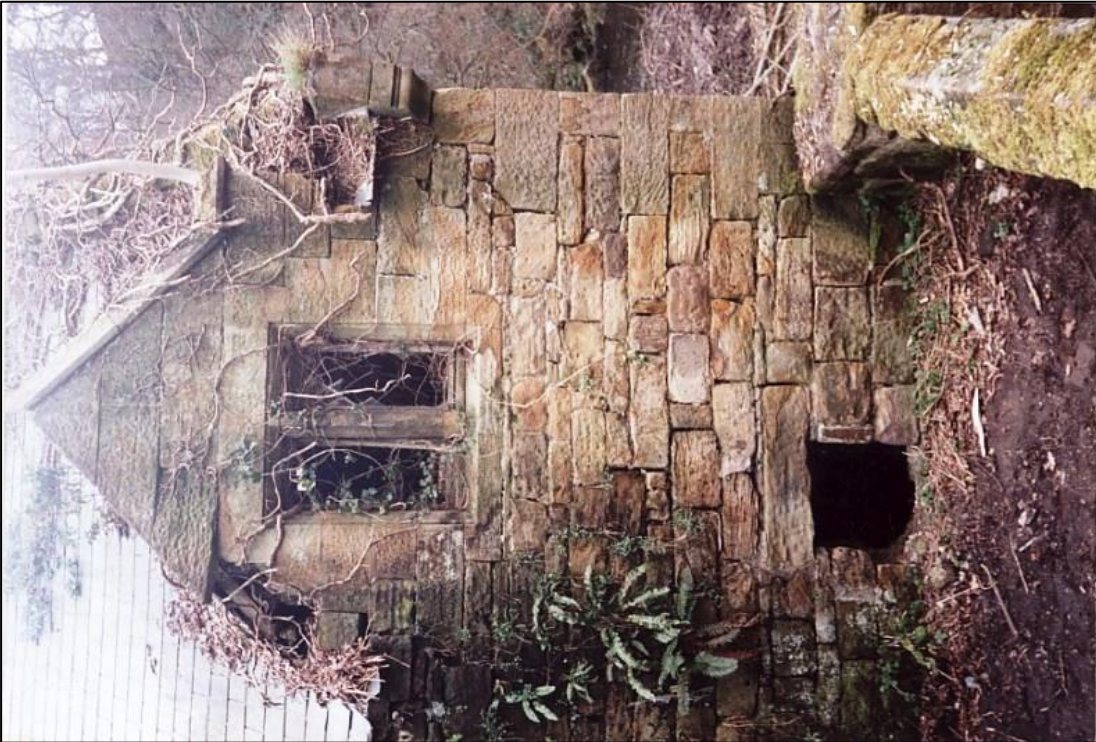
The window at the south end of the west front. Part of the cope had gone. It was found on the ground and replaced.

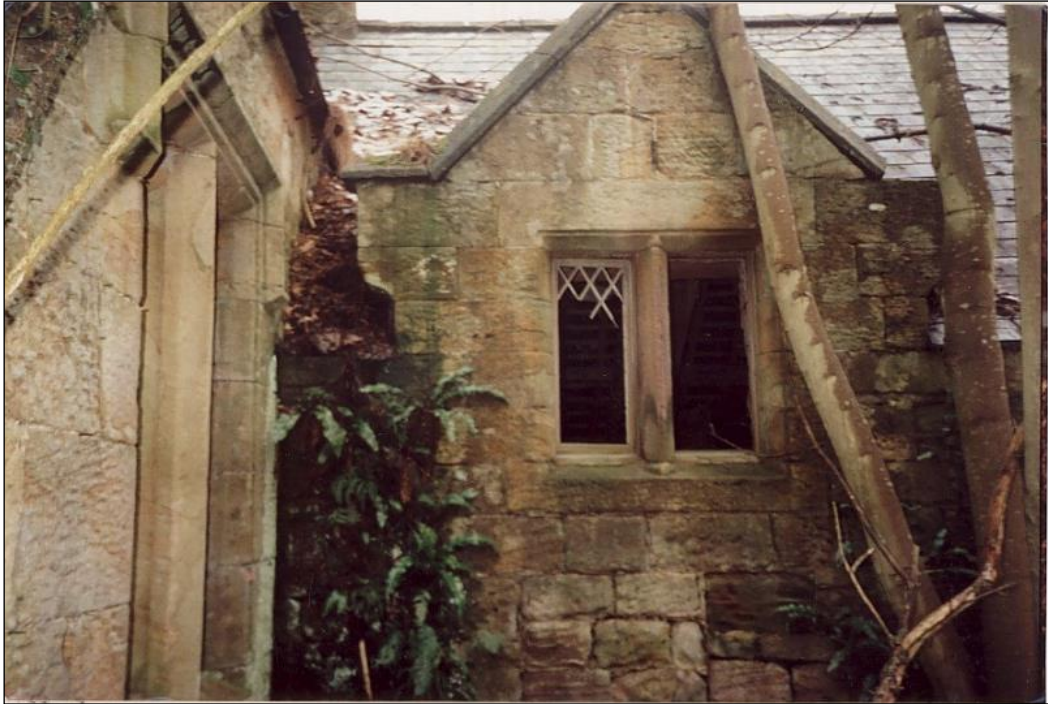
The window at the north end of the west front. The diamond panes had wooden astrigals, not lead, and they have been replaced as they were, in wood. In the top photograph traces of the old 18th- century window can be seen, blocked up when the dormer window was put in. In the bottom photograph it is being

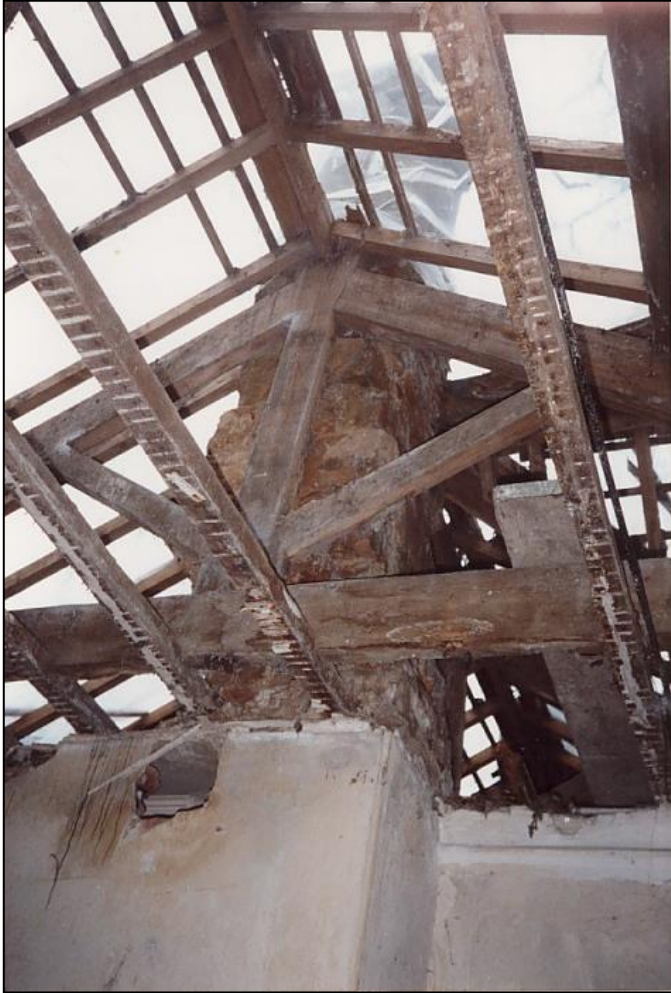
The sitting room chimney was frail and had to be rebuilt. The 19th-century truss is the same as the truss visible at the south end of the Mill, showing that in the 19th century the whole building was re-roofed at the same time.

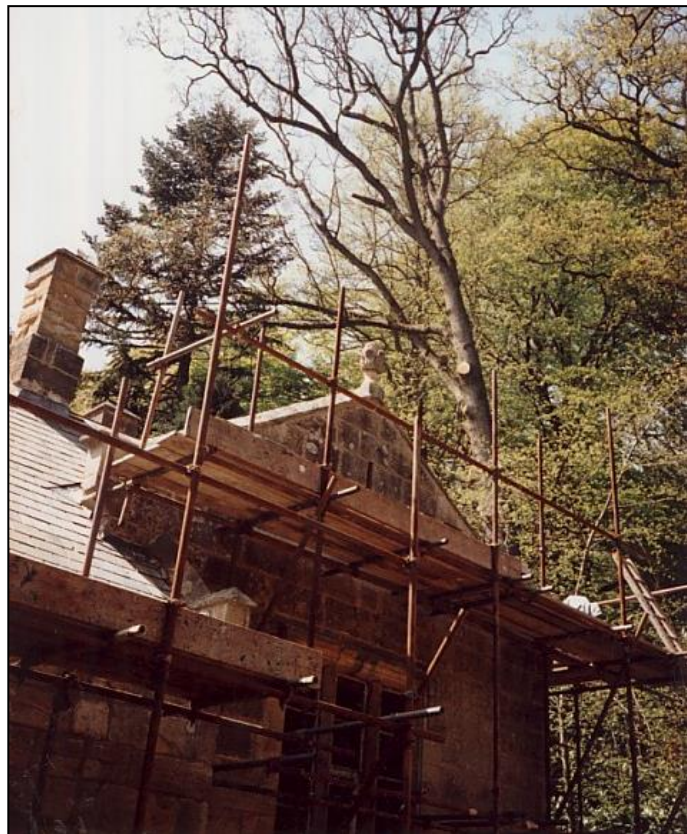
The sitting room chimney rebuilt. The acorn was found on the ground and was replaced on the gable.

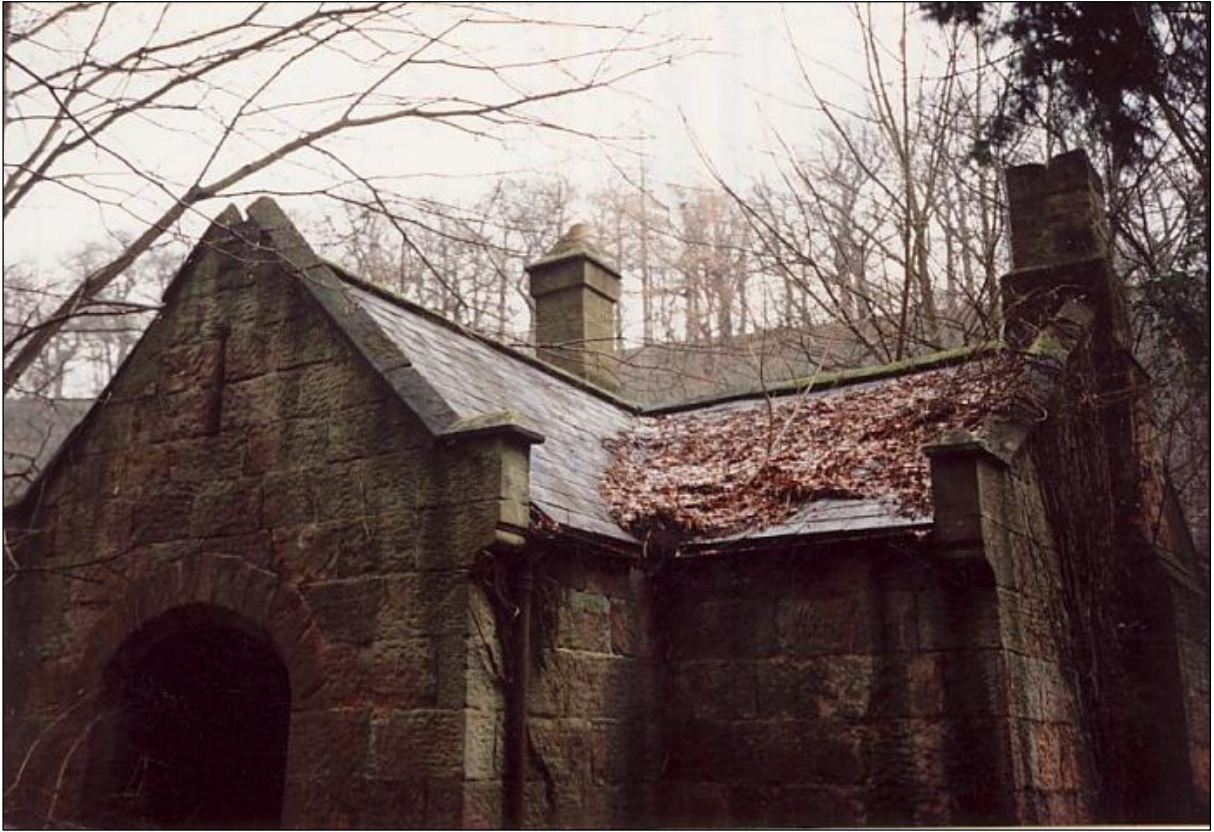
The north front in 1989. All three acorns are missing.

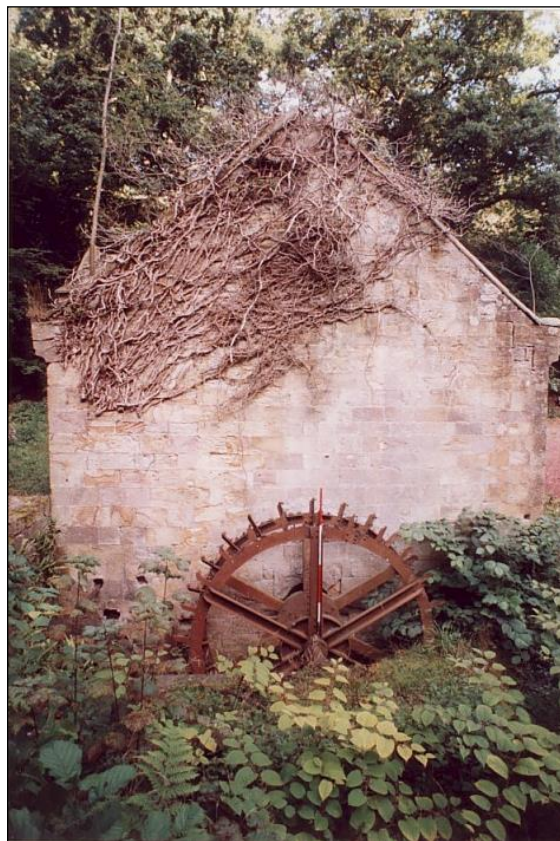
The south front. A blocked up slit window, under the ivy has been opened up.

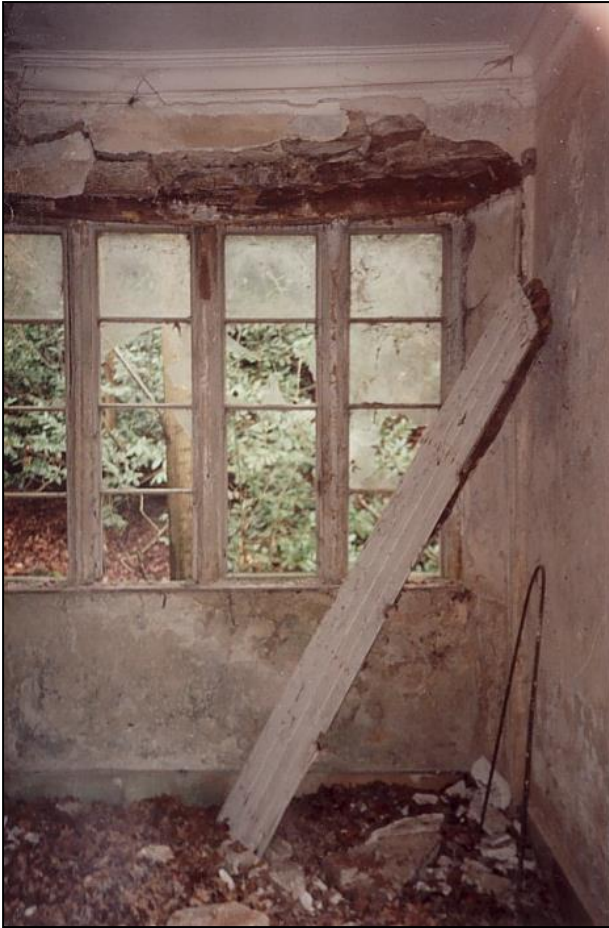
The sitting room, showing a rotten lintel above the north window.

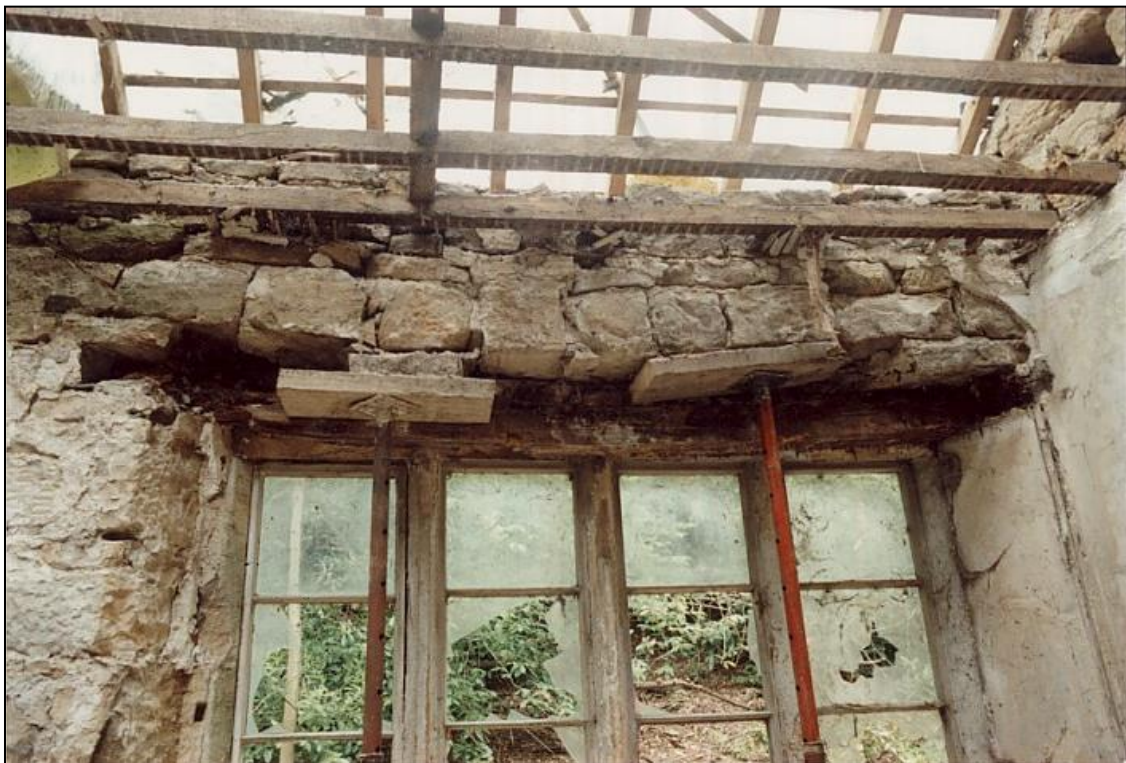
The lintel removed and about to be replaced.

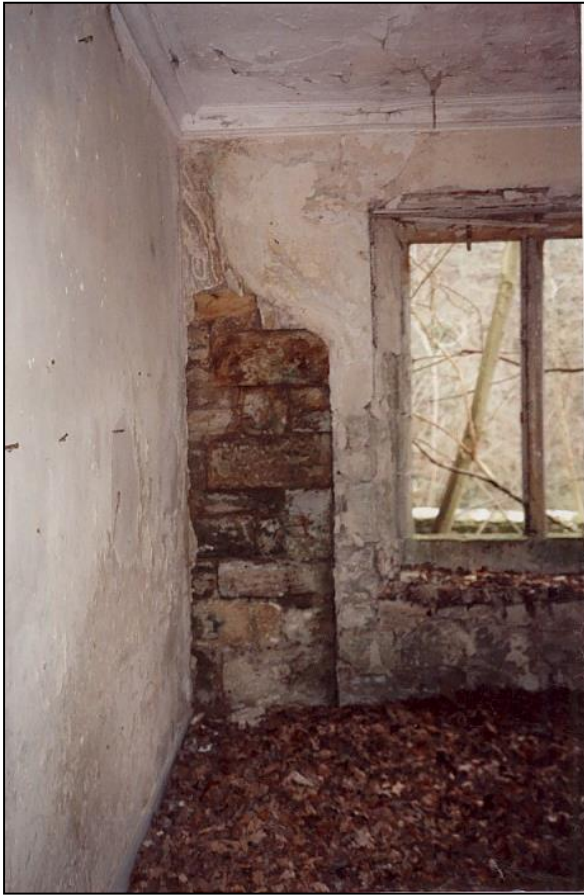
The kitchen looking south. The 19th-century cottage walls are not keyed into the old mill walls.

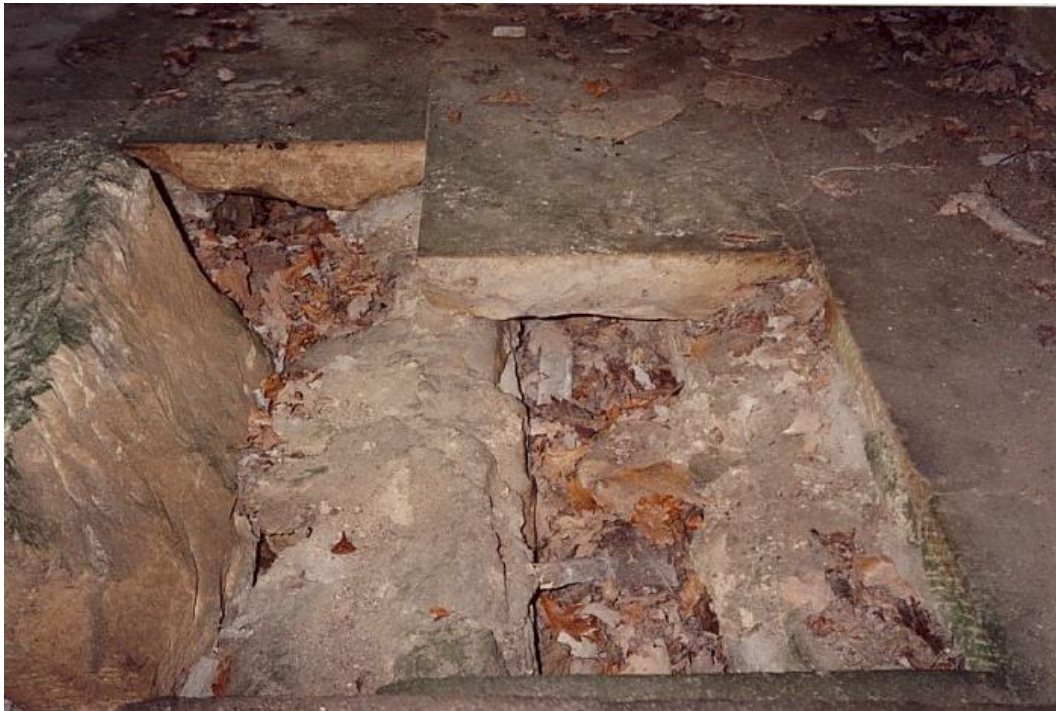
**The flags were not bedded down, but laid on strips of stone walling,
to improve ventilation.**

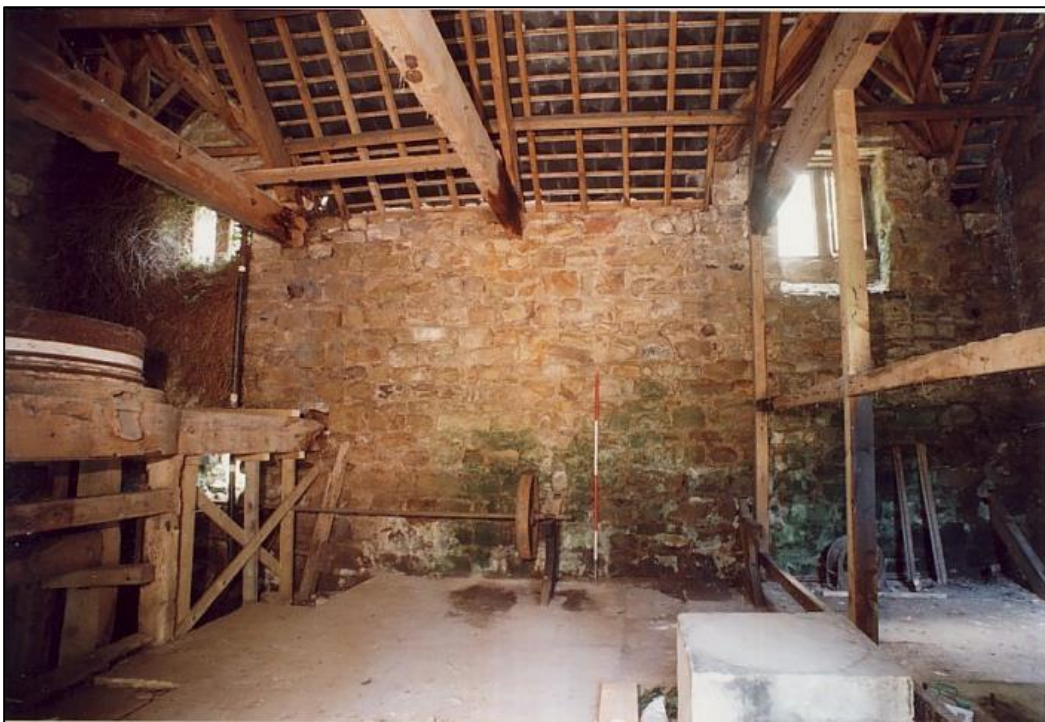
Looking west from the Mill door. The concrete blocks on the right, where the generator stood, have been removed.

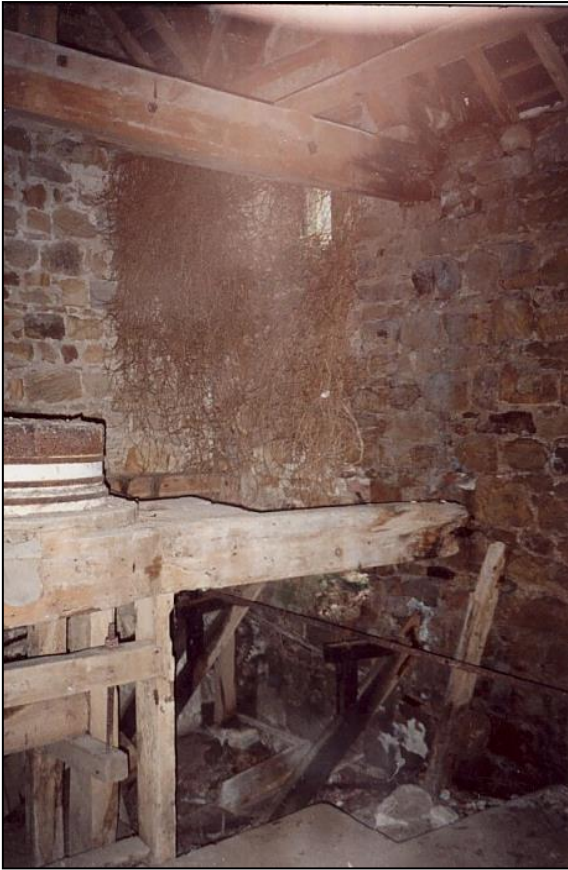
The beam in the south west corner in 1989. It had rotted below the damaged dormer window.

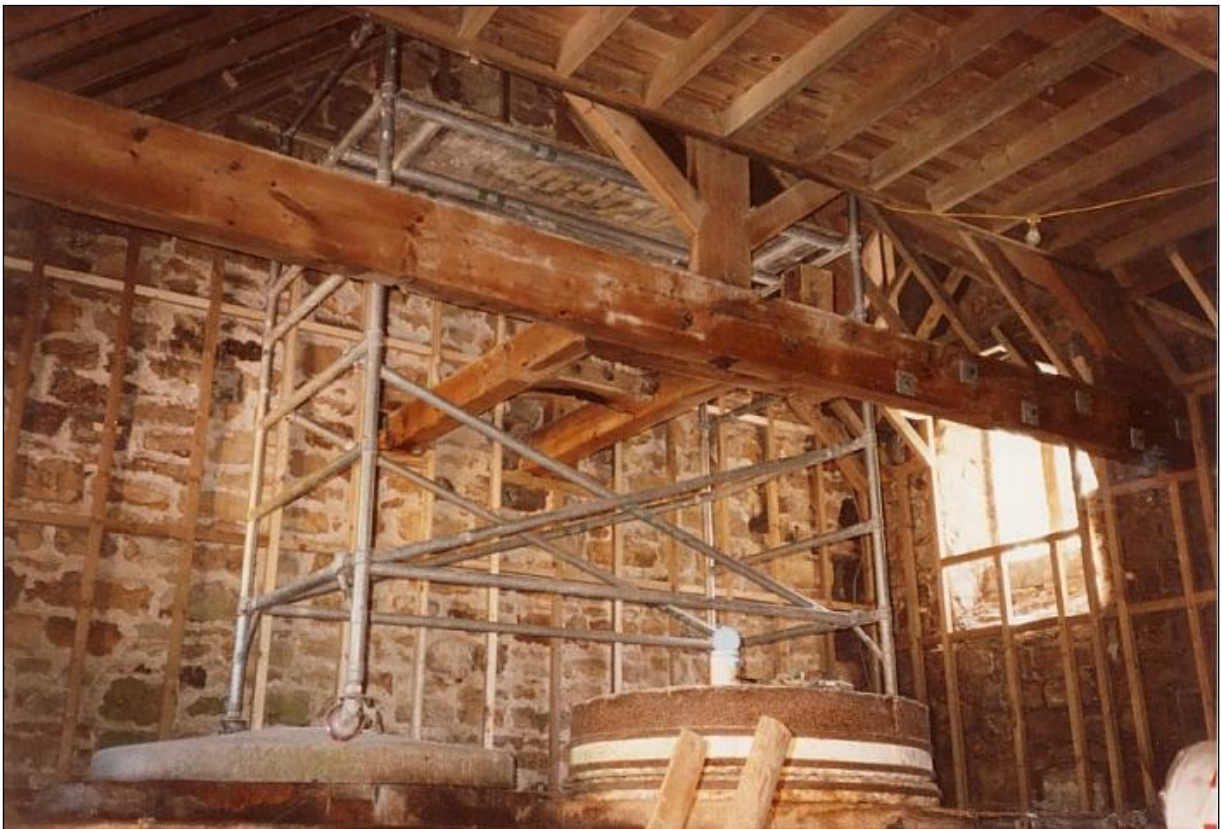
1992. The beam has been repaired.
