DOLBELYDR

History Album

VOLUME I

Written and researched
by
Caroline Stanford
July 2003

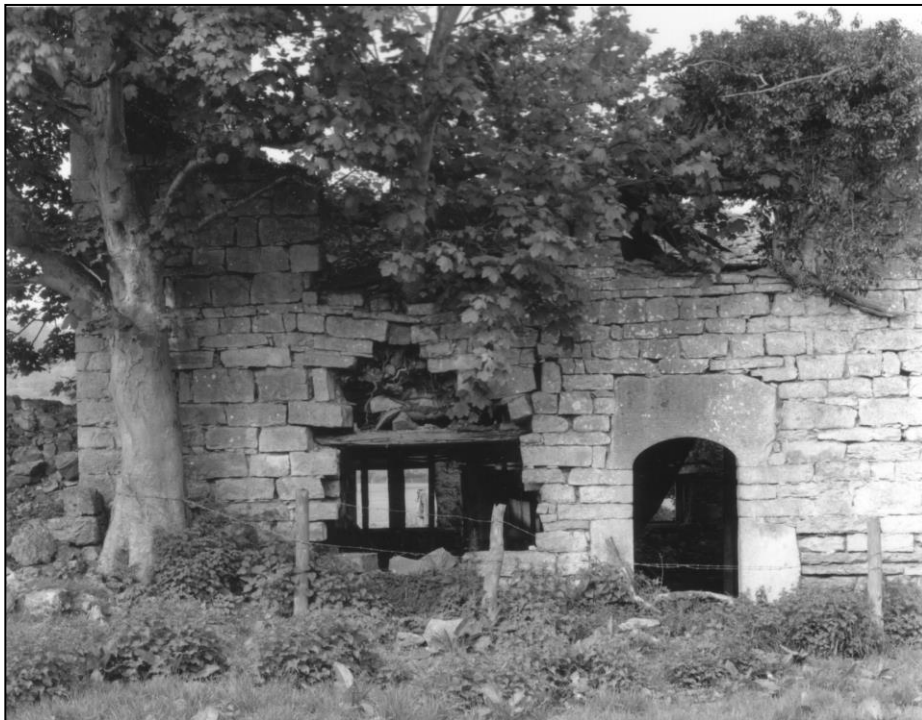
Detail of SE window and 'cyclopean' doorway

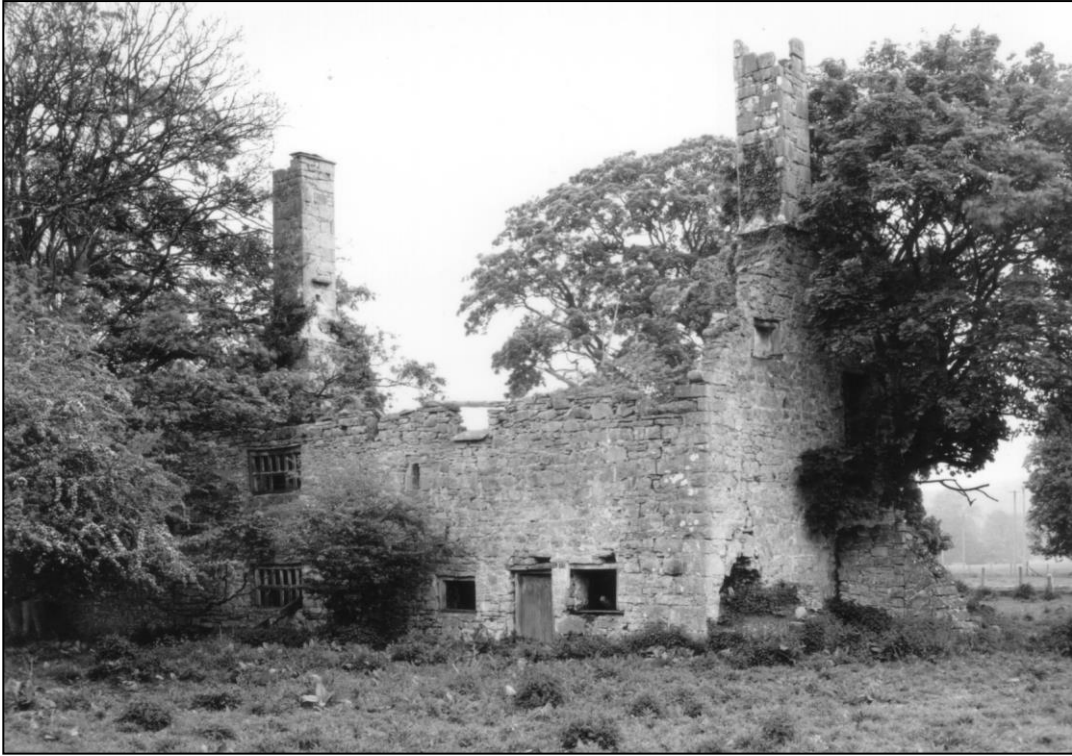
West ('rear') elevation with remains of bread oven in the SW corner and of external staircase on the west south wall.

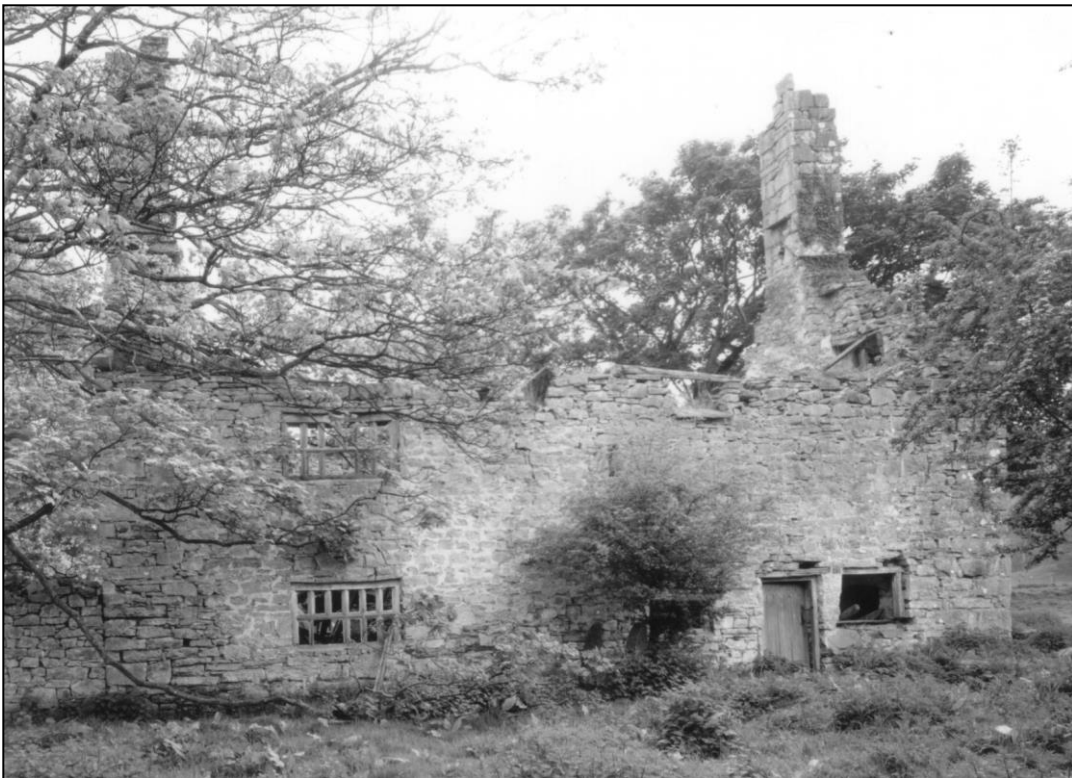
West elevation with inserted door and altered SW window.

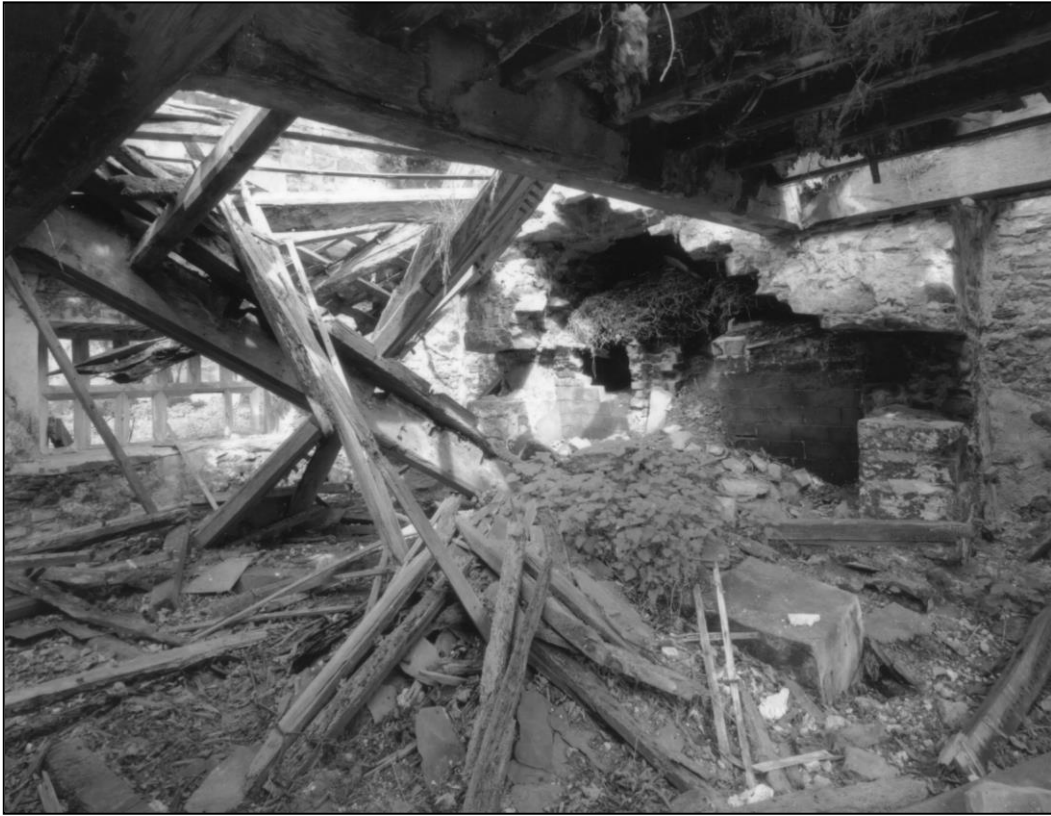
Hall fireplace – note removed bressumer under pile of rubble!

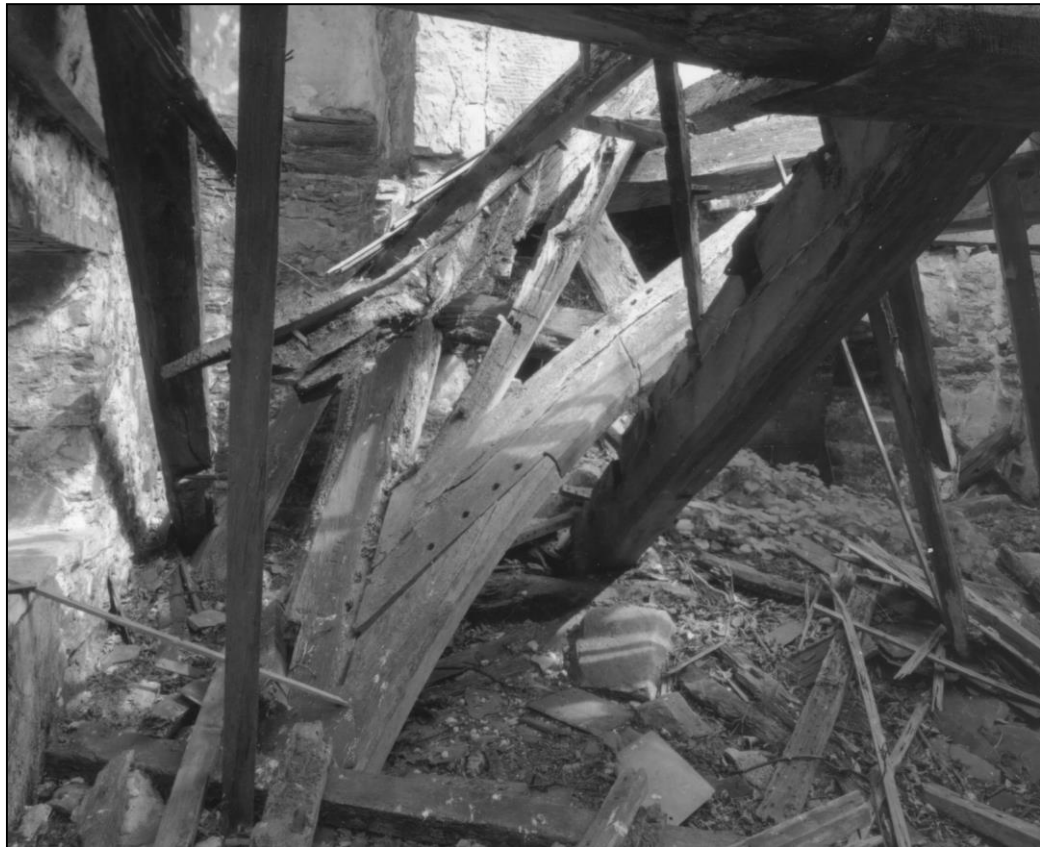
View north through hall, with collapsed arch brace from solar on floor.

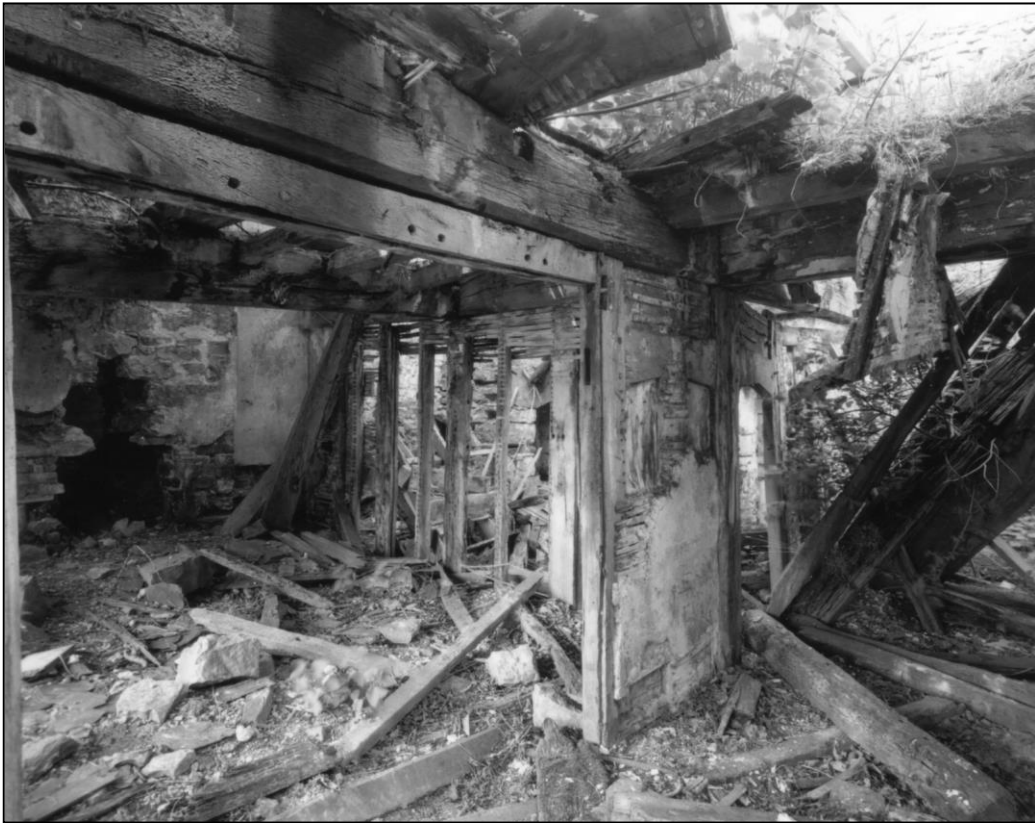
Looking west along the passage way from the front door. The screen and its pair of Tudor arched doorheads have been repositioned along the passage's south wall.

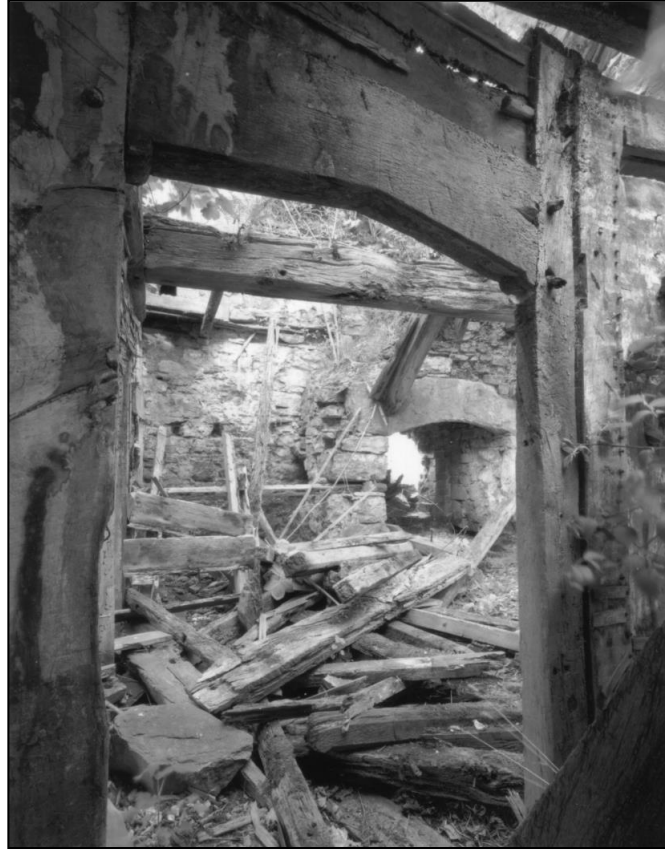
Top: View SW from passage through service room with remains of bread oven in the far corner. Its massive stone lintel was almost certainly re-used from an entrance gateway, where it now again resides.

Below: The 'cyclopean' doorway, outside and in. Note the socket for a draw bar.

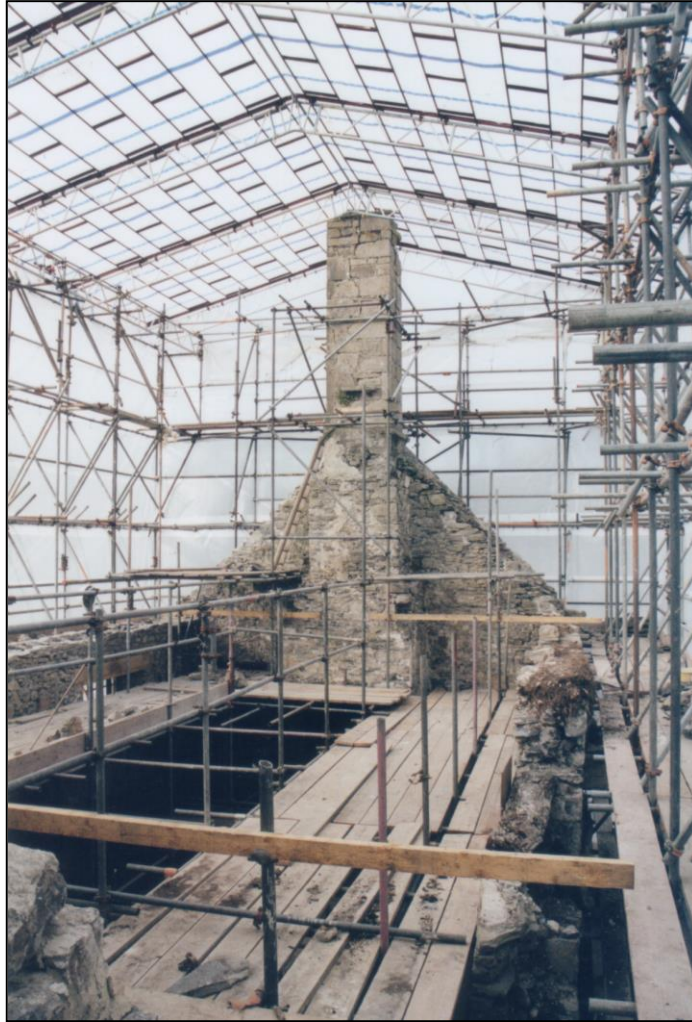
The roofspace beneath the canopy, all timbers removed.

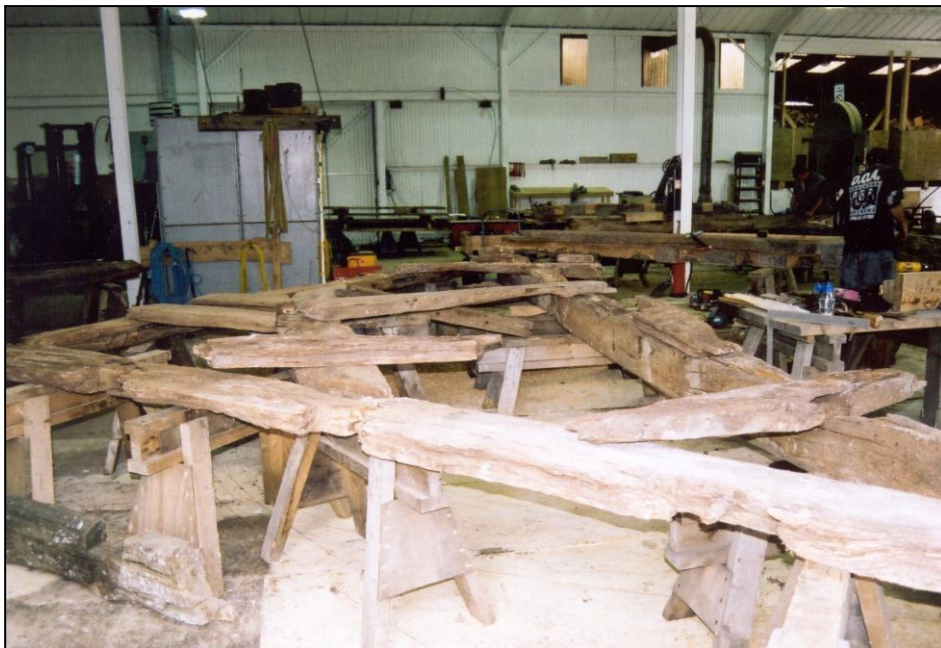
The arch-braced roof truss from the solar under repair at Carpenter Oak & Woodland's workshop in Perthshire.

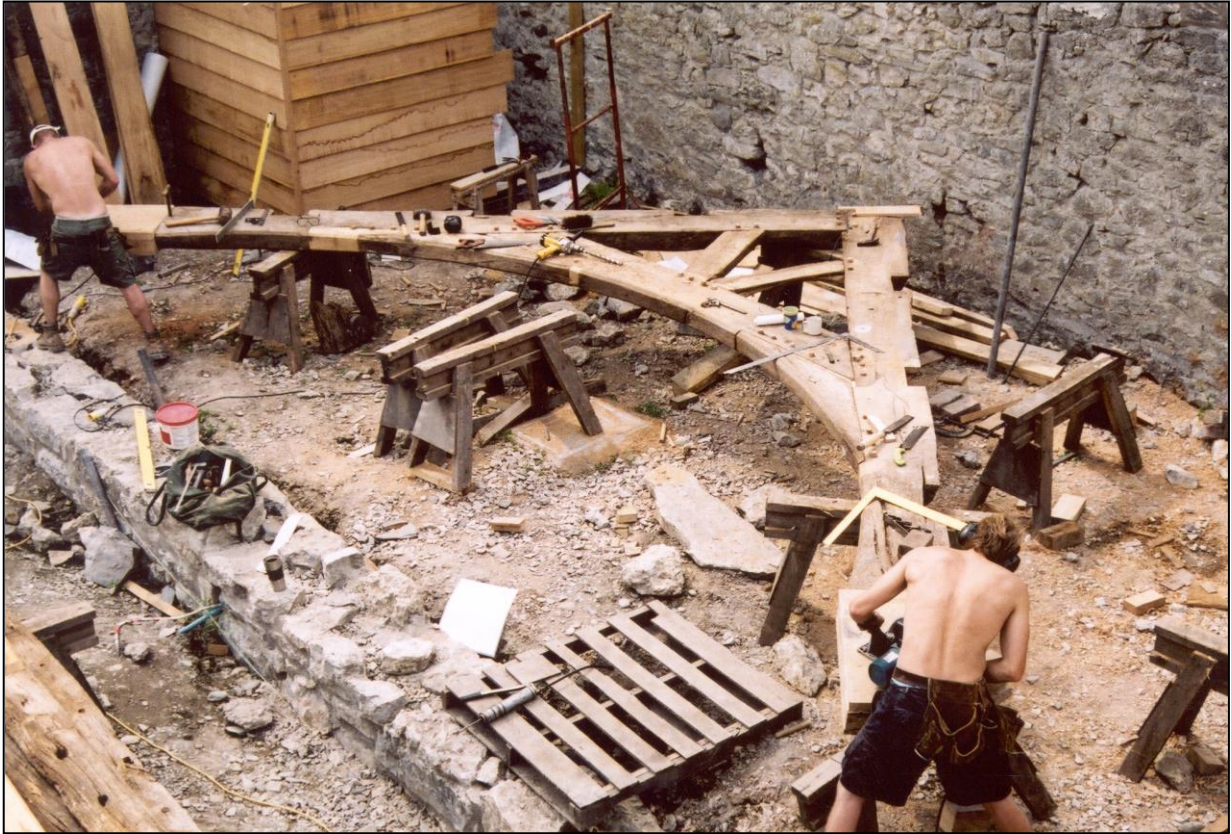
The truss was then returned to the site for final adjustments....

.... before being lowered back into place using a forty foot crane (July 2002).

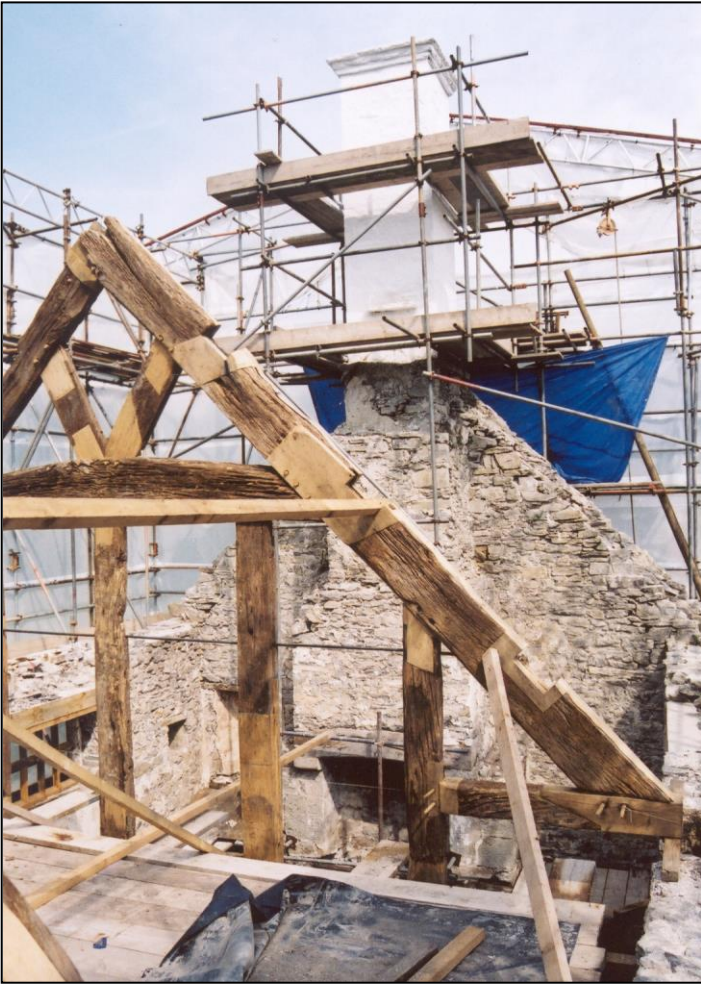
The repaired solar partition back in place (looking north) and then fixing the rafters.

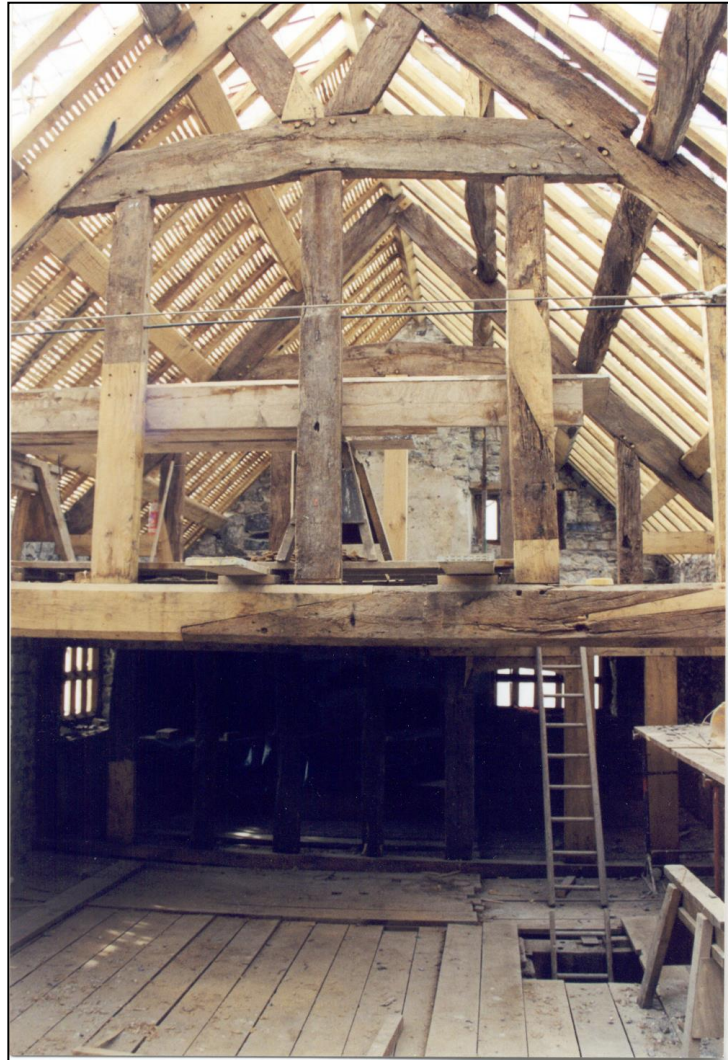
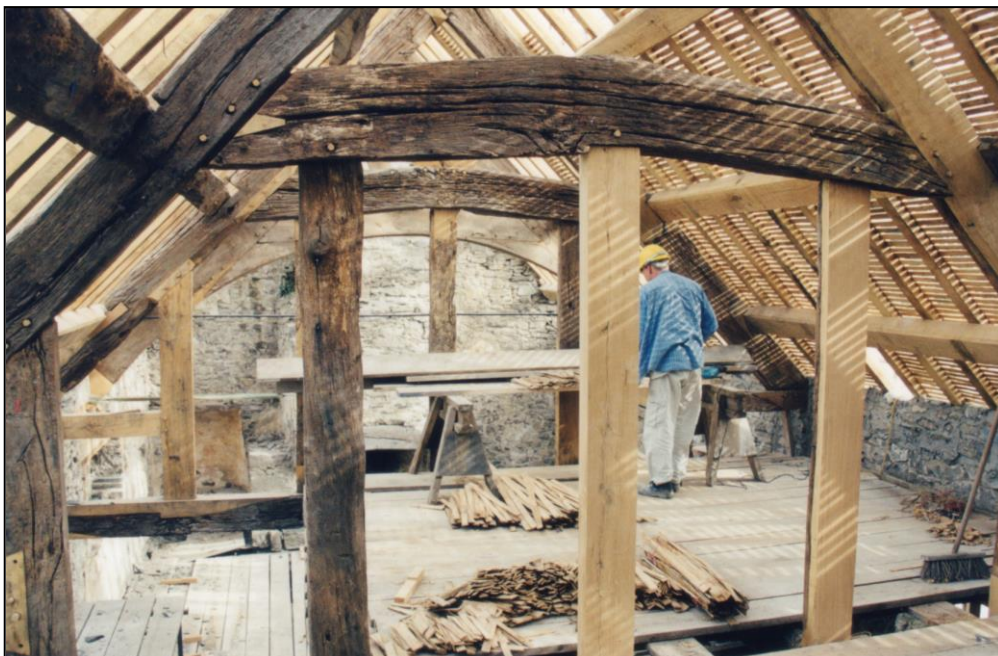
With the rafters in place, the fixing of battens could get underway (above, looking south across today's landing and below in the solar roof space).

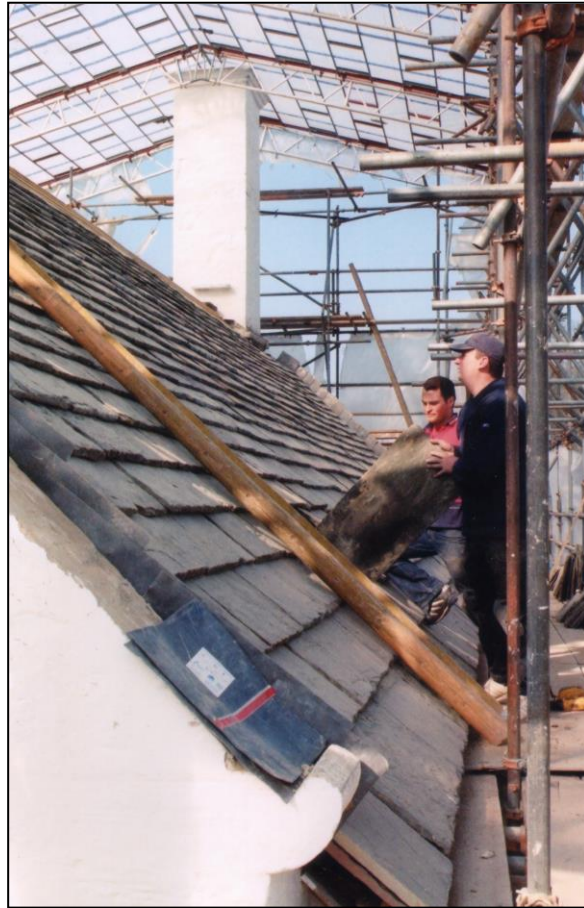
Fixing the stone rooftiles, huge at eaves level and representing some 35 tons in weight.

We had recovered some of the original stone ridge tiles and found a few stone slates on the site, more likely to have been the sixteenth-century covering than the later slate tiles, so stone was chosen for the new roof (which weighs over 30 tons). The roof also provides the evidence of a degree of error in the Tudor craftsmen's original setting out: close inspection of the way the southern gable end meets its chimney stack shows distinct asymmetry! Similarly the stone kneelers at each corner at eaves level are all at markedly different heights. This tested CO & W's ingenuity still further and to compensate for this irregularity, the feet were not added to the roof trusses until they had been returned to the site. The chimneys were each given a new slate capping.

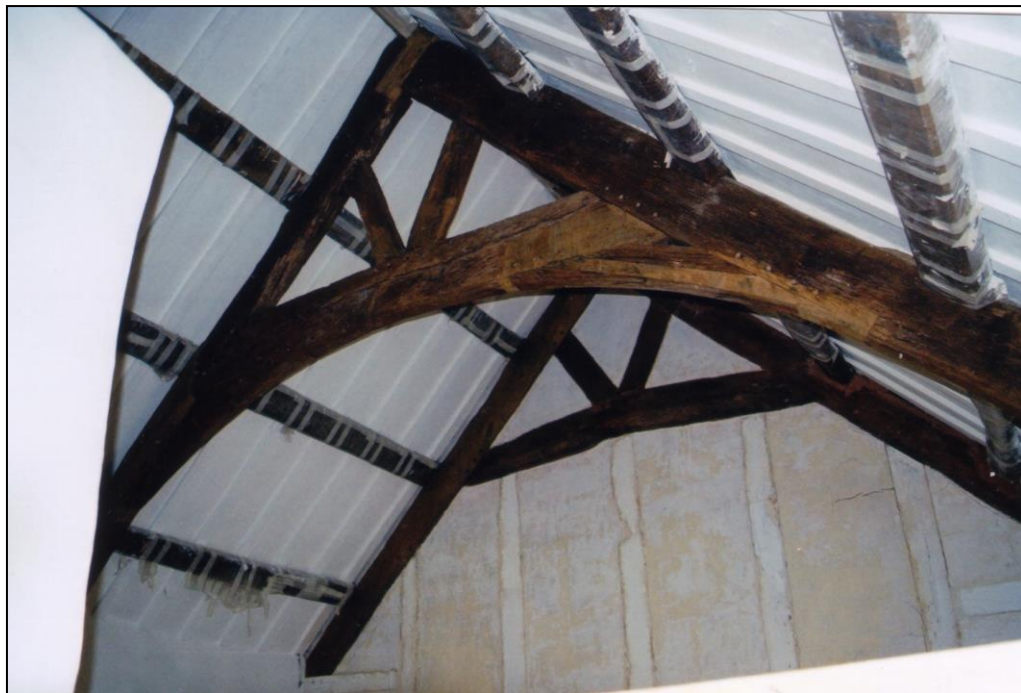
The solar ceiling: soffits torched and limewashed, purlins wrapped to keep them clean, screen partition limewashed, trusses as yet left clean. The roof is insulated with Cumbrian sheep wool (Cumbrian since Welsh sheep apparently have too oily a fleece!)

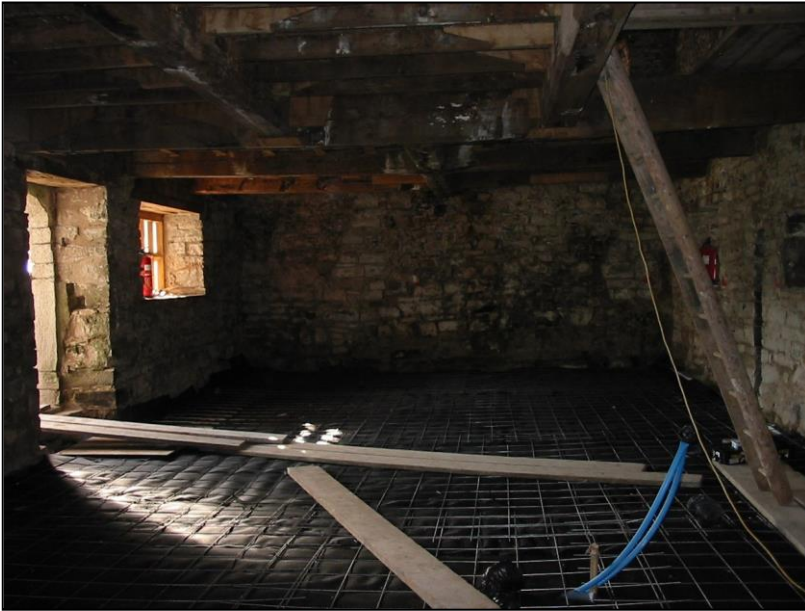
The ground floor cleared and the laying of the underfloor heating in progress

The slate floor on the ground floor may be primary, although almost all its flags had to be replaced or re-sawn. After careful recording, we lifted the floor in order to install underfloor heating. It was then replaced at the level we found it – it had almost certainly been relaid before at a slightly higher level than at first.

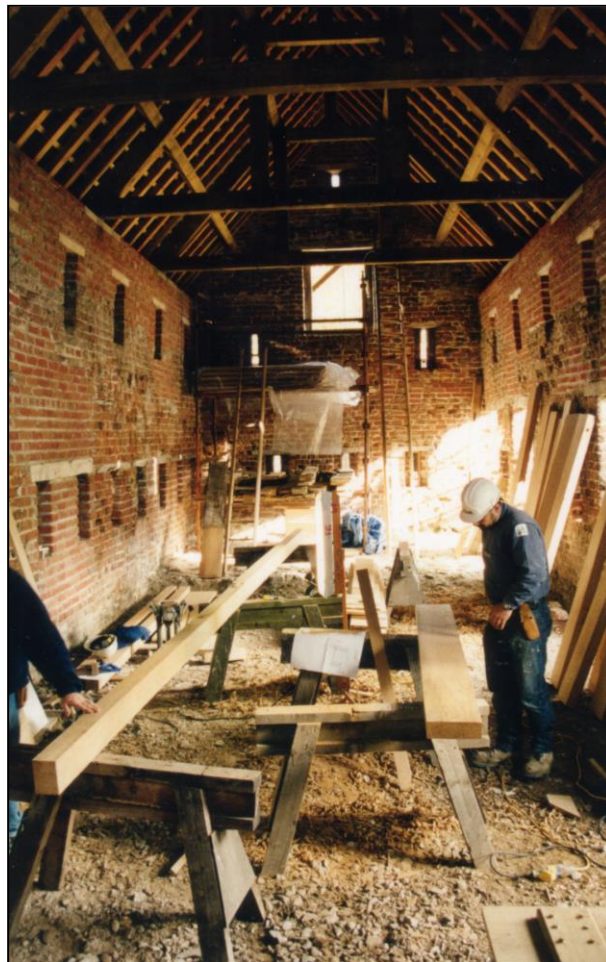
After repair with green oak, queen post roof at Cadw's request, the stables made the perfect setting out shed.

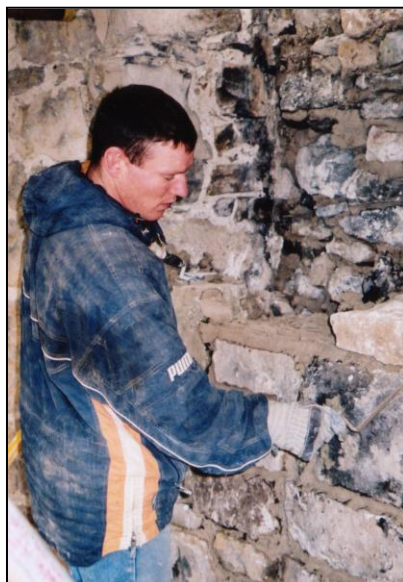
Repairs to the walls, using lime mortar.

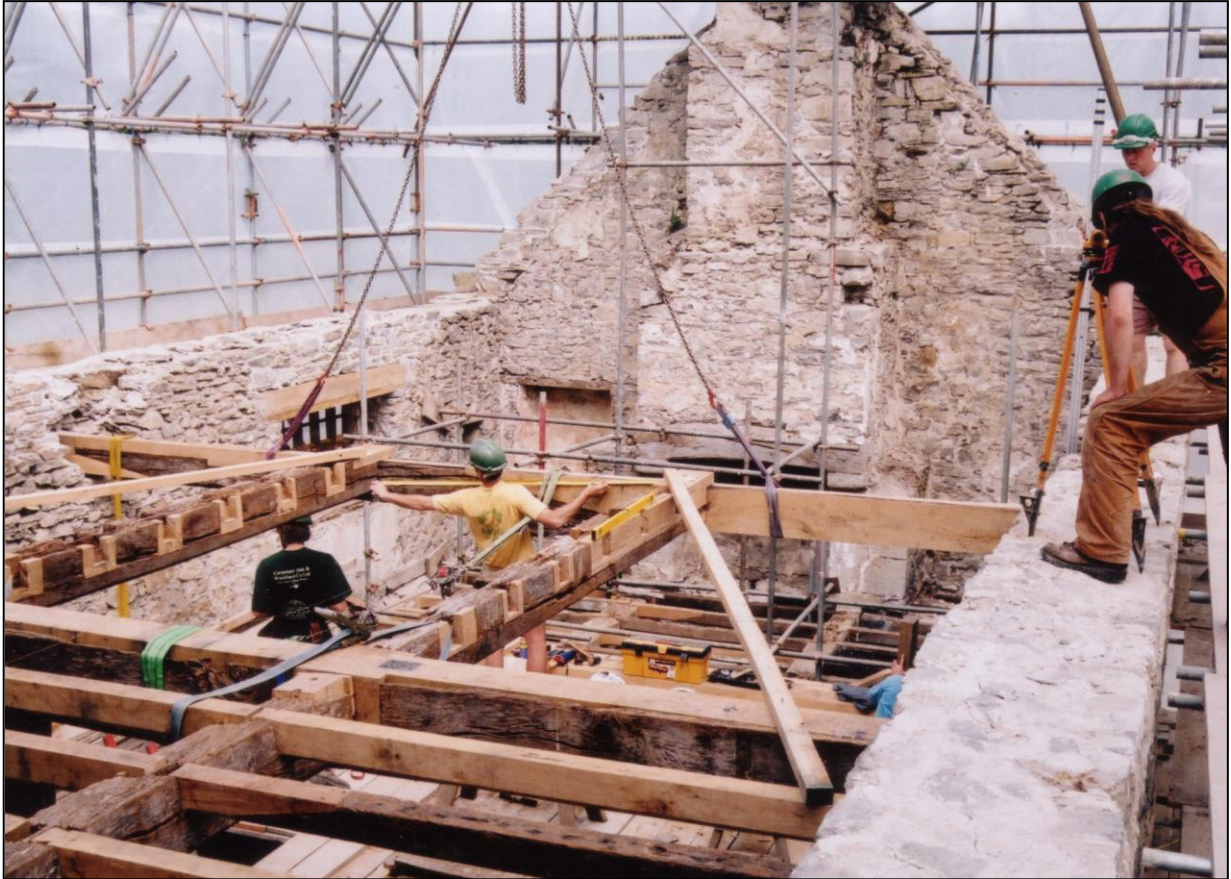
The repaired first floor joists being carefully repositioned above the hall.

Much of the first floor framing remained on site if not exactly in situ as well as some from the second floor, so replacement of the floor joists was not too difficult. Only the bridging beam in the hall had to have a steel flitch inserted for strength. The collapsed roof structure was a bigger job. For that specialists Carpenter Oak and Woodland were employed. After careful labelling, they took away the roof timbers to their framing yard in Perthshire where they painstakingly reassembled the roof frame with instructions to keep as much of the original fabric as possible, working to the architect's detailed instructions. The repairs that were necessary are honestly expressed to be read as such. Late in the autumn of 2002, a forty foot crane arrived on site to lift the three massive roof trusses back into position through the scaffold of the temporary roof which had been protecting the building and allowing it to dry out in the meantime.

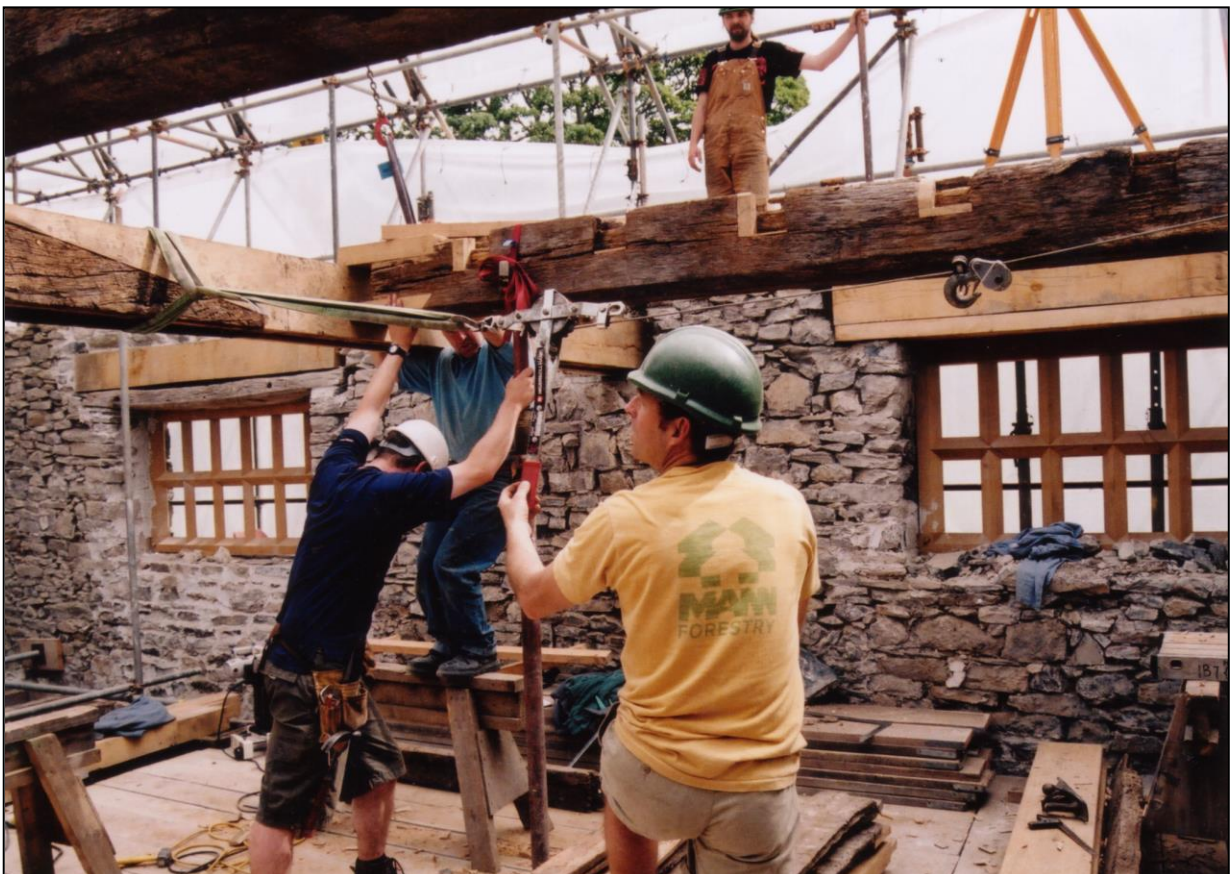
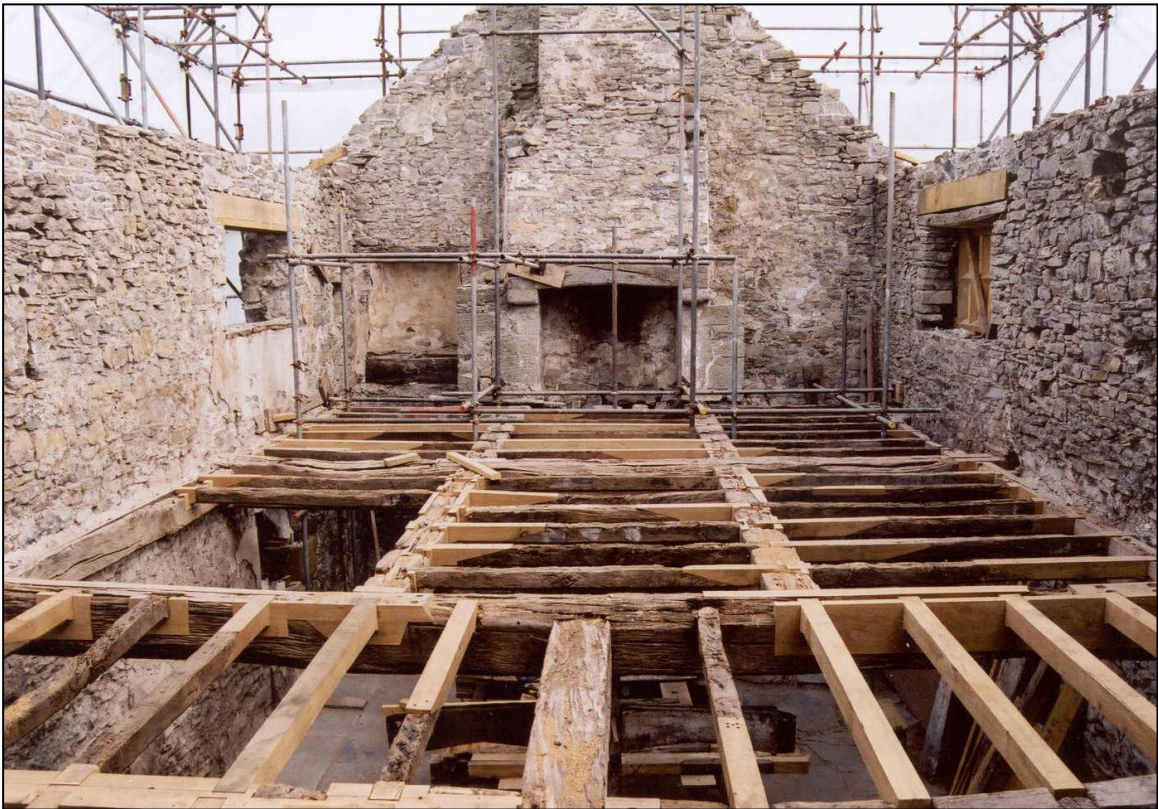
The first floor joists patched and reinstalled, looking across the solar floor.

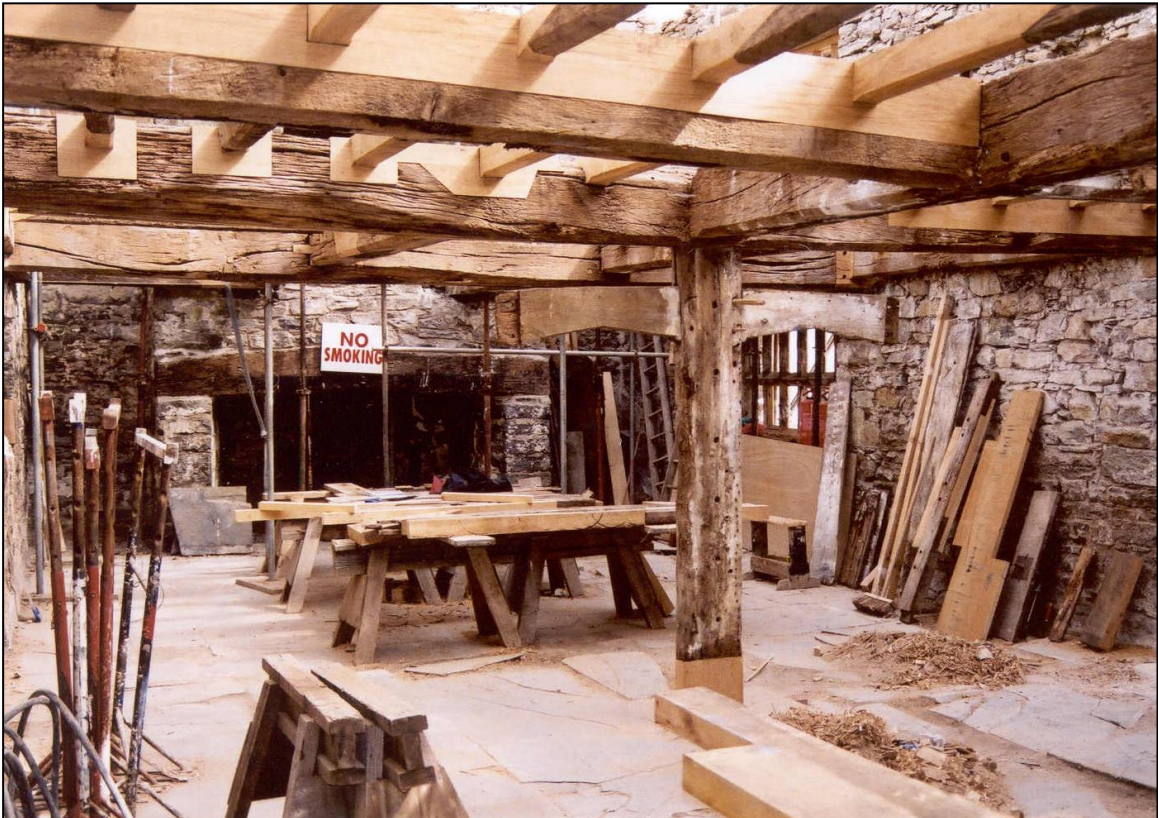
The same floor structure viewed from the hall below.

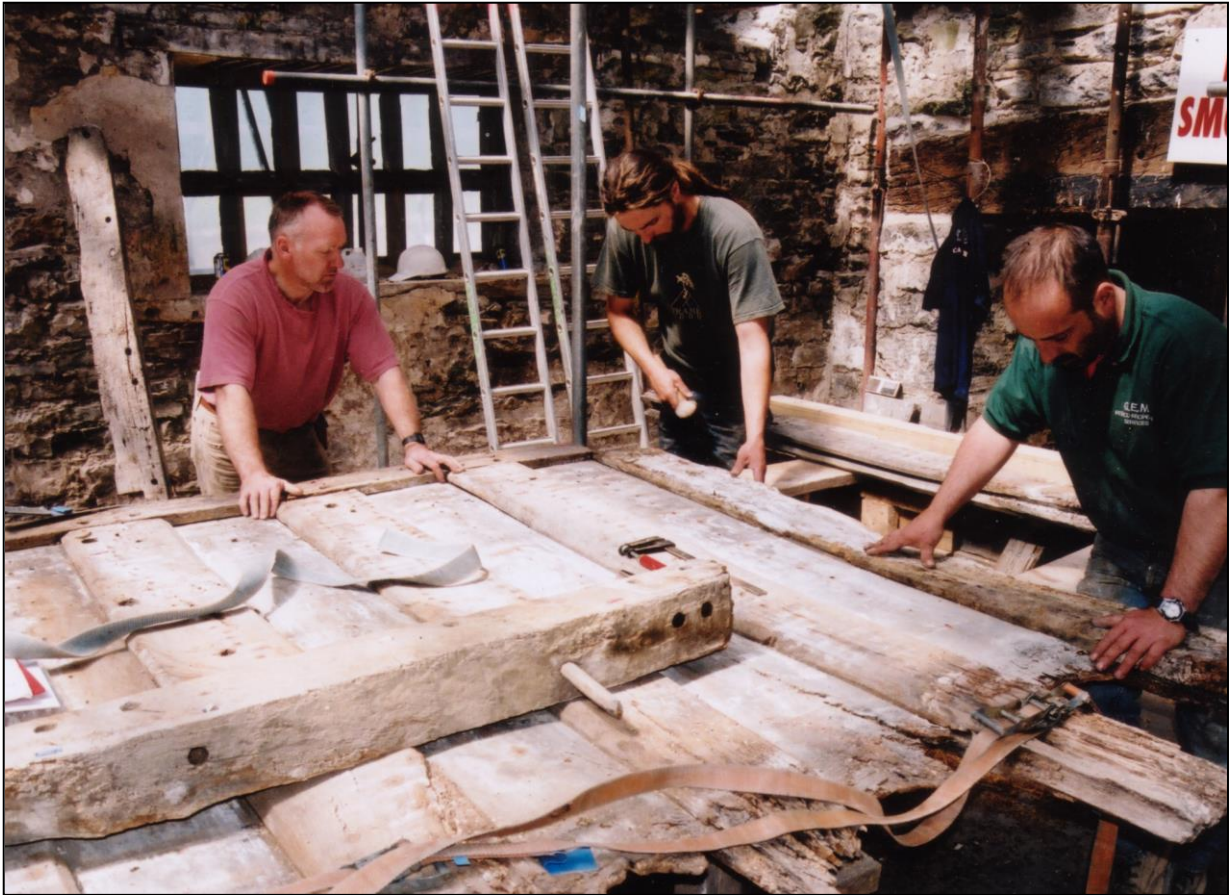
Piecing the plank and muntin screen back together.

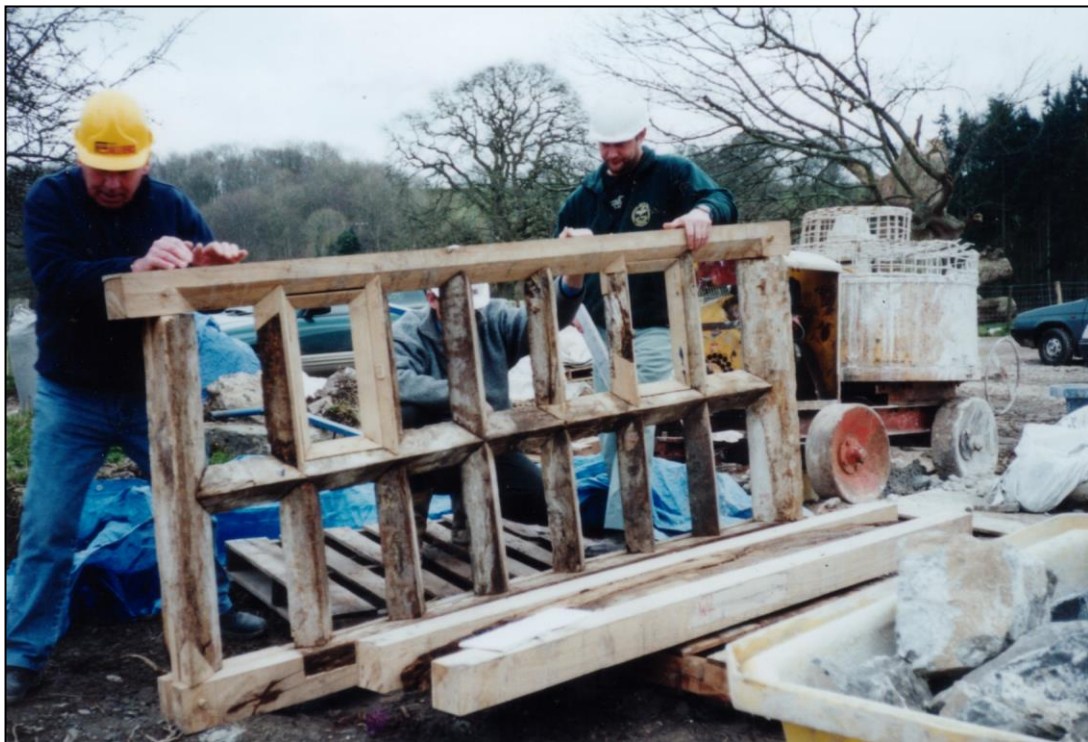
The east hall window repaired and ready for return to the building.

As apparent from early photographs, much of the fabric of the many mullioned window frames is, remarkably, primary, except for the little opening casements which were probably added later. Repairs have been carefully patched in where necessary and they have been limewashed inside and out as they would have been originally, in imitation of stone. We found a single diamond-shaped quarry amid the debris of the house, which, like much early glass, was a surprisingly dark green. Careful thought went into the choice of today's lead and glass, which retains a greenish tinge and was made in France. Despite the many-light windows, the heavy beams made lighting an issue in this room and so we have resorted to recessed lights on the ground floor to provide an even spread of light to the inner parts of the room without visually obtrusive lamps or light fittings. The ironwork throughout the building (latches, hinges, bolts, handles...) was all made for us in wrought iron by John Hoare Ward, to architect Andrew Thomas's designs.

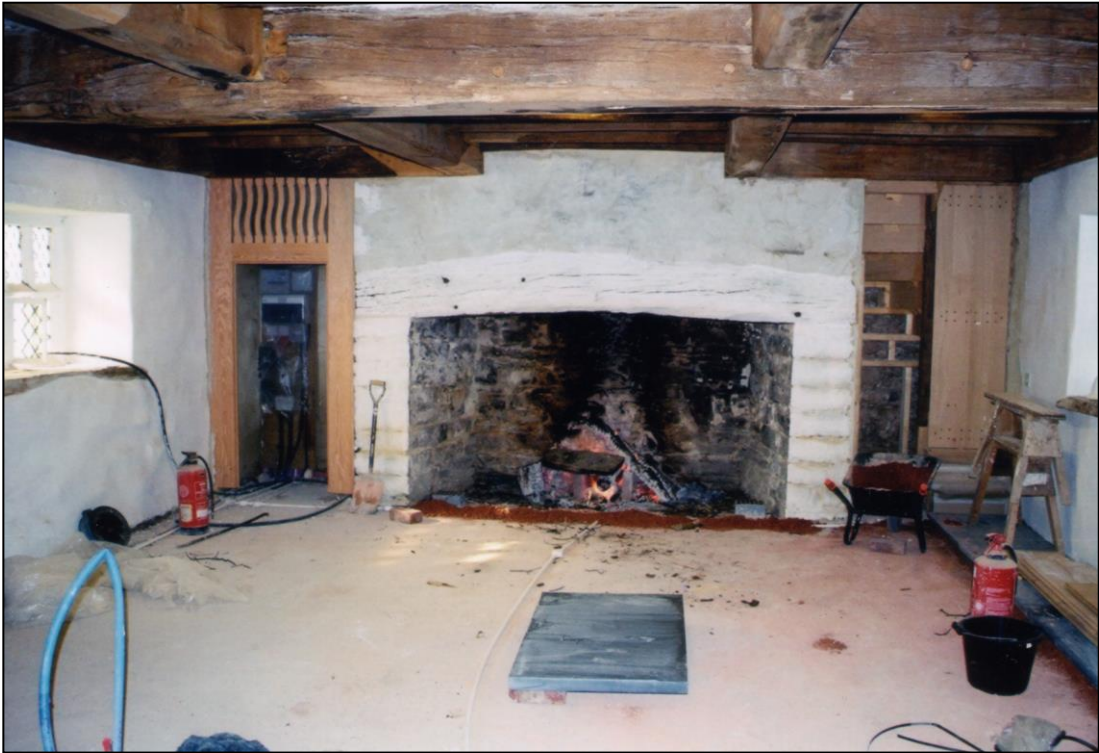
Test fire in the hall hearth – always a relief when it draws! A sample floor slate is laid out and the fretted screen above the cupboard is now installed. The spiral stairs are under construction.
