The Landmark Trust

KINGSWEAR CASTLE

History Album

Compiled by Charlotte Haslam in 1990

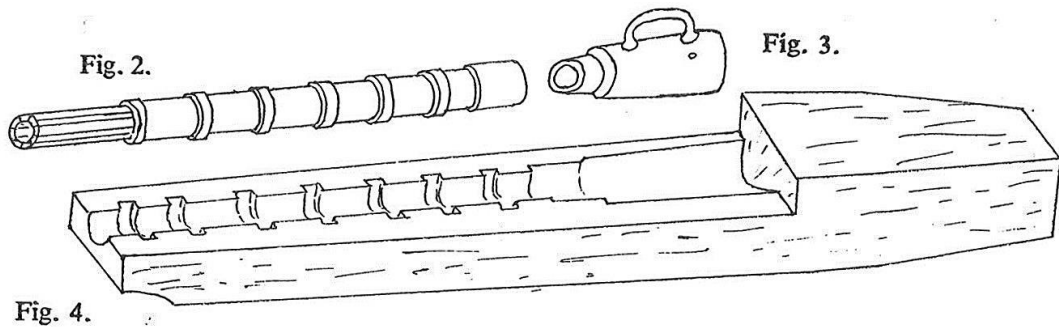
Figs. 2, 3 and 4. The components of a breech-loading gun. Fig. 2. The barrel in the making. Fig. 3. The breech chamber. Fig. 4. The bed.

The second component was the breech-chamber (Fig. 3) which held the powder charge and was forged from wrought-iron strip wound one coil on top of another leaving a central cavity to take the charge and being coiled thickly enough to withstand the pressure generated by exploding gunpowder. One end of the chamber was forged over and sealed, the open end was shouldered to fit snugly into the breech end of the barrel previously described.

The final requirement to complete the piece was the bed or stock and Fig. 4 gives a general idea of the design which housed the barrel and chamber. This was usually made of elm or oak and fitted with straps of wrought-iron to hold the barrel into its bed, some of the more primitive being held in place by ropes or bindings. An iron wedge attached by a chain to the bed was used to force the loaded powder-chamber into the barrel prior to firing (Fig. 5).

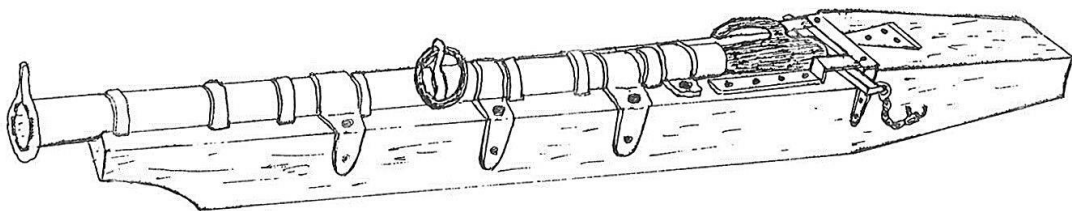
Fig. 5. A wrought-iron breech-loading gun on a bed-stock showing the chamber and wedge in position.

From *The Cannon of Dartmouth Castle* by Austin C. Carpenter.
Kingswear was designed for guns similar to this.

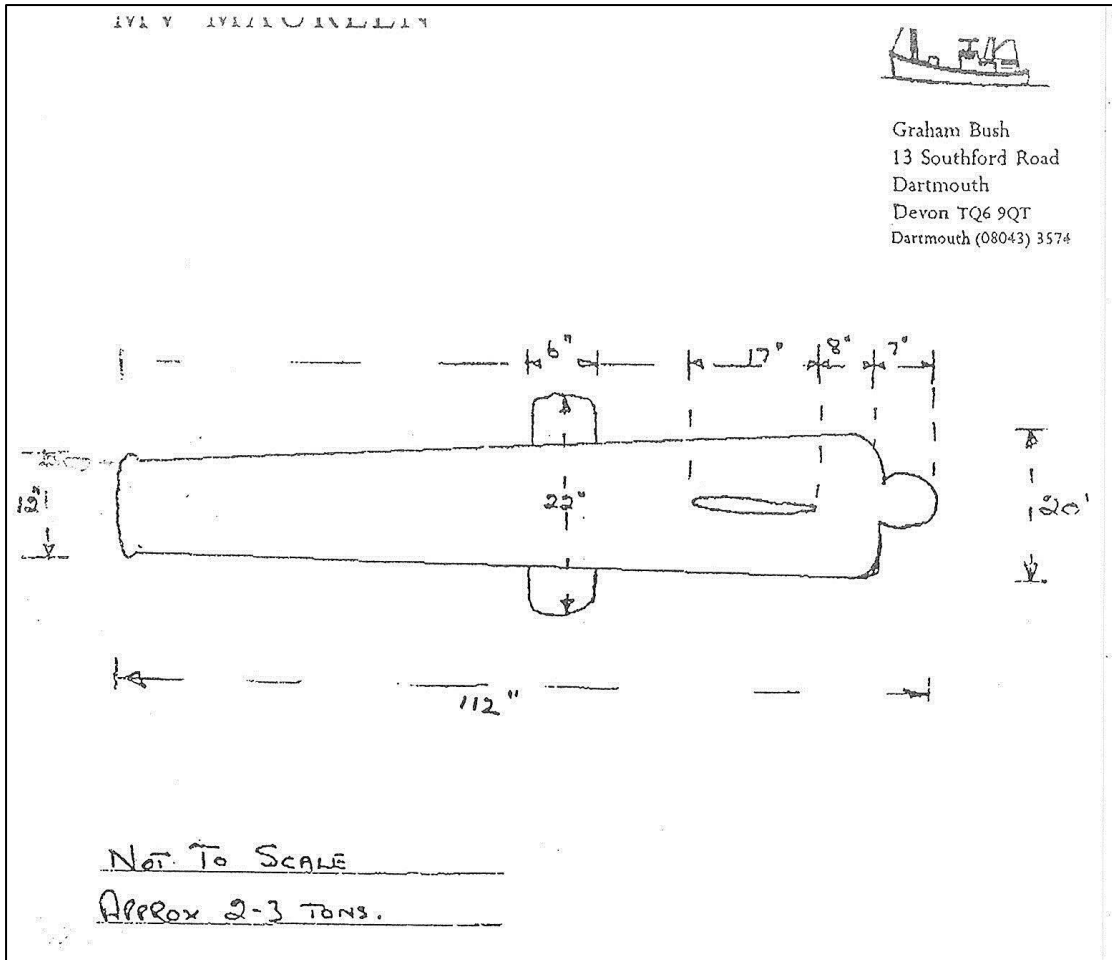
Gun found on sea bed below the Castle

In 1988, two guns matching Colonel Lilly's descriptions were seen on the seabed below the castle. It would not have been the first time that redundant guns were simply consigned to the waves.

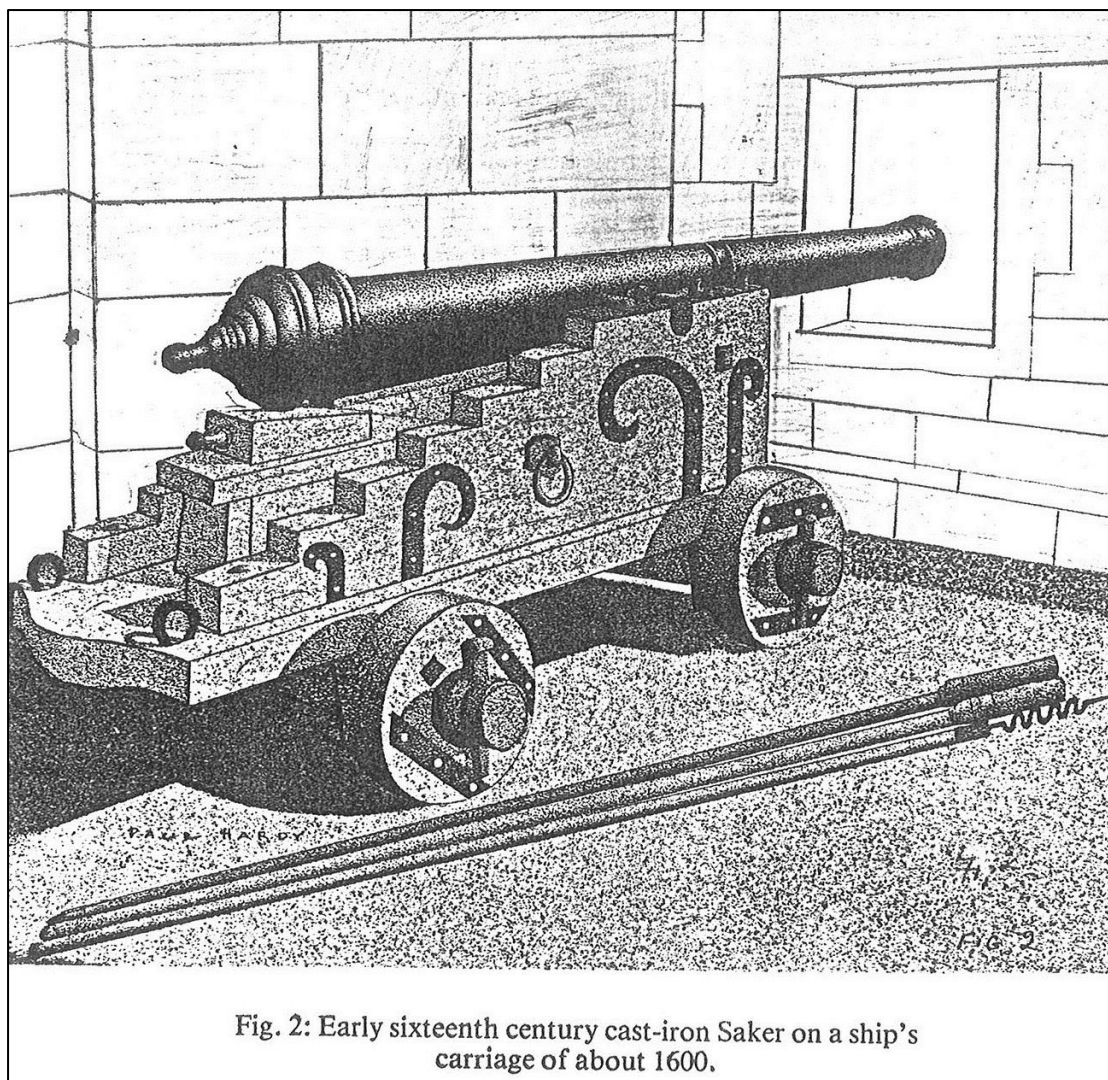
Fig. 2: Early sixteenth century cast-iron Saker on a ship's carriage of about 1600.

An illustration from Austin C. Carpenter's *The Cannon of Pendennis and St Mawes Castles, Cornwall*. Similar ad hoc combinations of guns and carriages would have been found at Dartmouth and Kingswear Castles in the late 16th and early 17th centuries.

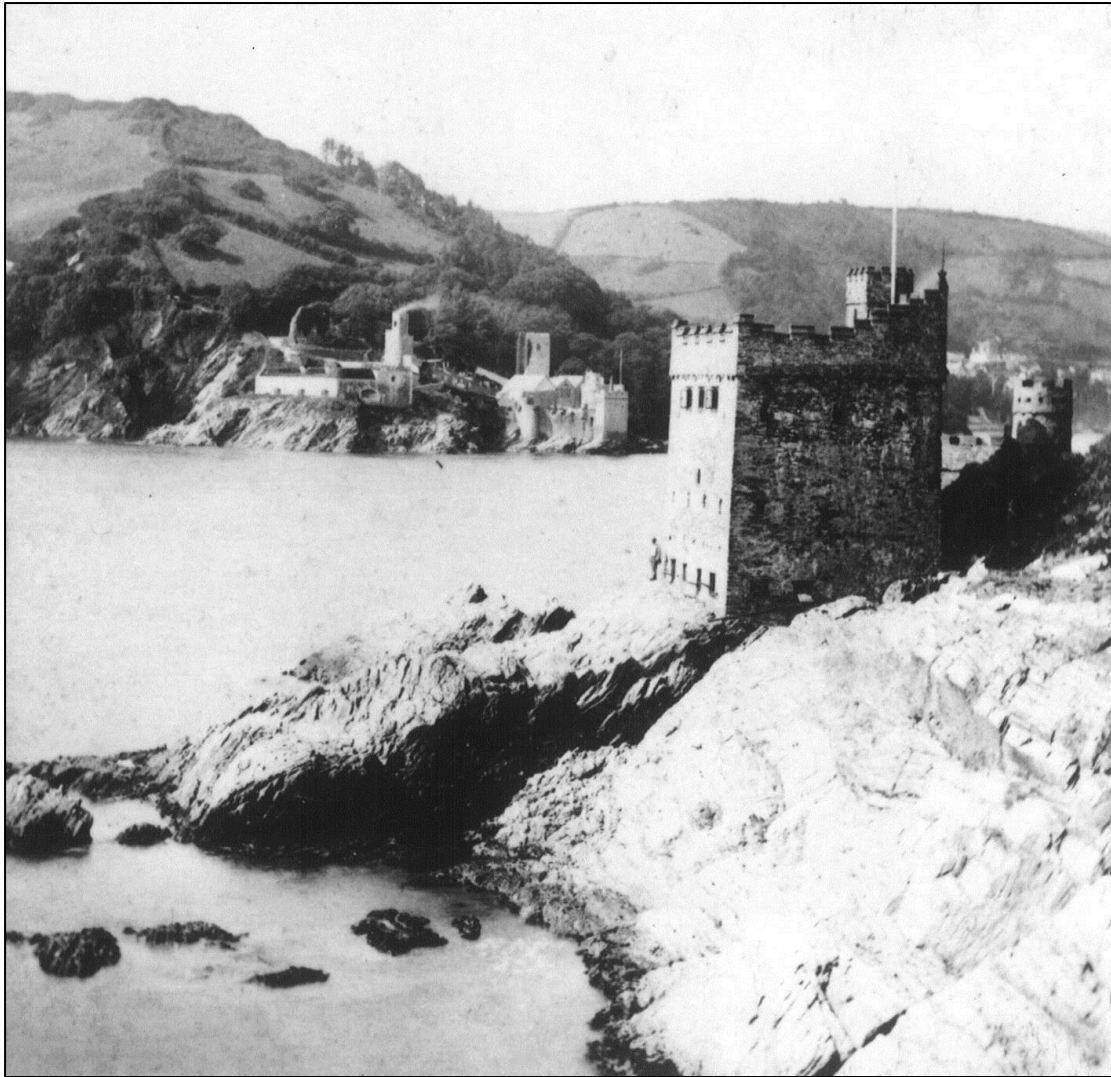
Photograph in the National Monuments Record, of about 1930. The large window on the first floor has not yet been formed.

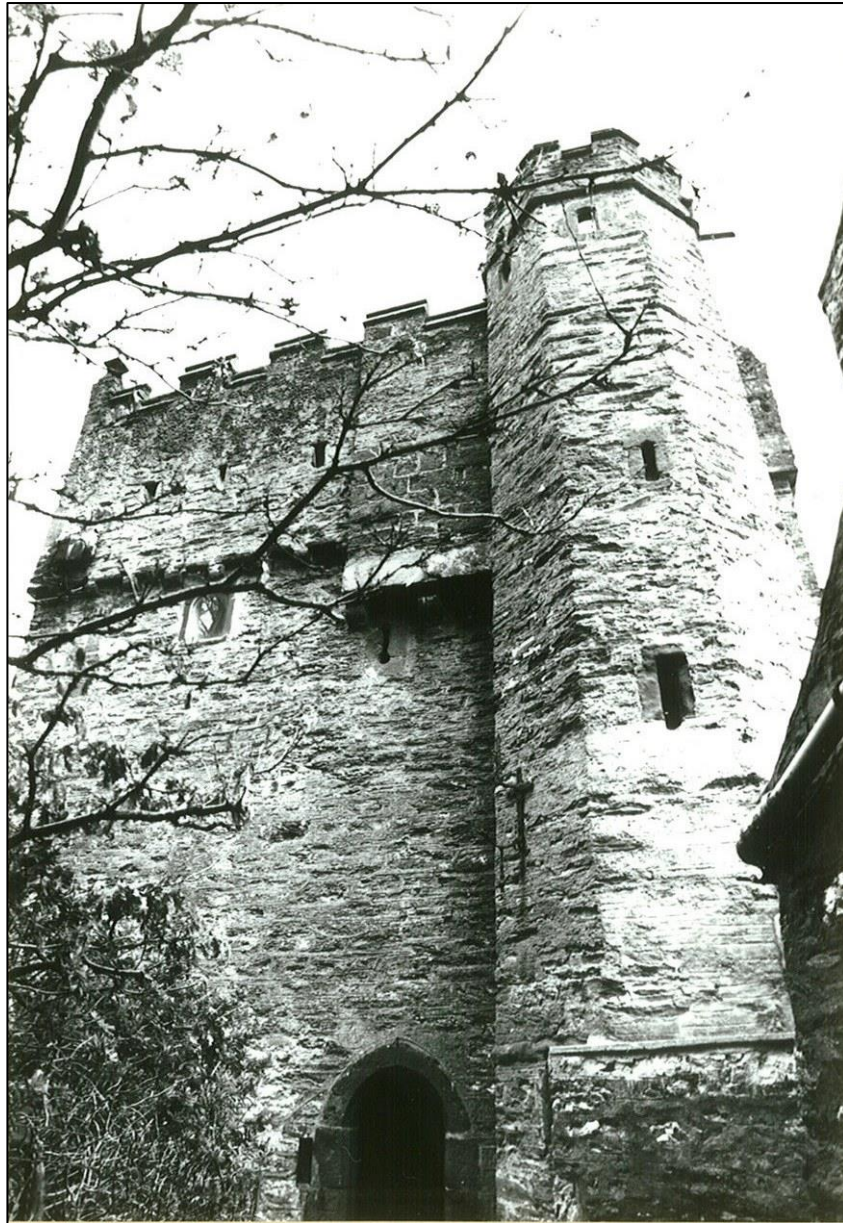
Cement had been smeared over the walls of the castle

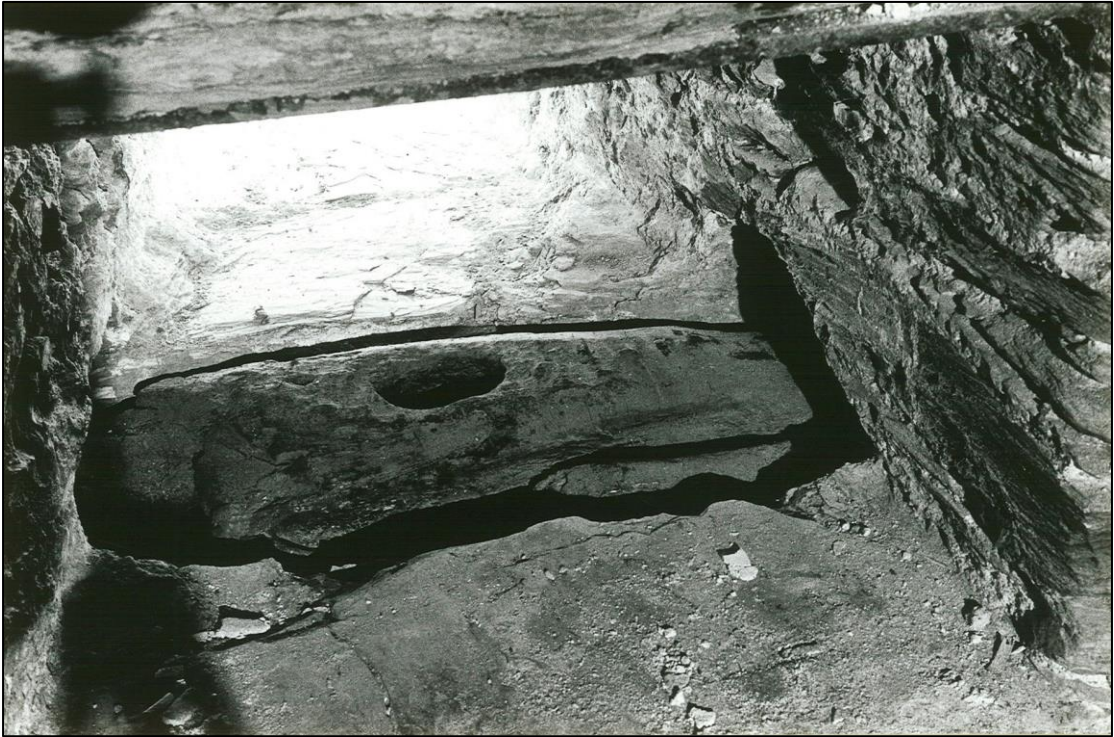
One of the timber plates discovered in the cills of the gun embrasures.

An interesting detail at Kingswear is the timber plate that was found to run through the cills of the gun embrasures. On the ground floor this had almost entirely rotted away, leaving only an empty channel that has now

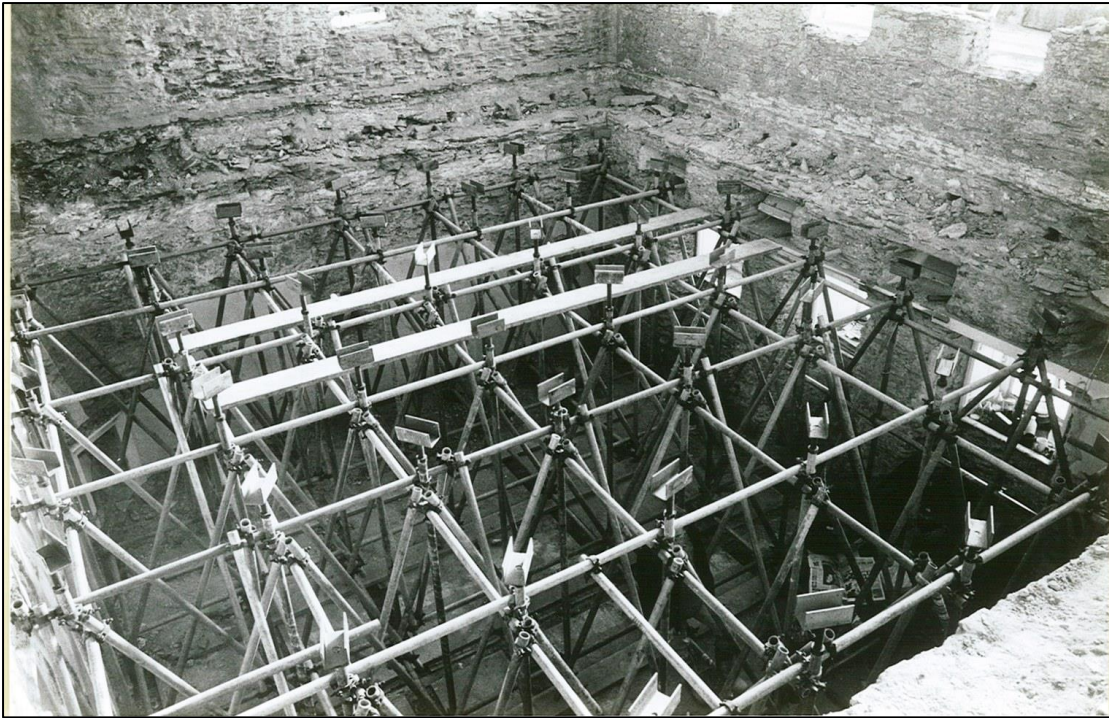
The birdcage scaffold for the shutterings of the new cast concrete roof structure.

Before any of this could be realised, and the refinements of finishes be arrived at, there was a lot of structural work to be done: the Victorian pitched roof, for example, was decayed and leaking badly, and had to be

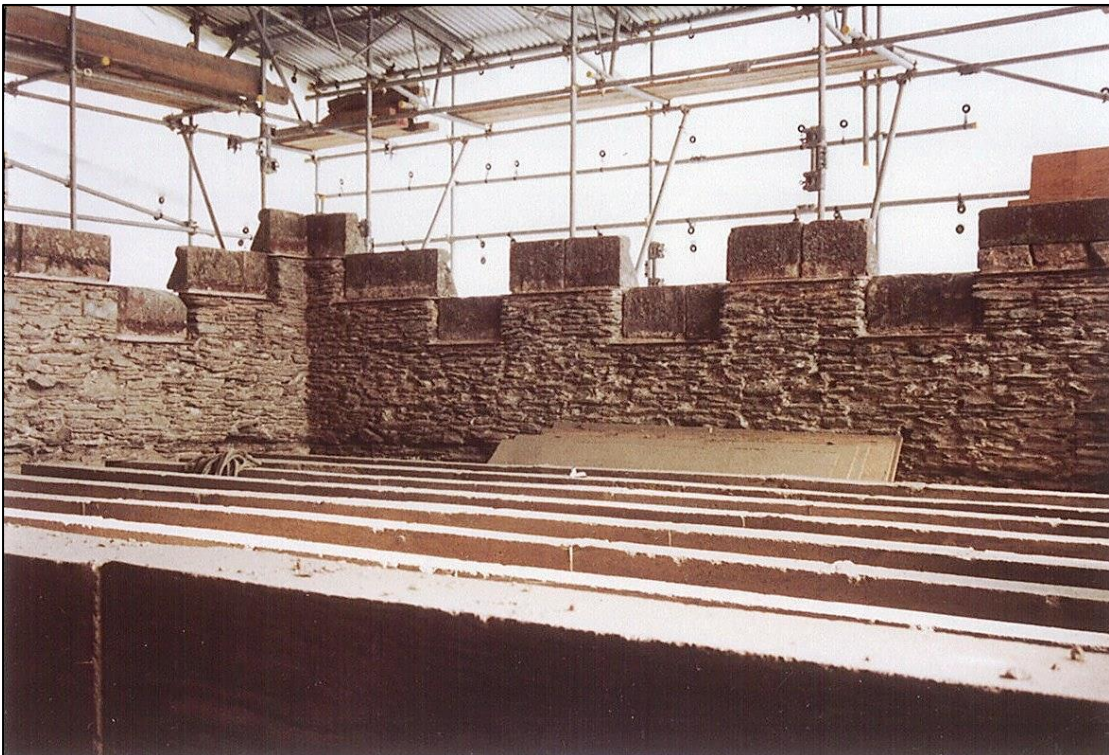
The new roof, with its upstand beams, or ridges.

17th century, but any traces of this were lost in the 1855 restoration. The Victorian roof was pitched, and was replaced by the existing platform.

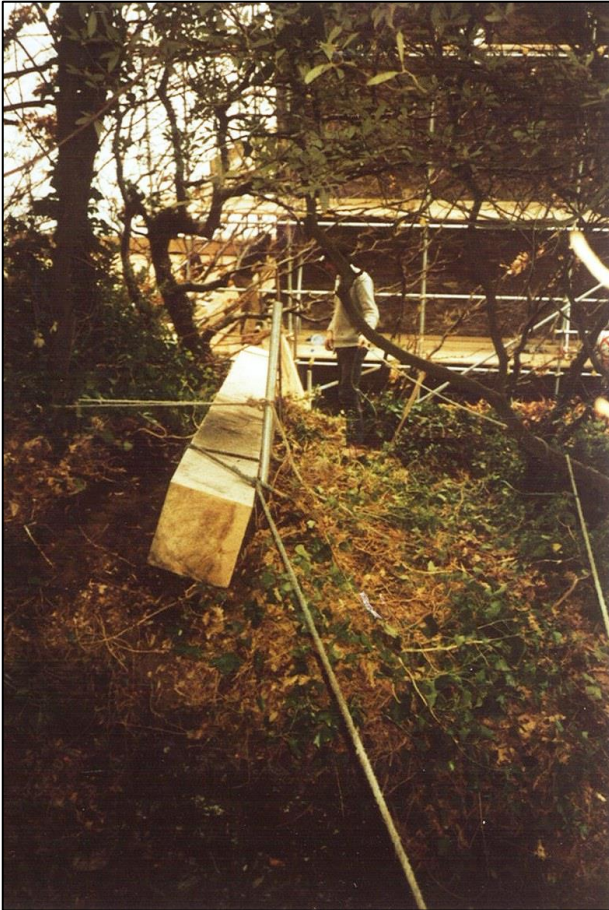
Working the bridging teams for the new first floor.

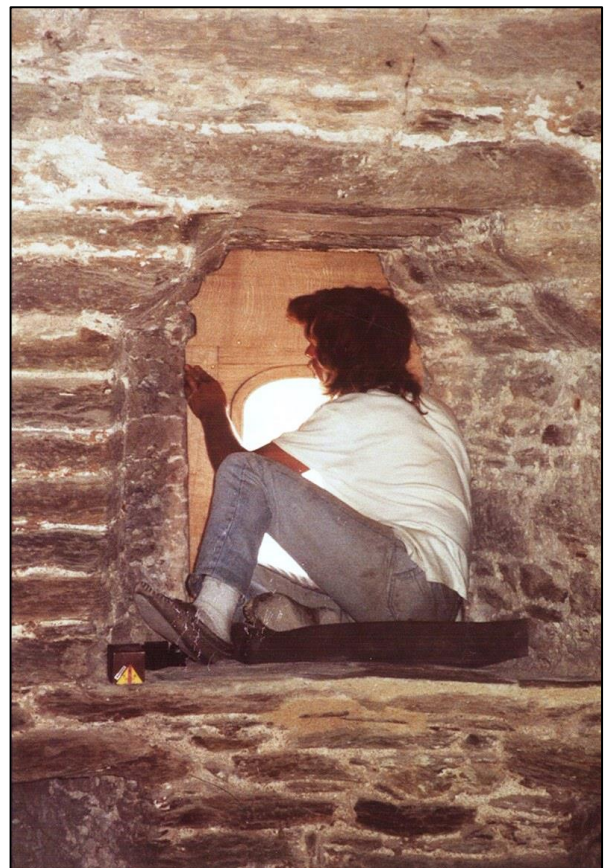
Fitting a new window on the first floor.

The other windows had been glazed close to the inner face of the wall, which allowed seagulls to nest in the gun embrasures, making a lot of mess. The new oak windows have been set on the outer face, therefore.

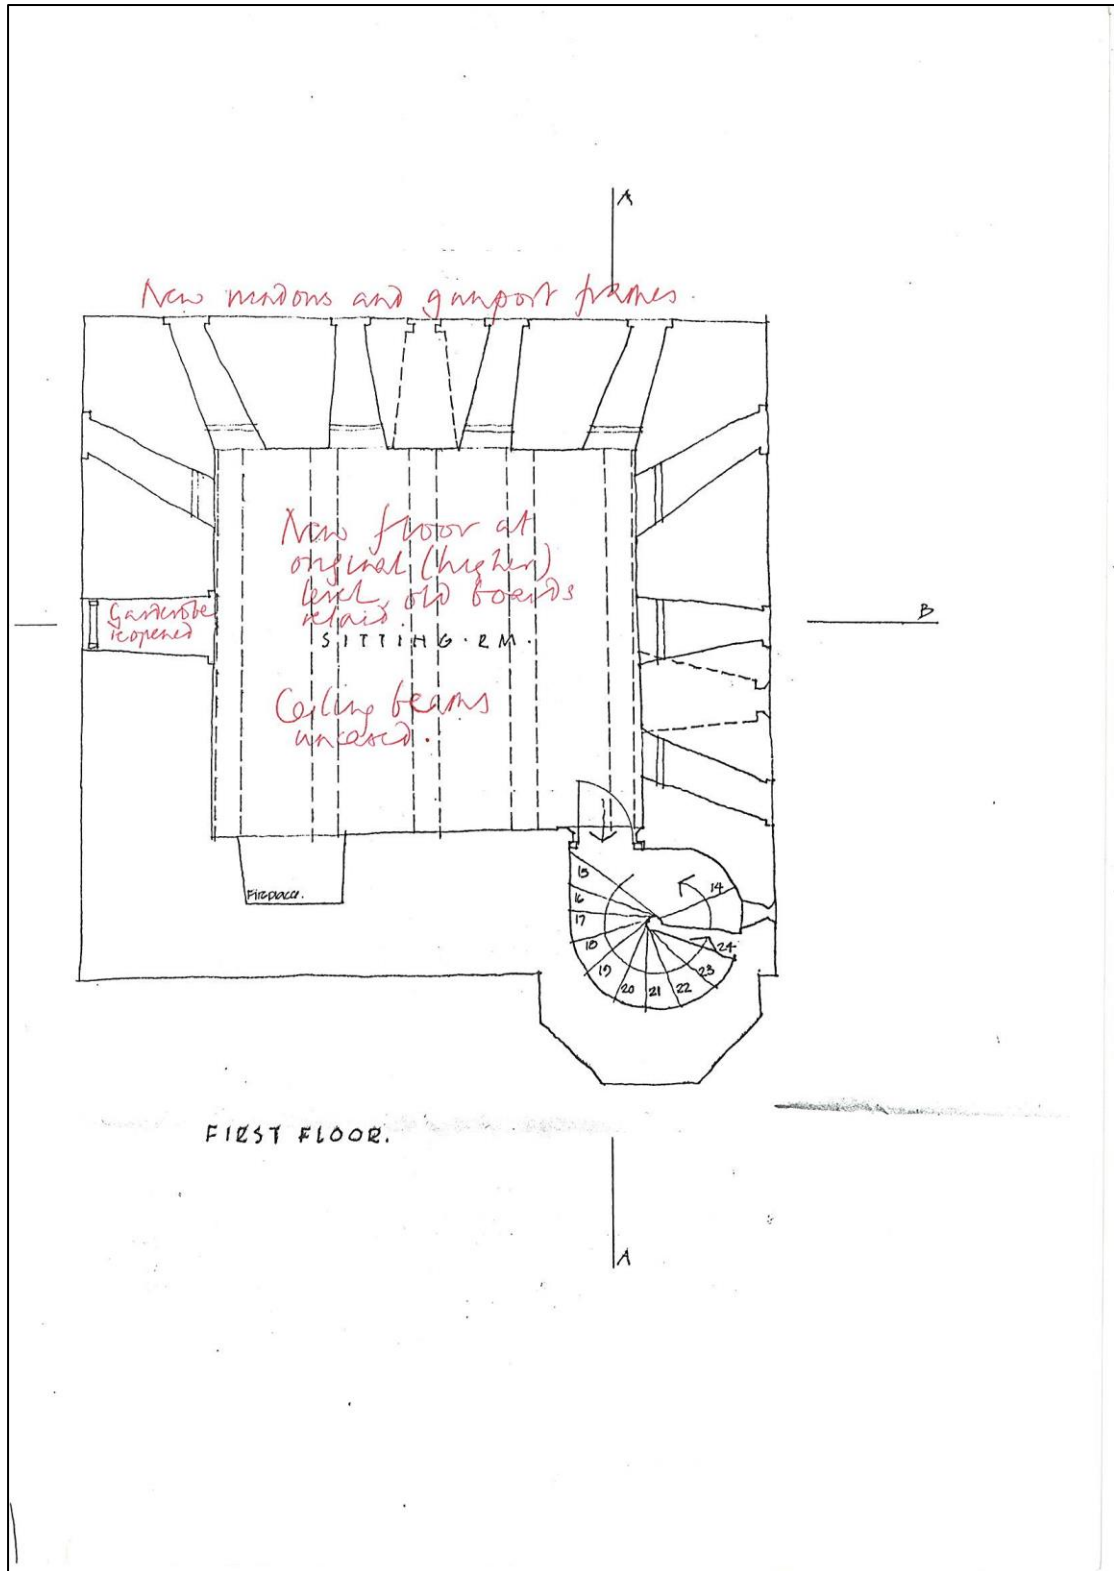
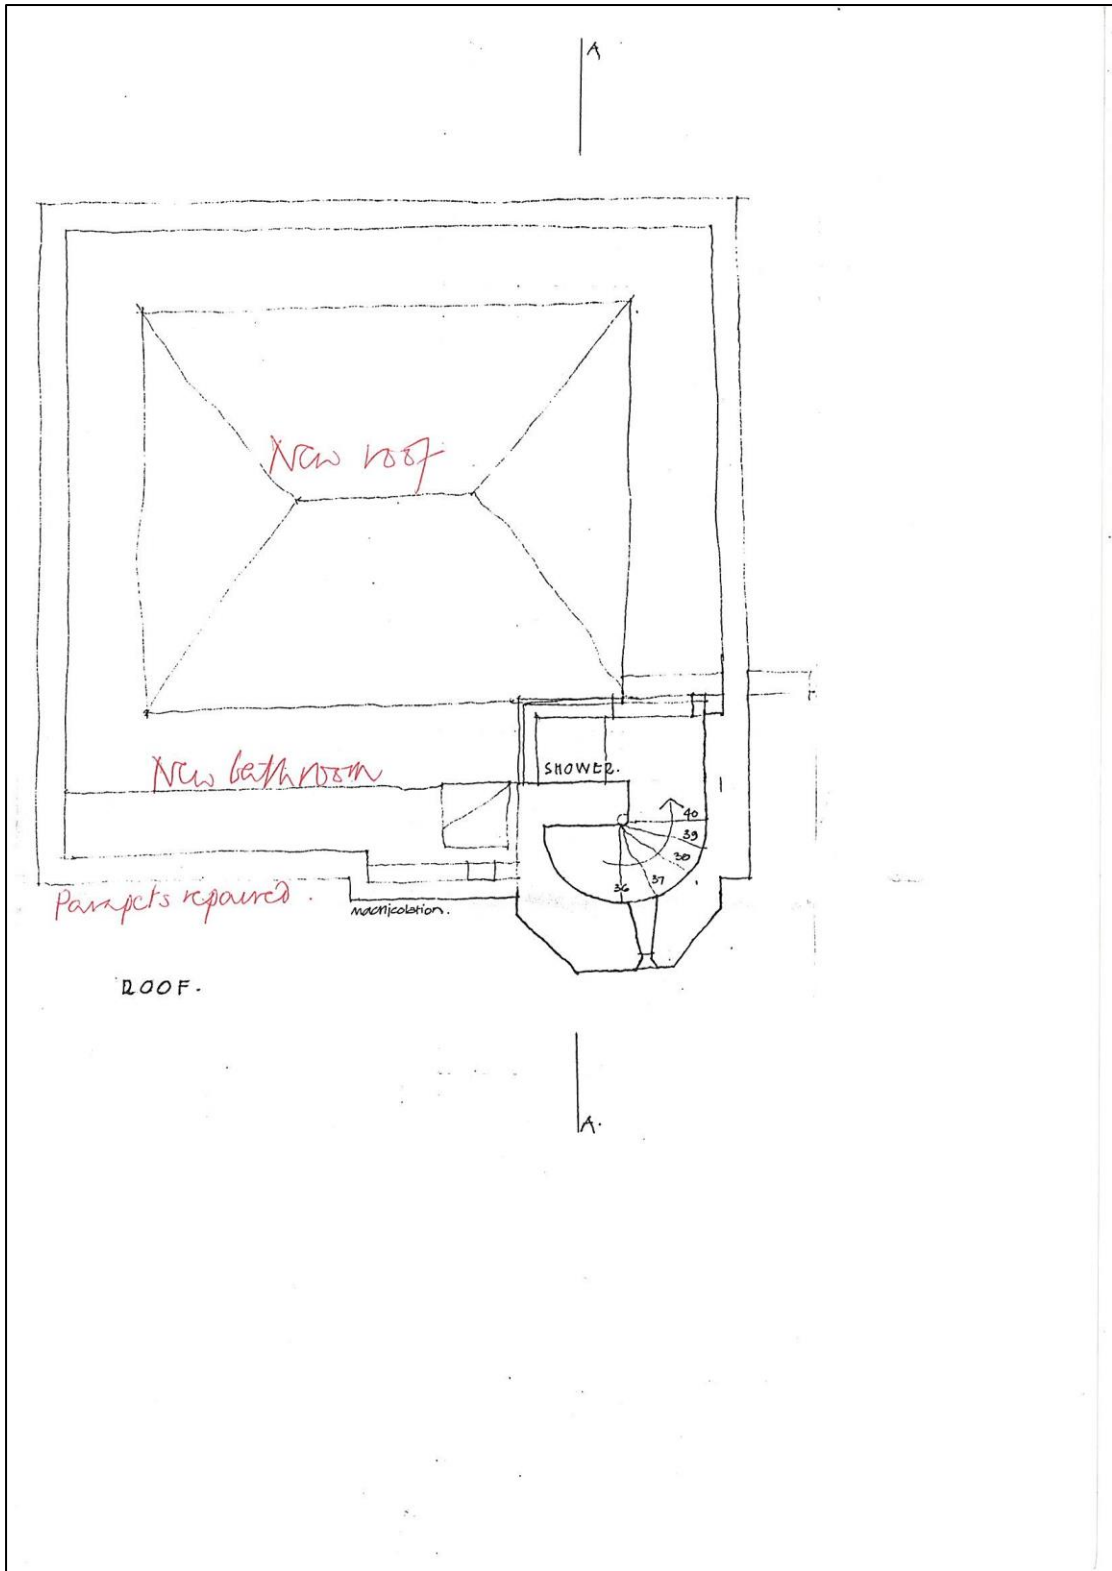
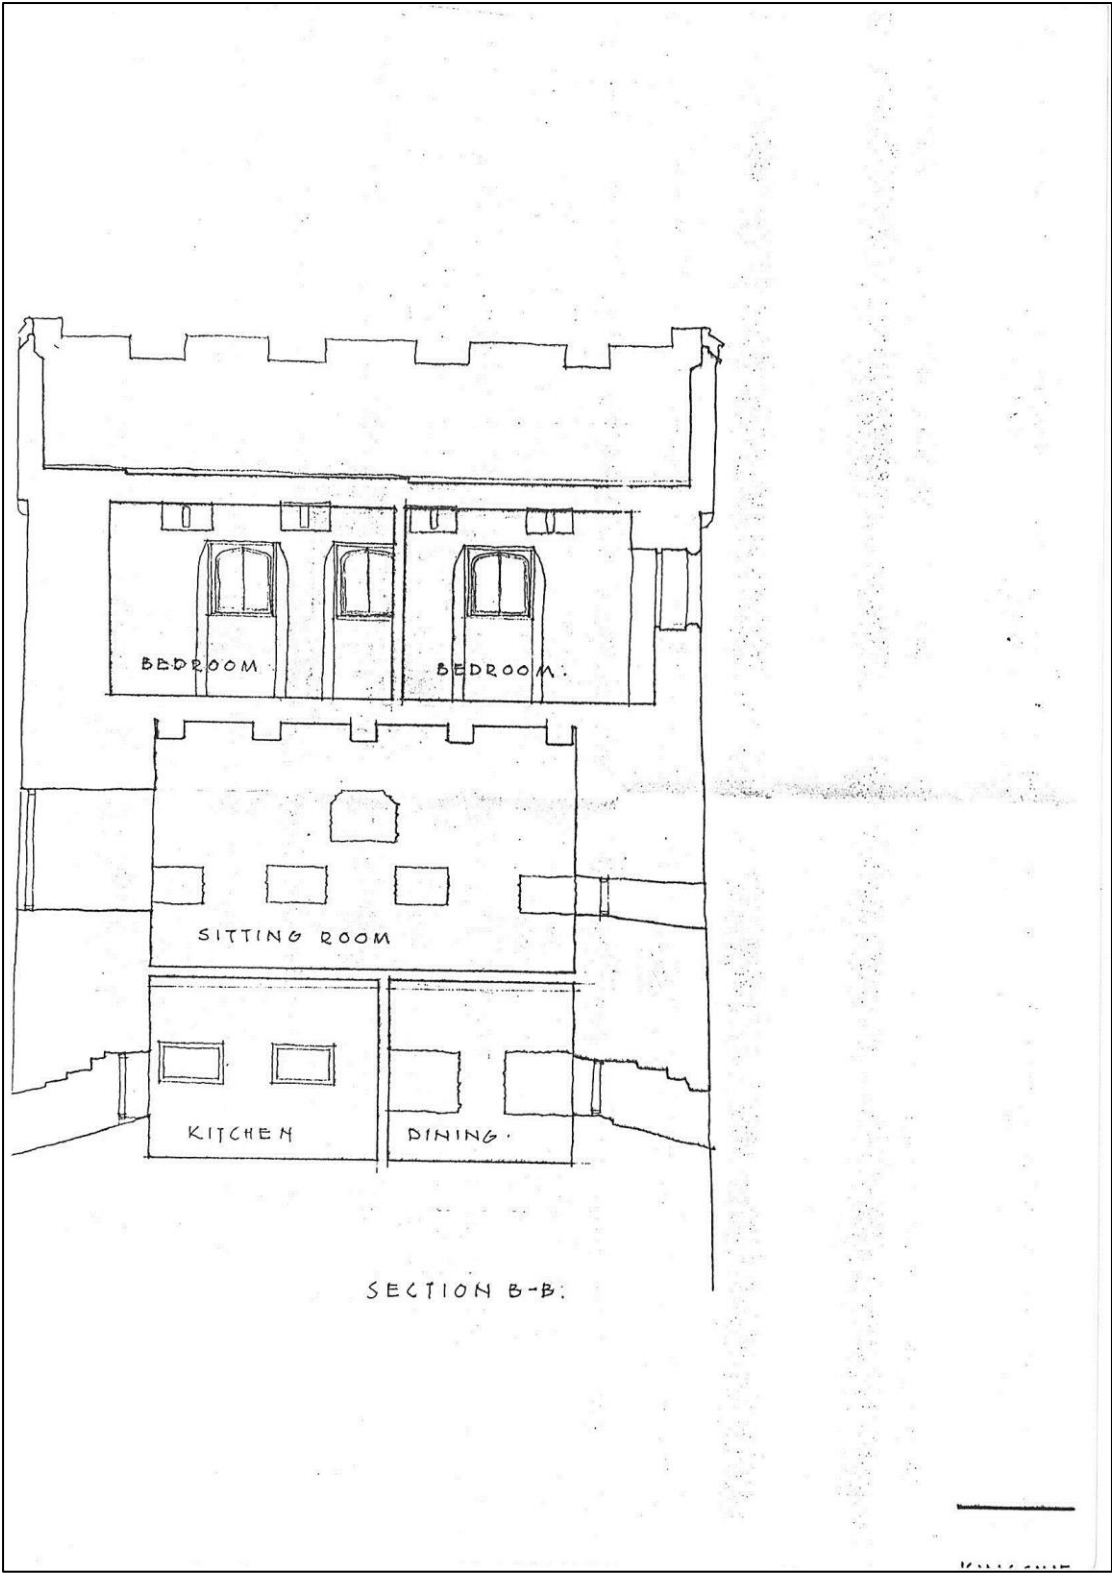
Survey plans before restoration.

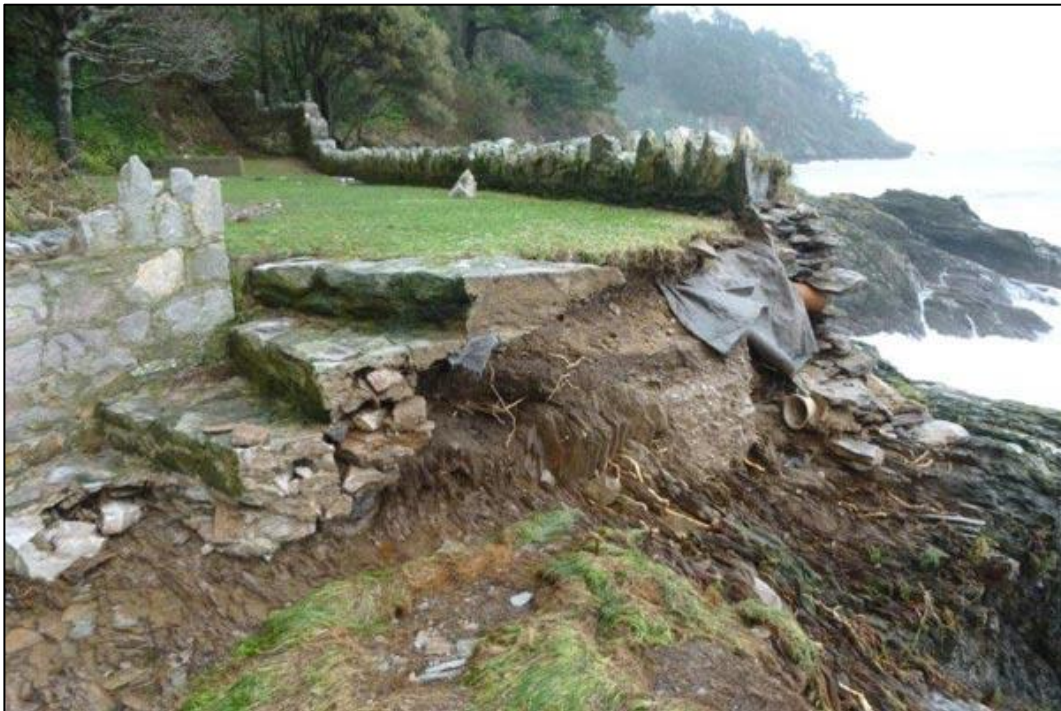
Castellations were knocked down at Kingswear.

In February 2014 a storm ran up the English Channel and within the space of a couple of hours had inundated two Landmark buildings, Fort Clonque on Alderney and Kingswear Castle. Both suffered similar degrees of damage caused by the huge waves and storm surge. The ground floor of Kingswear Castle was flooded and the surrounding land was eroded where the waves hit. We arrived the following morning to find sections of wall missing as well as erosion of the garden.

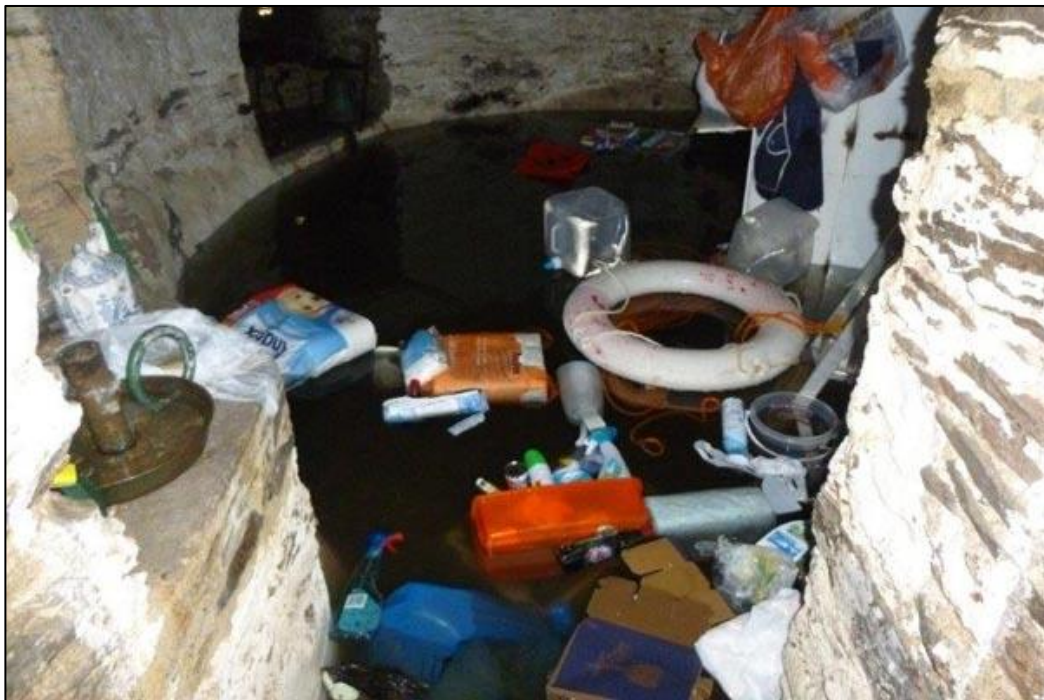
The waves breached the twin room.
