CALVERLEY OLD HALL

History Album

Volume II:

Repair & Conversion

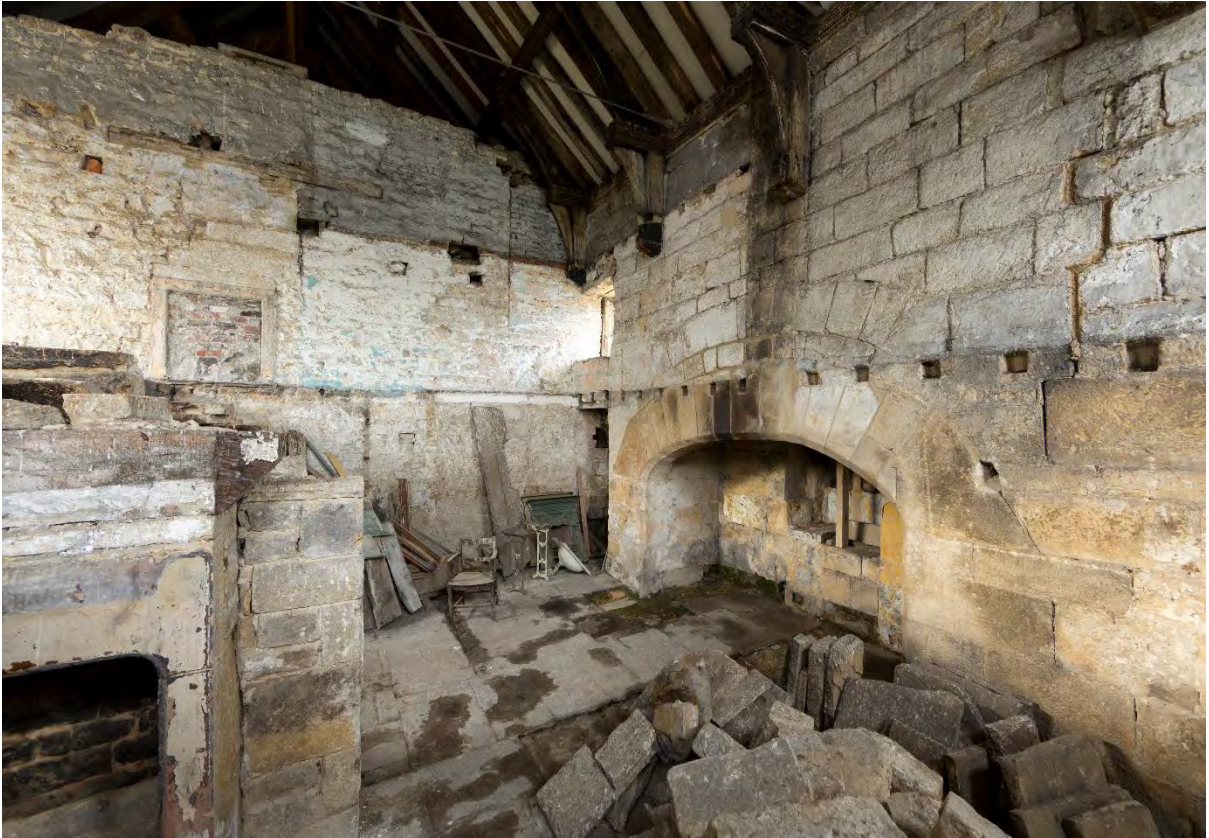
The Great Hall in 2020. The remains of cottage chimney breasts have yet to be cleared. While they remained in situ, it was impossible to find a viable alternative use for the Great Hall. Heaps of carefully salvaged stone and other materials lie on the original flagstone floor.

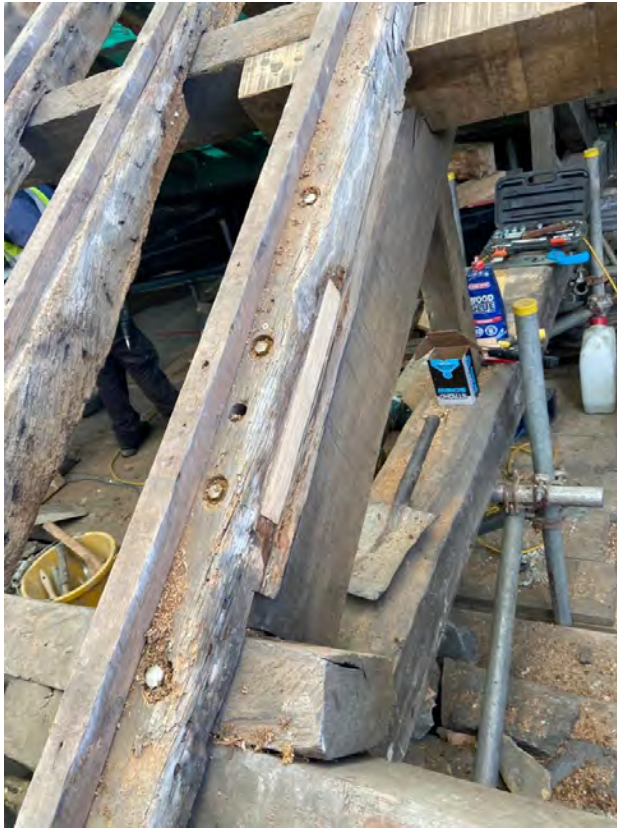
Examples of timber repairs, each carefully specified.

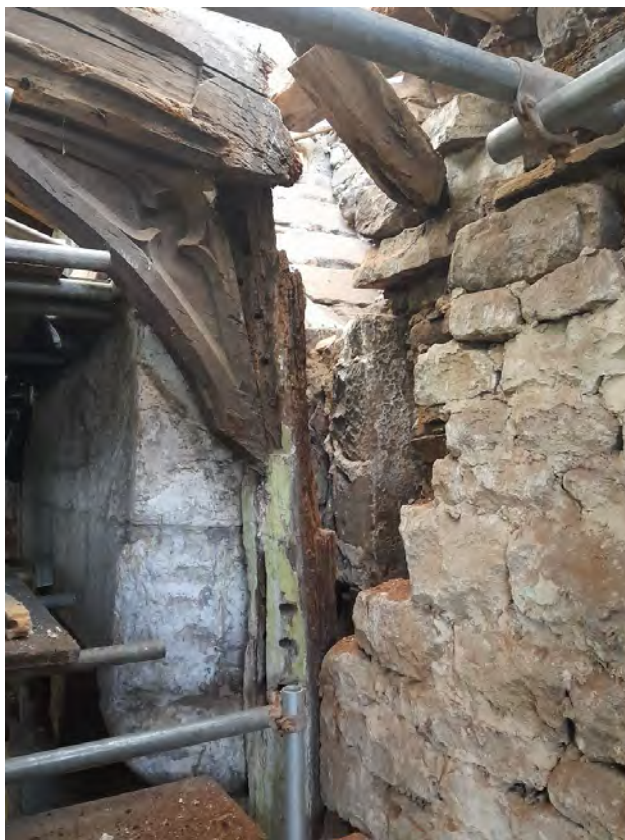
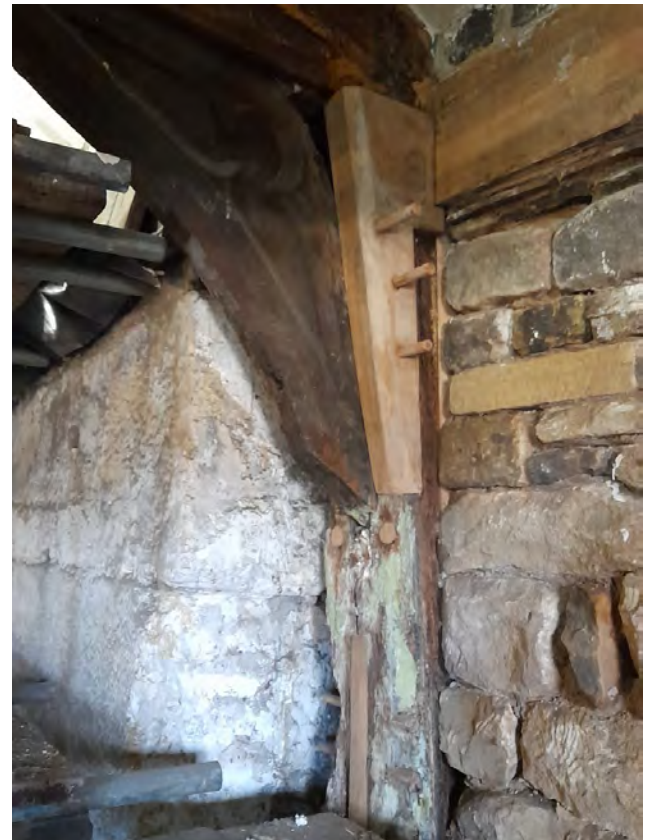
Below: this junction point had fared especially badly, with considerable decay in a post holding one of the ornamental trusses in the Solar Block above the huge hearth. The wall plate had also rotted. With advice from the structural engineer, we were able to repair it in situ. The void behind the post was one of the locations where a cache of concealed finds was discovered, a typical location for such finds beside an opening (the chimney flue).

The roof timbers were found to be in mostly sound condition except for rotten feet of many of the rafters in the valleys between the Solar Block and the other blocks. The wall plate was also rotten in places. We took a very conservative approach to the timber repairs, scarfing in new wood, inserting stainless steel bolts and fitches where necessary, in order to retain as much of the original fabric as possible.

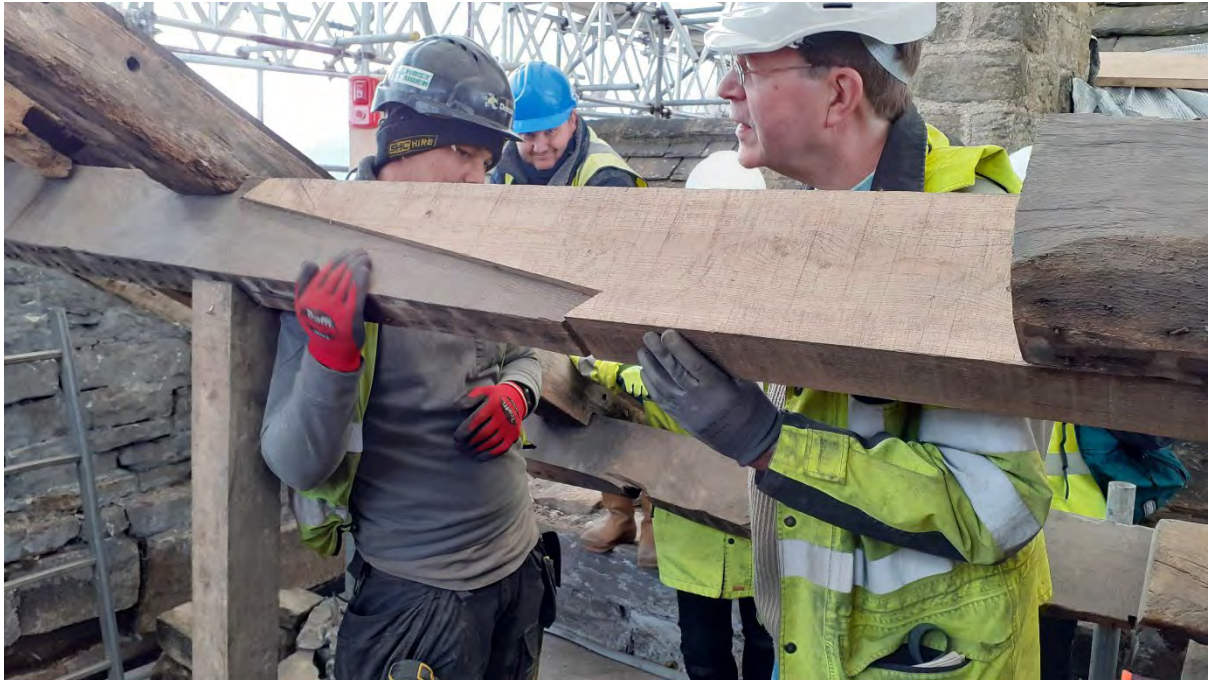
Archaeologist Jonathan Clark inspects a scarf joint repair to a decayed purlin.

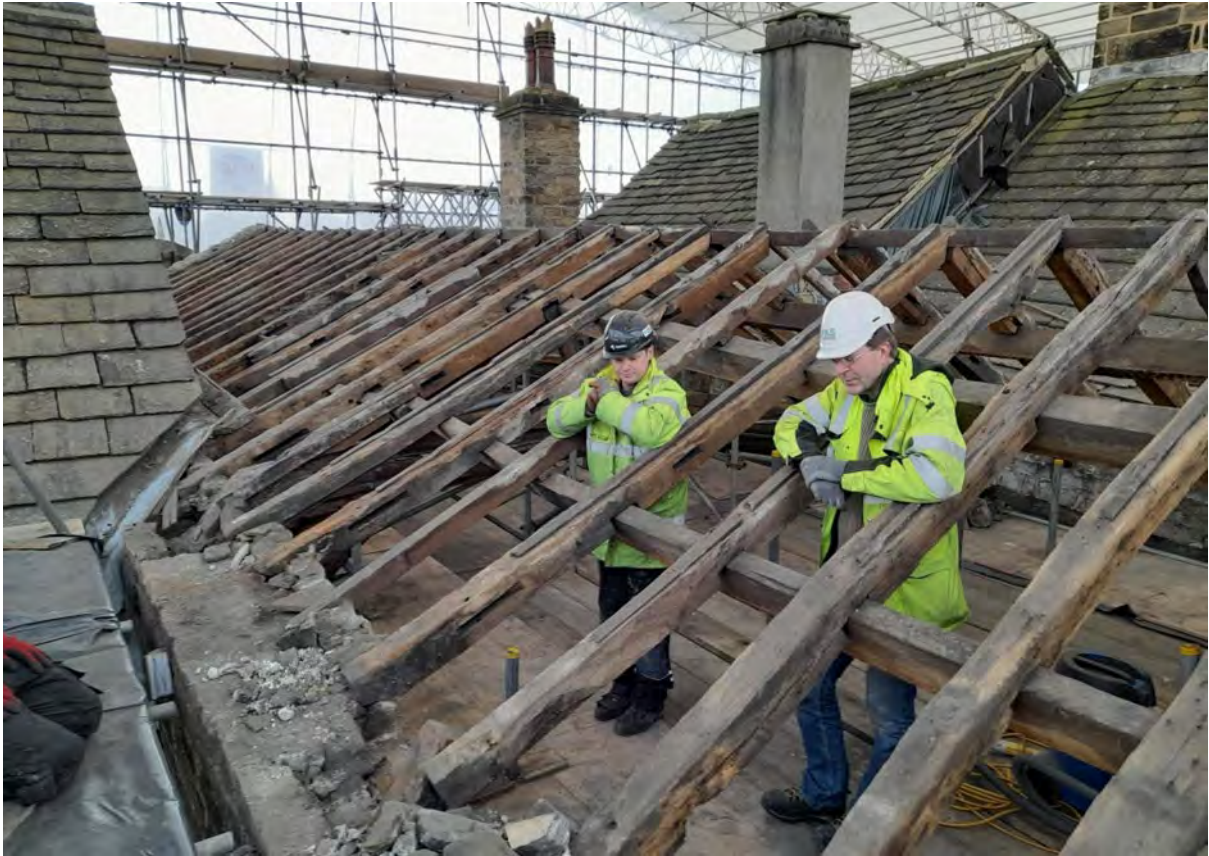
Pondering the evidence in the roof of the Solar Block. The rafters mostly belong to a re-roofing campaign in the late 19th century, but include many 17th-century timbers re-used from the roof from a barn or similar structure, perhaps one of the outbuildings known to have stood on the site previously.

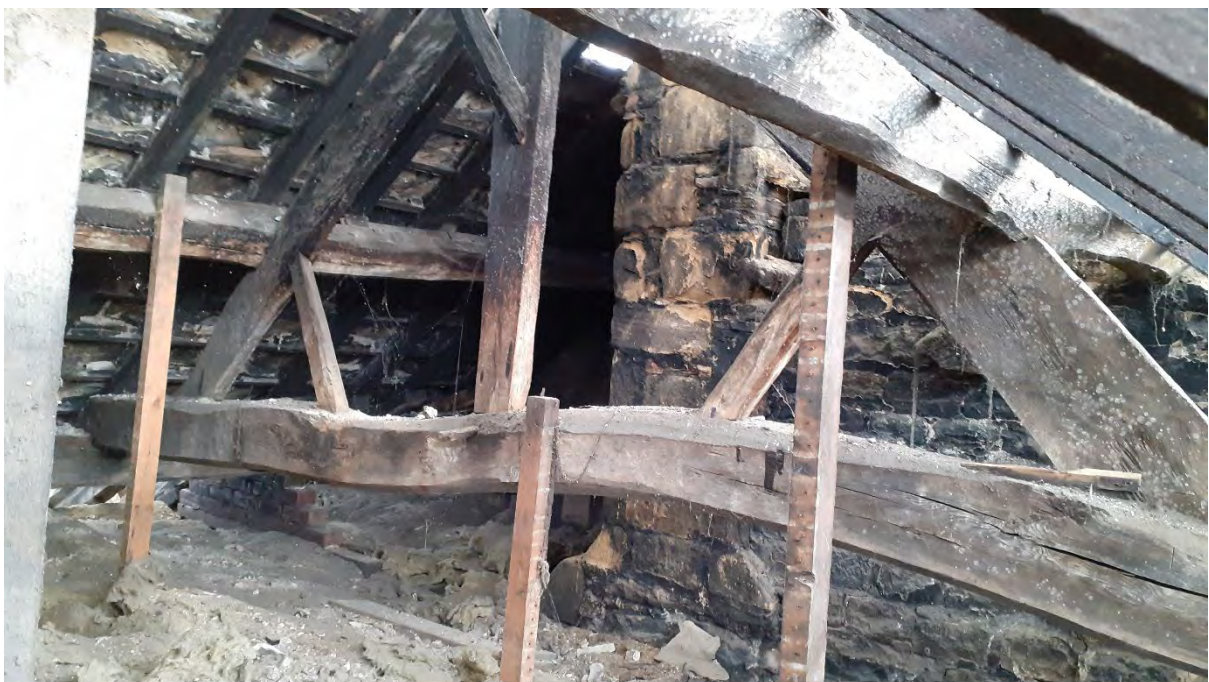
Below: timbers in the original early-14th century roof truss of the early solar range, now embedded in the roof space of the Lodging Block and smoke blackened, probably by the 1977 fire.

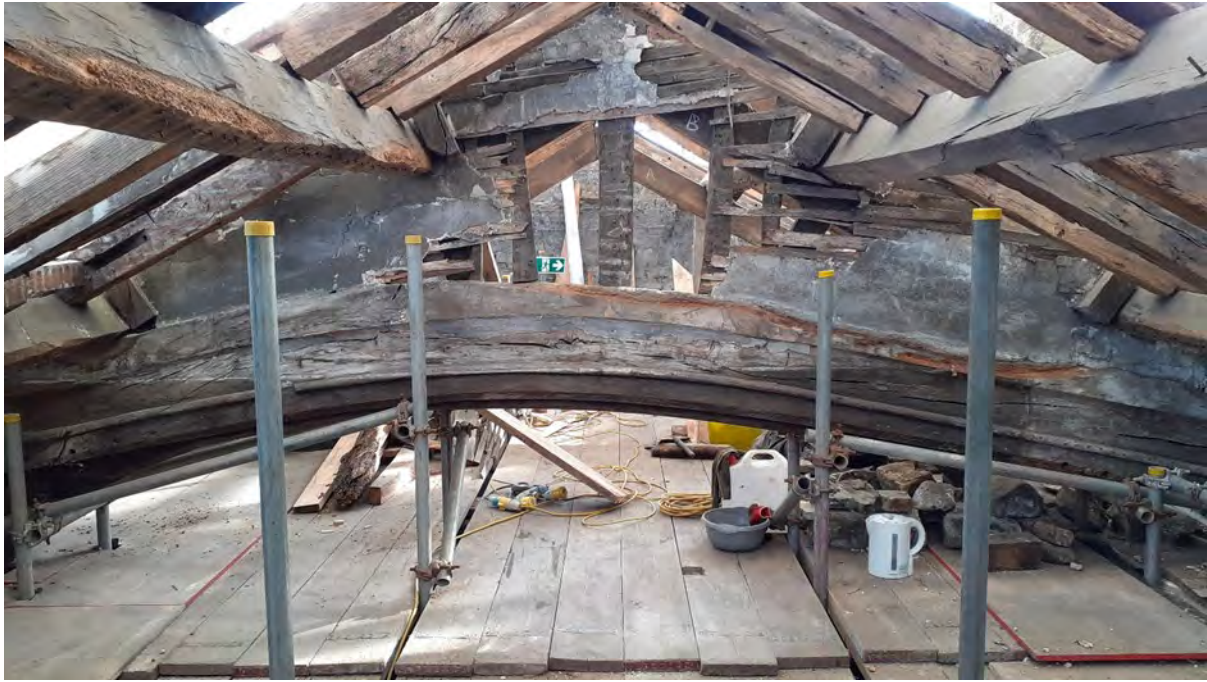
Remnants of lath and plaster above a roof truss in the Solar Block, dating from the 19th century when three storeys were created in the block. The fabric has been incorporated into the repaired apex.

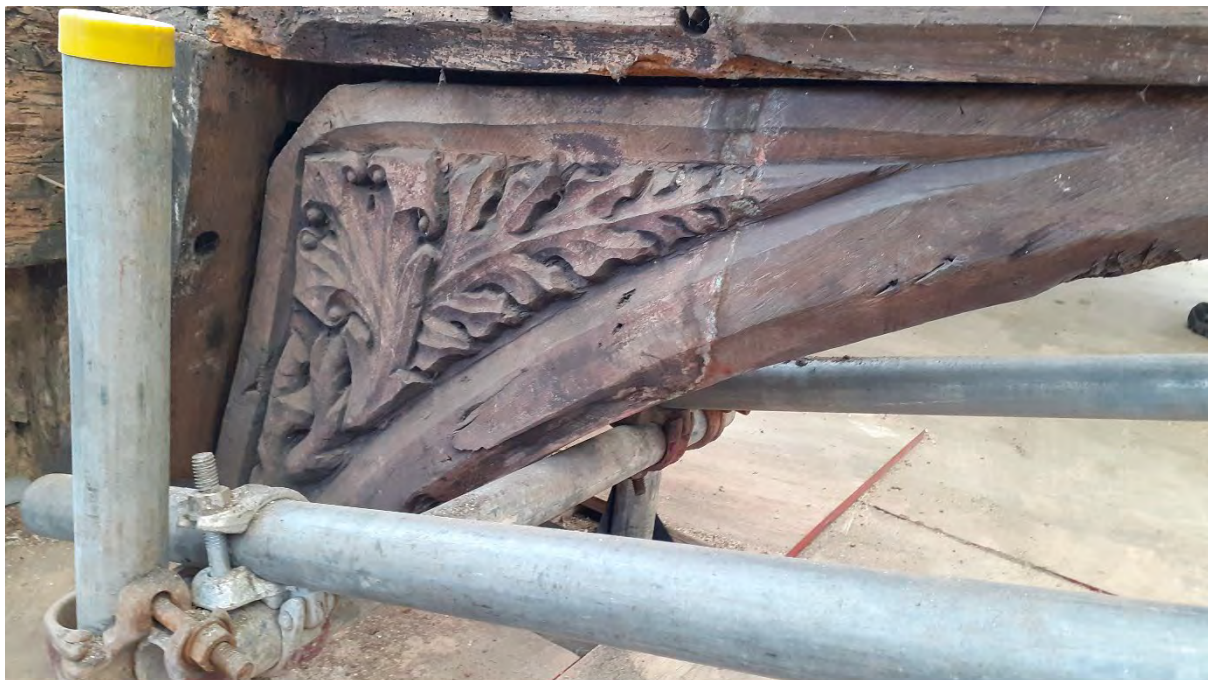
Close-up of one of the elaborately carved spandrels on a roof truss in the Solar Block, dating from the early-14th century.

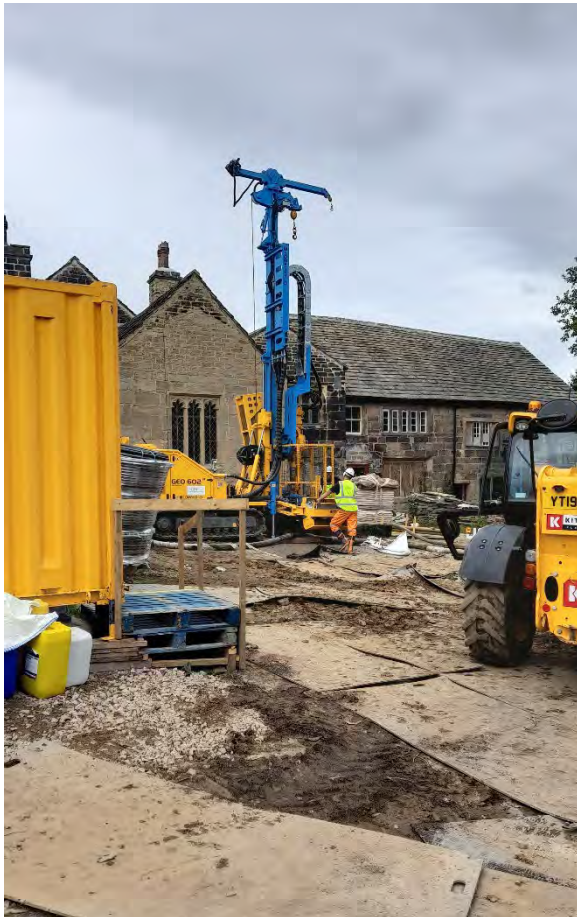
Drilling the bore holes for ground source heating. Six bore holes were drilled to a depth of 143 metres. The process proved easier than anticipated, to everyone's relief.

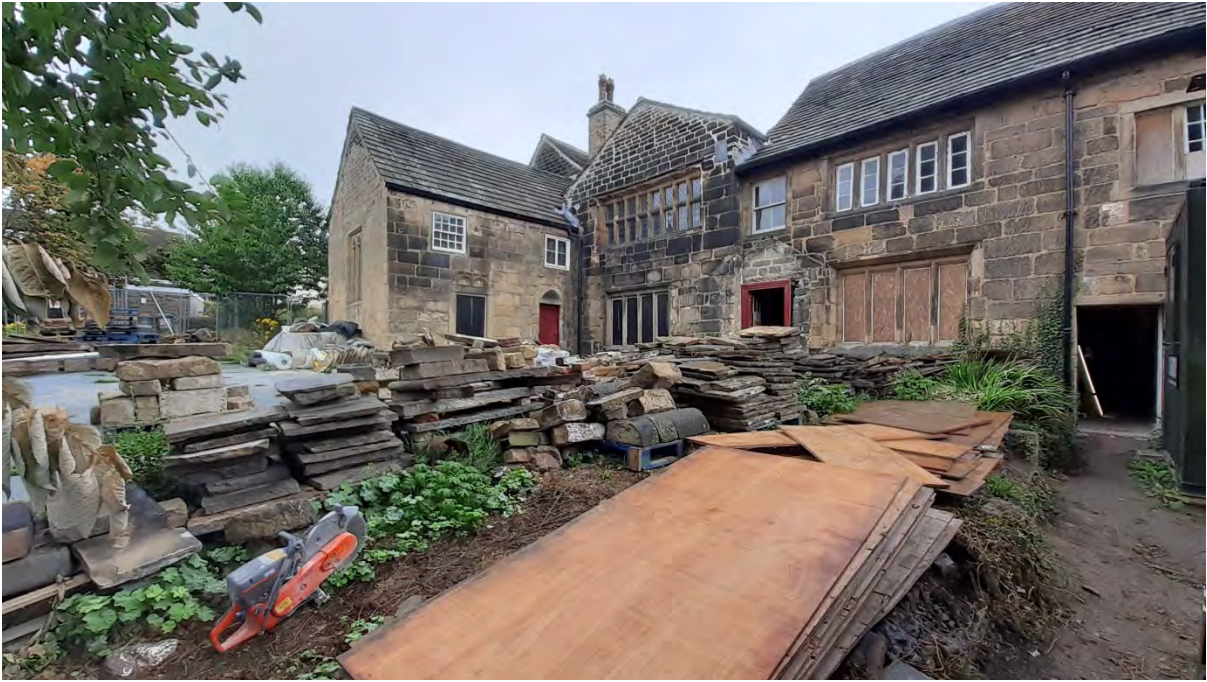
By summer 2022, the scaffolding was down and site set-up complete. The flagstones from the Great Hall had been recorded and were now carefully stacked while underfloor heating was installed.

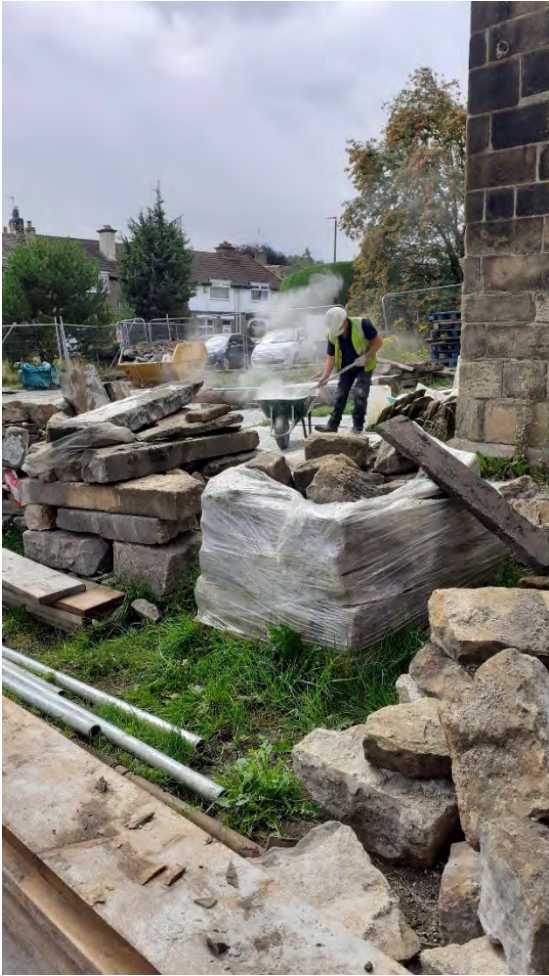
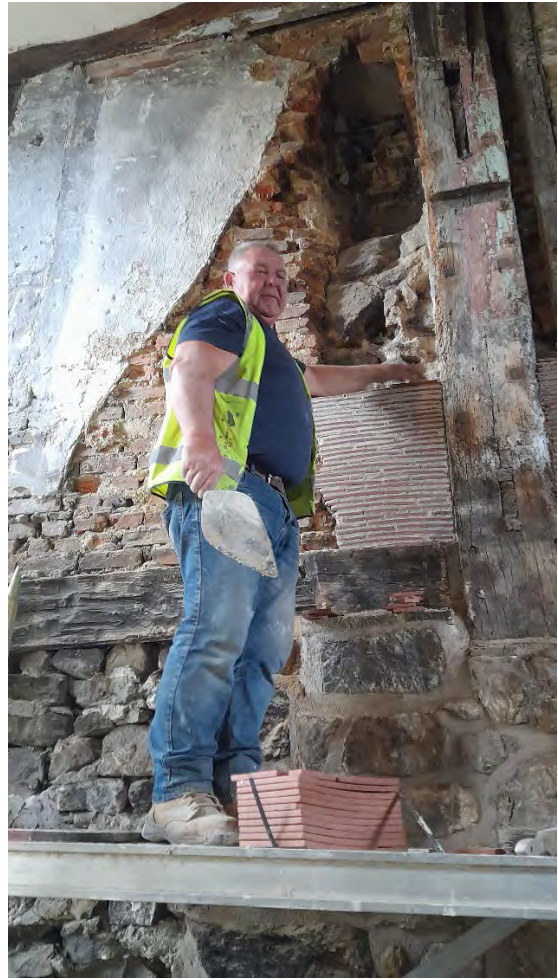
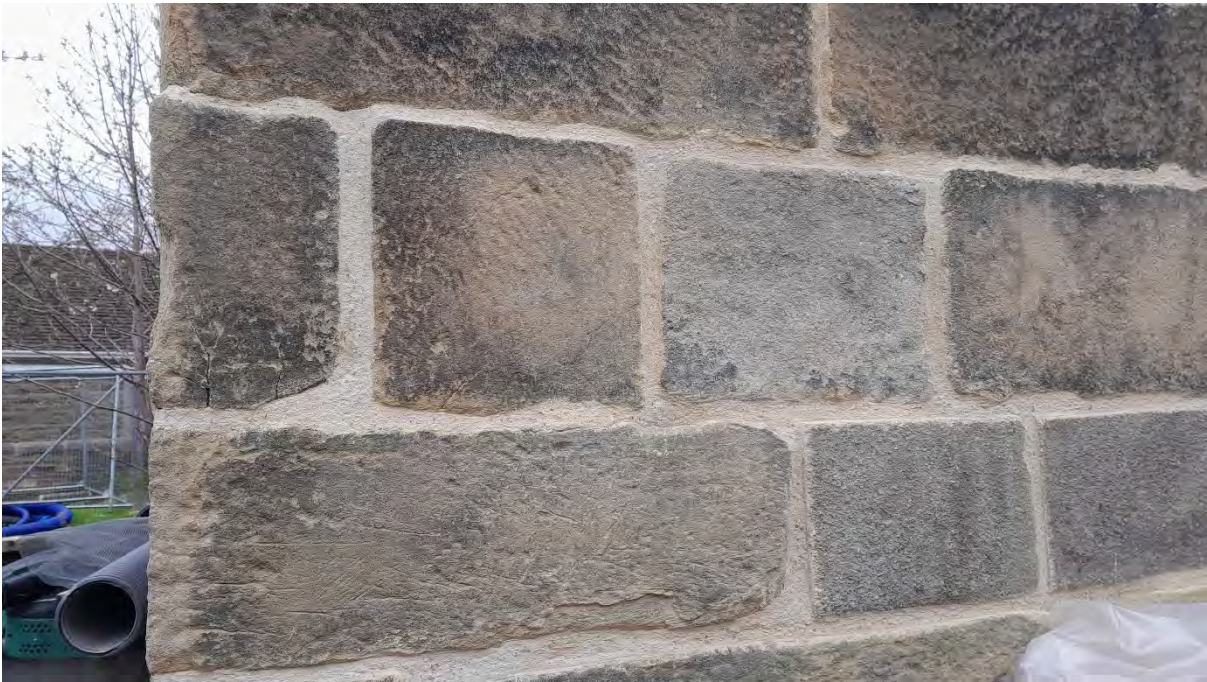
From top left: slaking lime on site; tile repairs in one of the many wall cavities, here in the partition wall of the Great Hall; a sample of external pointing, the mortar mix and style refined with great care by Dobsons'

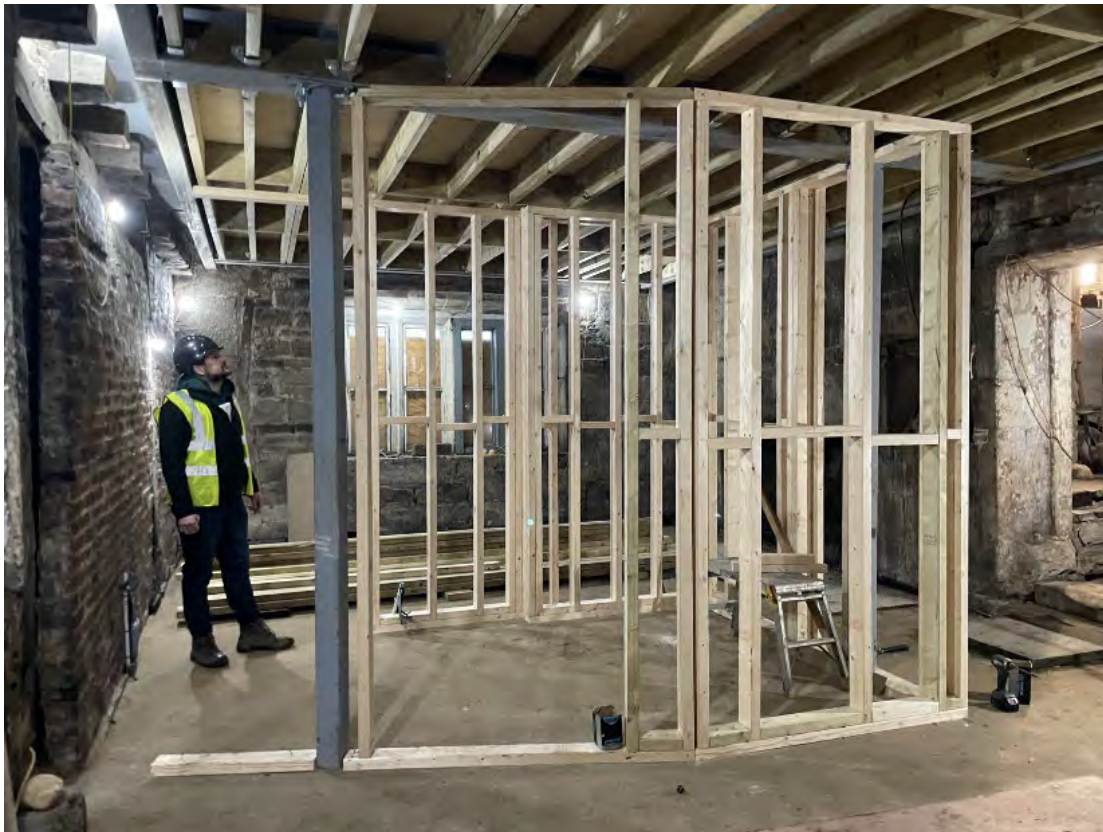
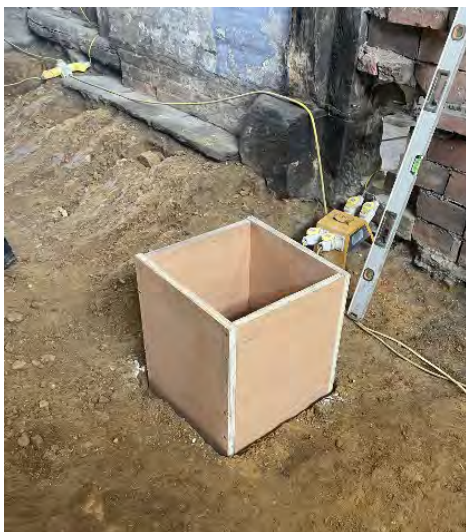
The huge steel frame that supports the floor in the Solar Block and around which the ground-floor partition walls are constructed. It mostly stands clear of the external walls.

A huge steel framework to hold the first floor was installed, resting on concrete pads; the architect's scheme envisaged this new insertion 'floating' within the ancient shell such that no damage was done to the historic walls, while at the same time providing a framework to tie them into. Beneath this frame, the partition walls for the two ground floor bedrooms and bathrooms were faced with Glulam. The divisions make best use of the spaces while still allowing the most significant architectural features to be visible. Movement sensitive lighting illuminates an otherwise windowless central lobby. A doorway was re-opened on the ground floor to lead up a couple of steps into the ground floor bedroom of the Parlour Block.

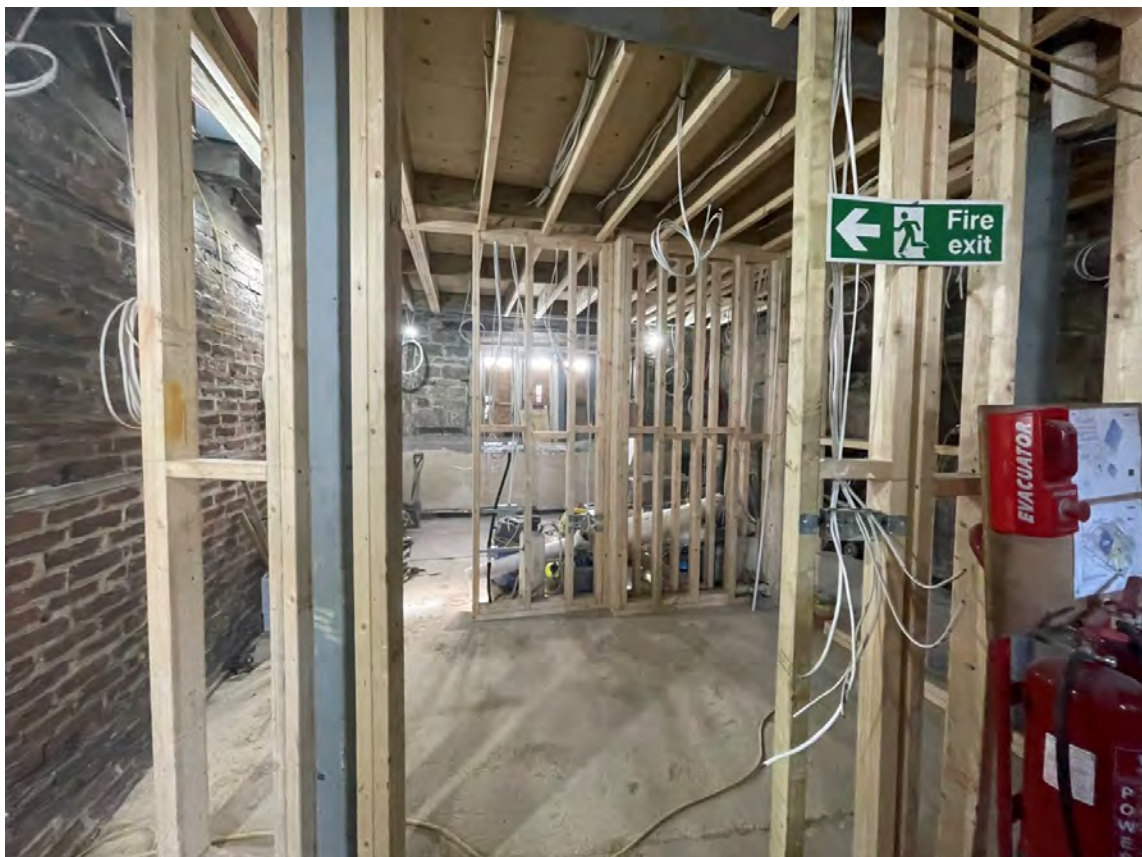
A forest of wires and timber partitions, precursors to the creation of the bedrooms and bathrooms on the ground floor of the Solar Block. Such use echoes the service rooms that occupied the ground floor originally.

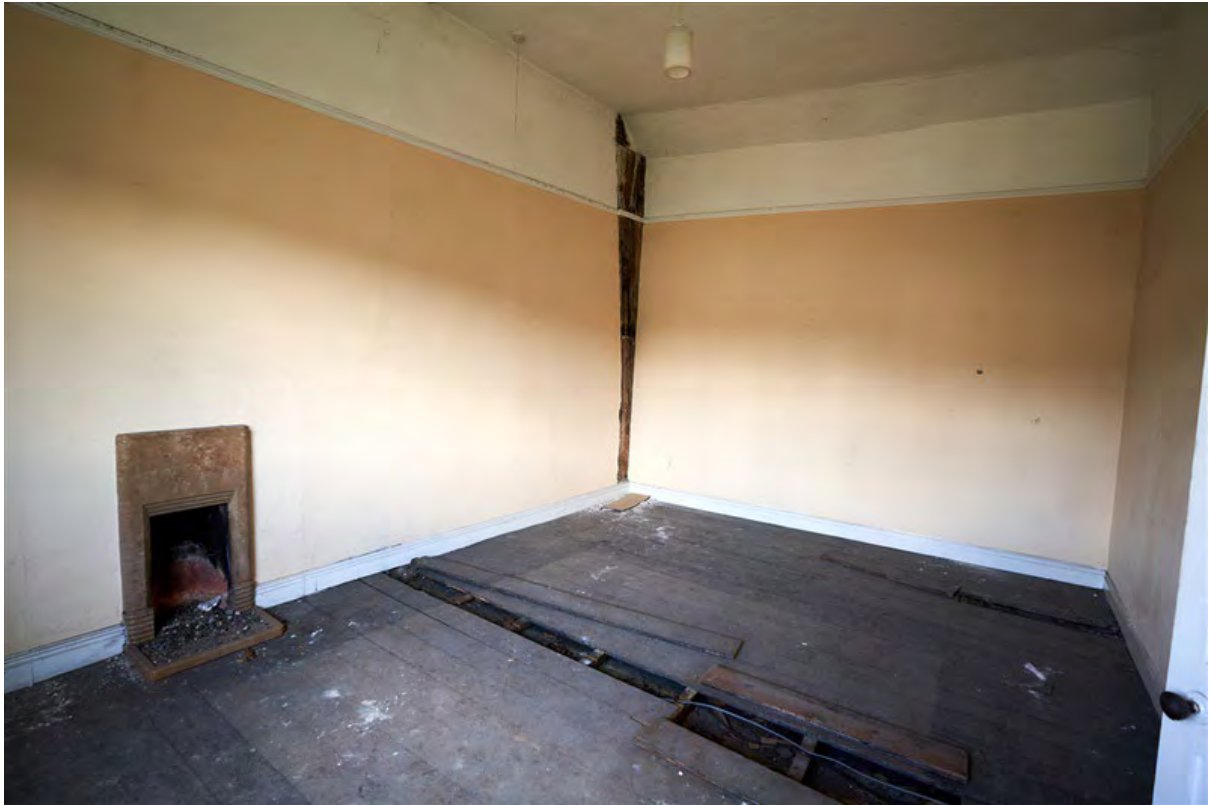
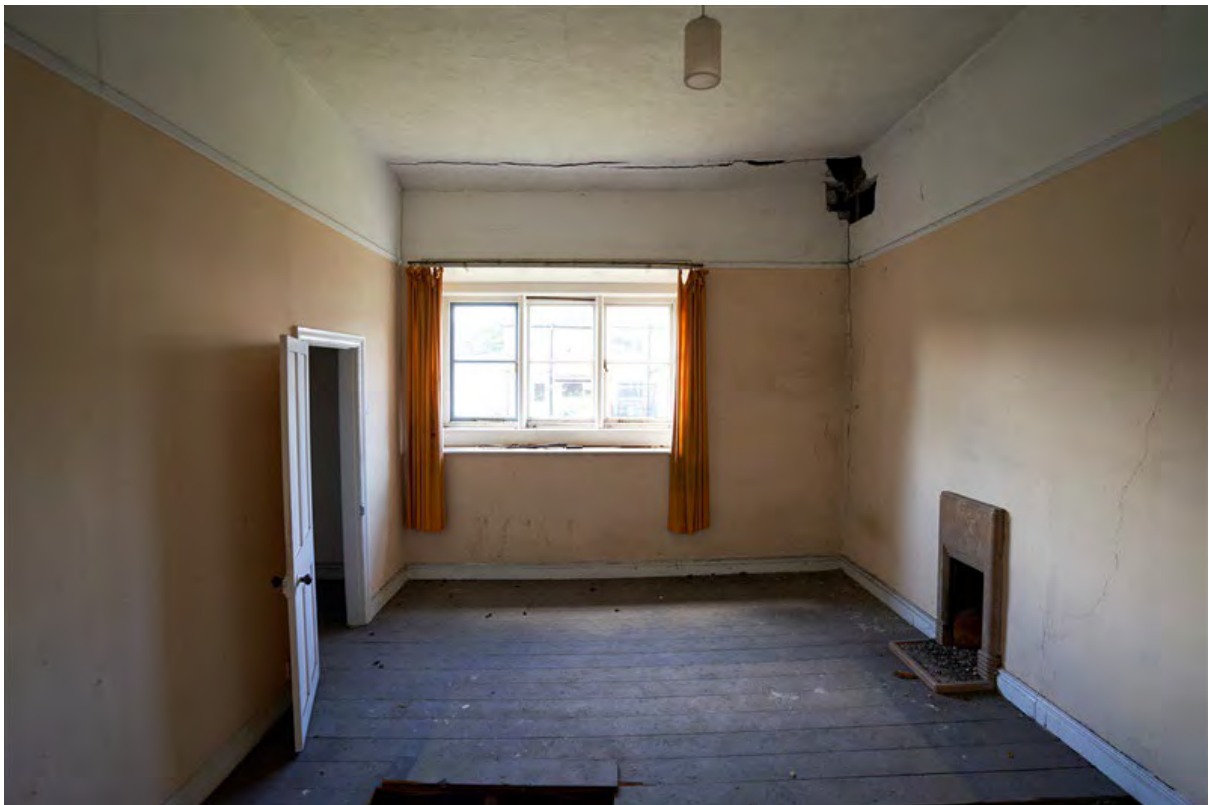
The Painted Chamber as cottage bedroom in 2019. Apart from the corner jowl post and hint of a coved ceiling in the top picture, there was little suggest that there was anything of significance. Only the small mid-20th fireplace and slight shadowing in the plaster hinted at a bigger hearth.

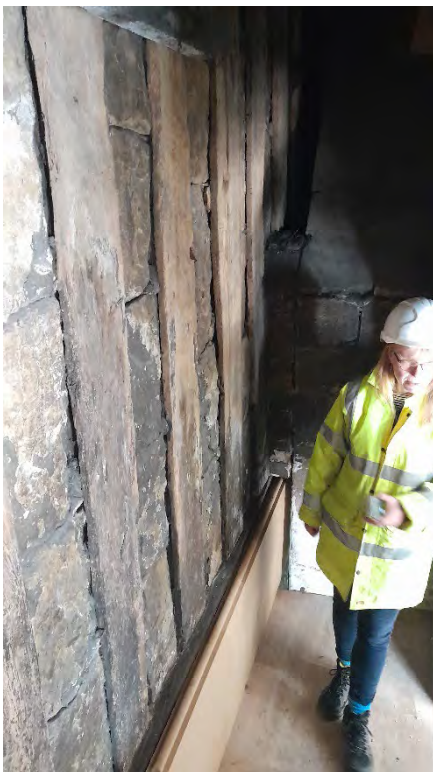
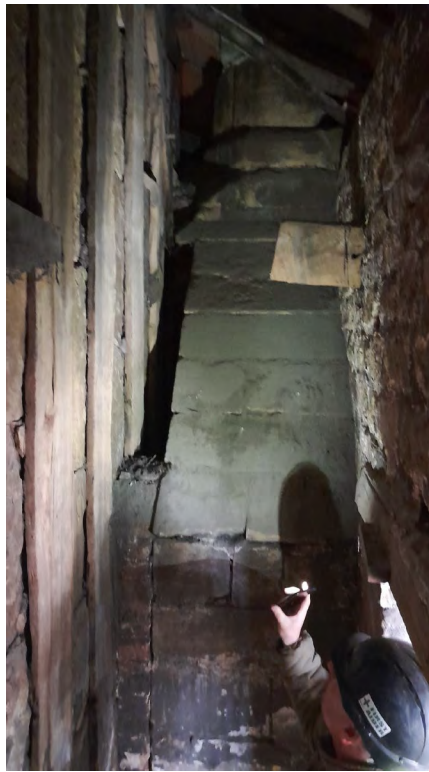
The void between the walls of the Parlour and Solar Blocks at first floor level. Left: slate slabs form the partition wall of the Parlour Block, and the ground for the gypsum plaster on which the paintings are done.

Right: the glimpse of the 1320s chimney.

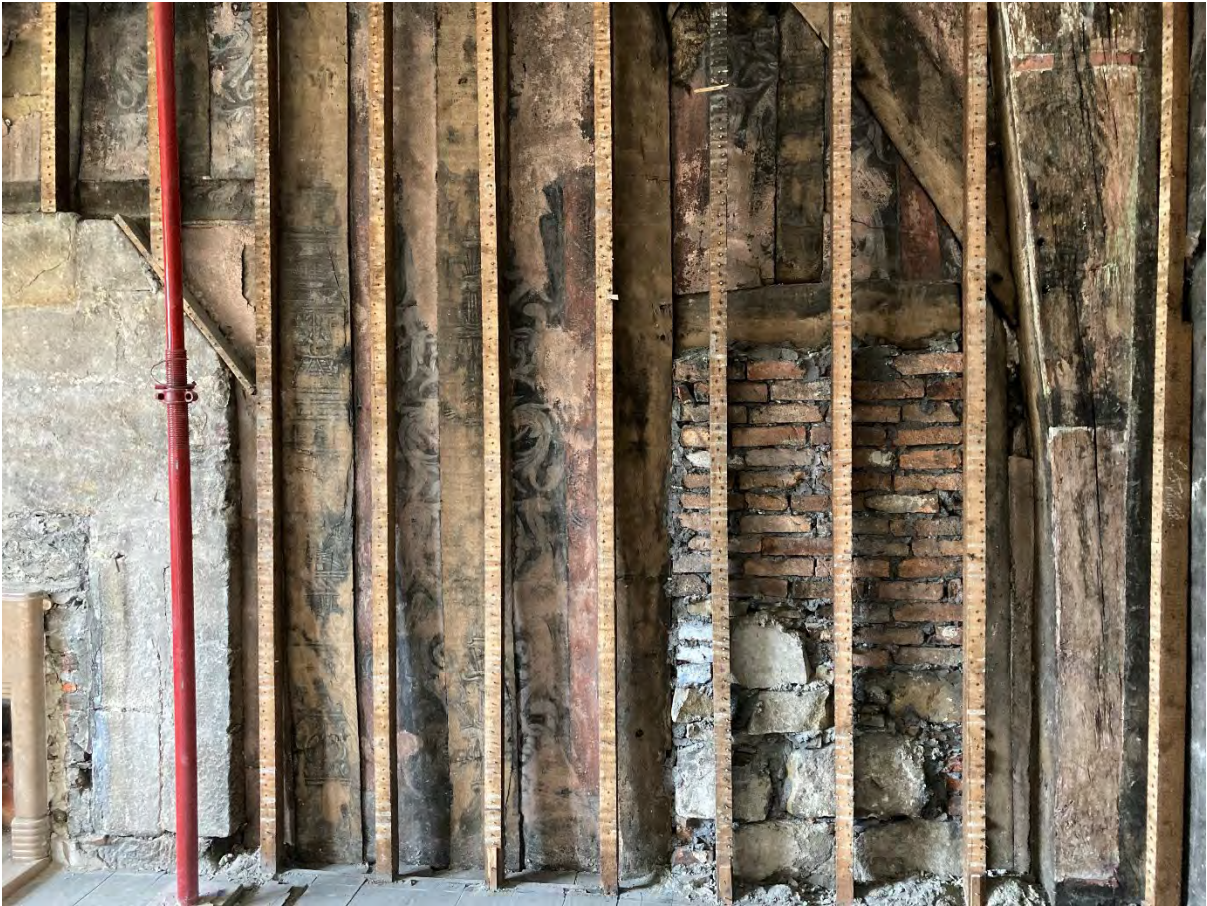
**Top: the northwest wall as first revealed.
Below: conservation work under way by Opus Conservation in summer 2024.**
