The Landmark Trust

MORPETH CASTLE History Album

Researched and written by Clayre Percy, 1991

THE GATEHOUSE OF MORPETH CASTLE, NORTHUMBERLAND

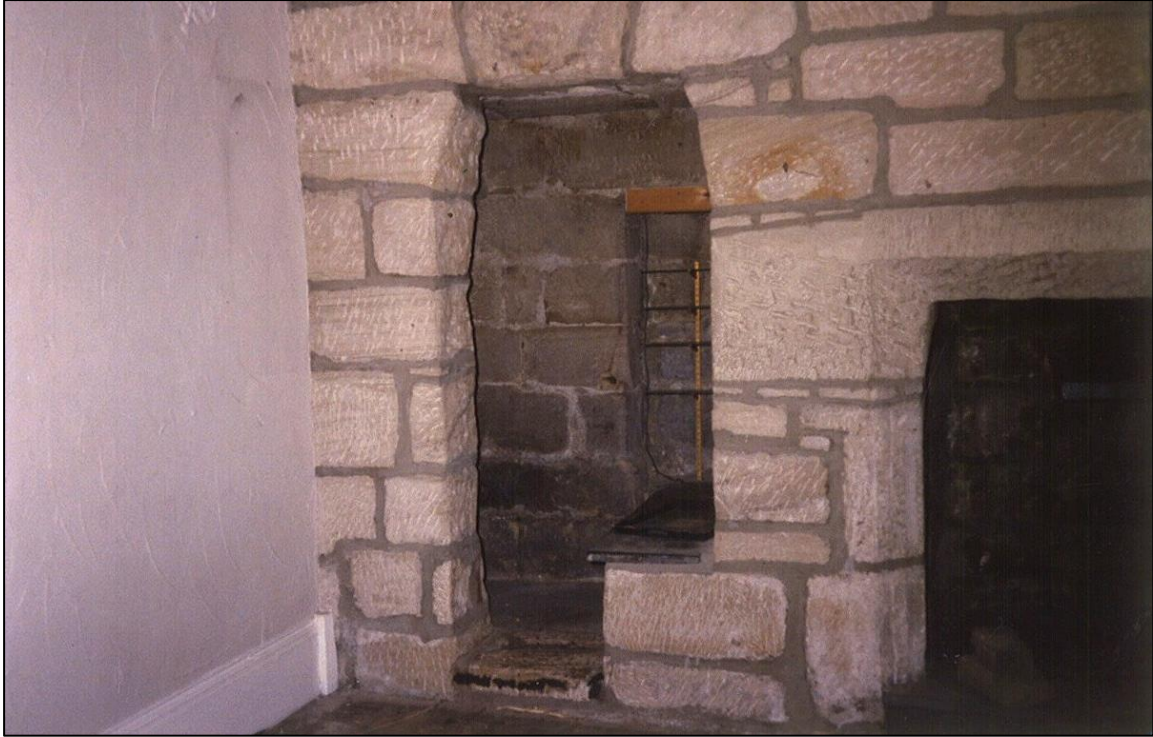
Opening made in 1960s into garderobe on north end of first floor, now built up.

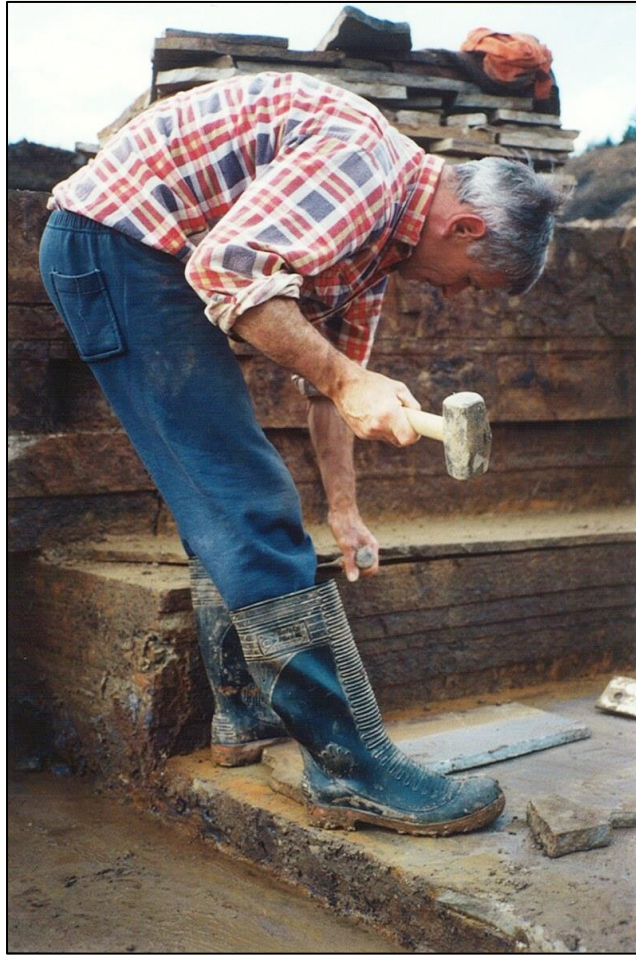
Stone slates for the roof came from Ladycross Quarry near Allendale, Hexham.

The Gatehouse was re-roofed with stone slates from Ladycross Quarry near Allendale, south west of Hexham. York paving was laid on the walkway round the roof and the lead was replaced.

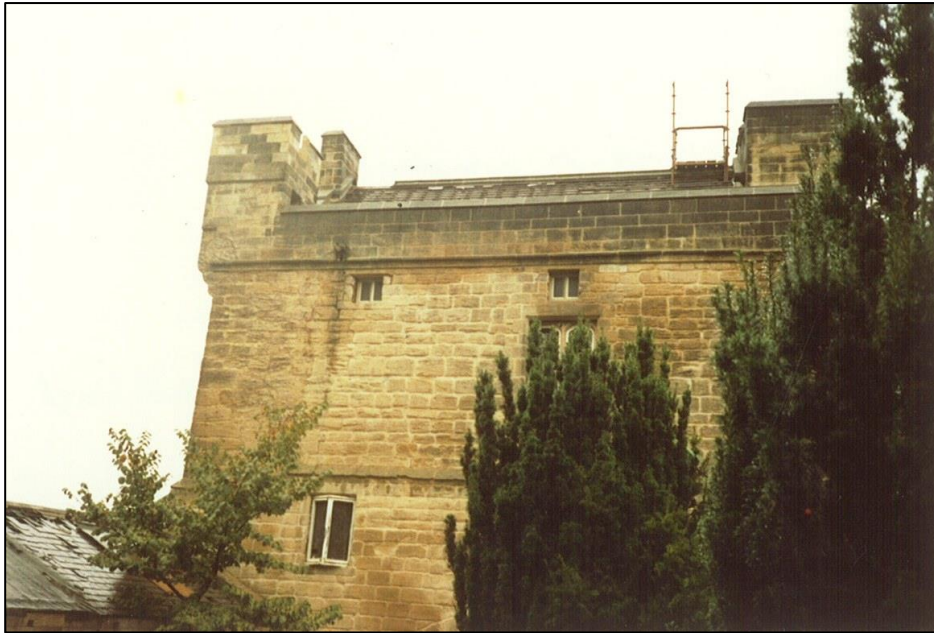
The 17th century windows as they must have looked. Here they are mock-ups made of cardboard.

The two small 17th-century windows were partially unblocked and repaired and the sky lights were renewed.

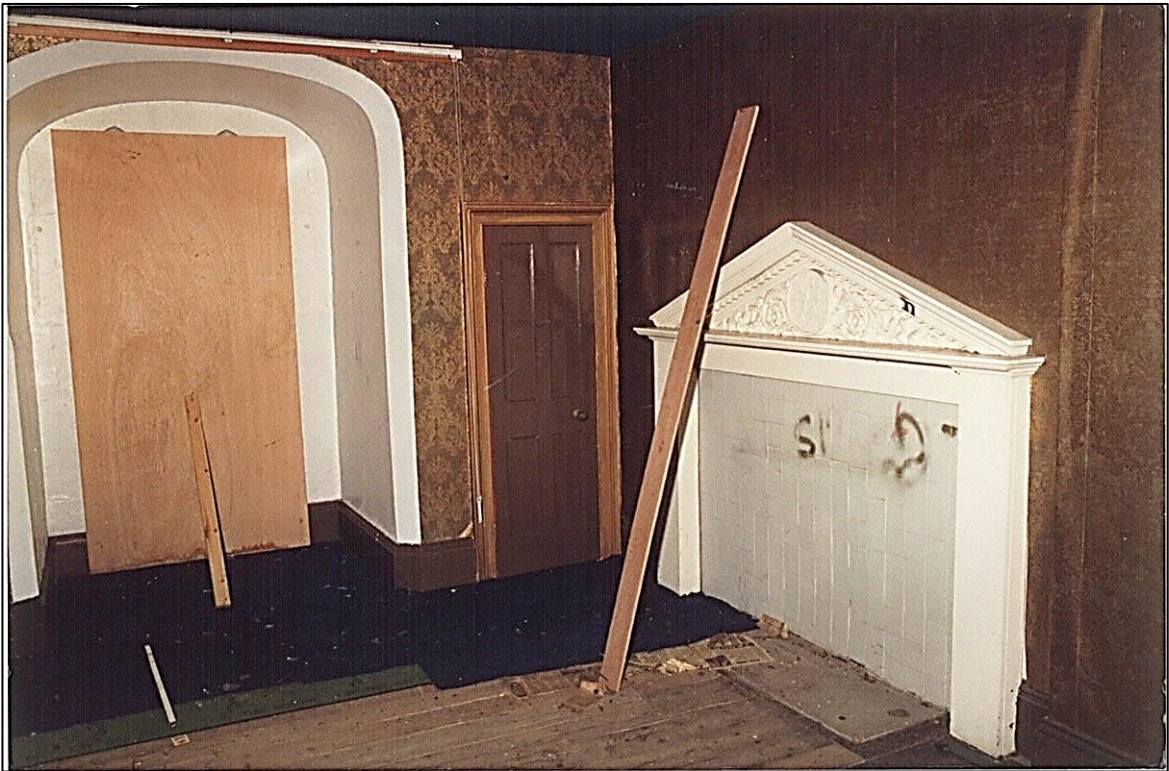
First floor, kitchen end before restoration. The door led into a wall in the garderobe.

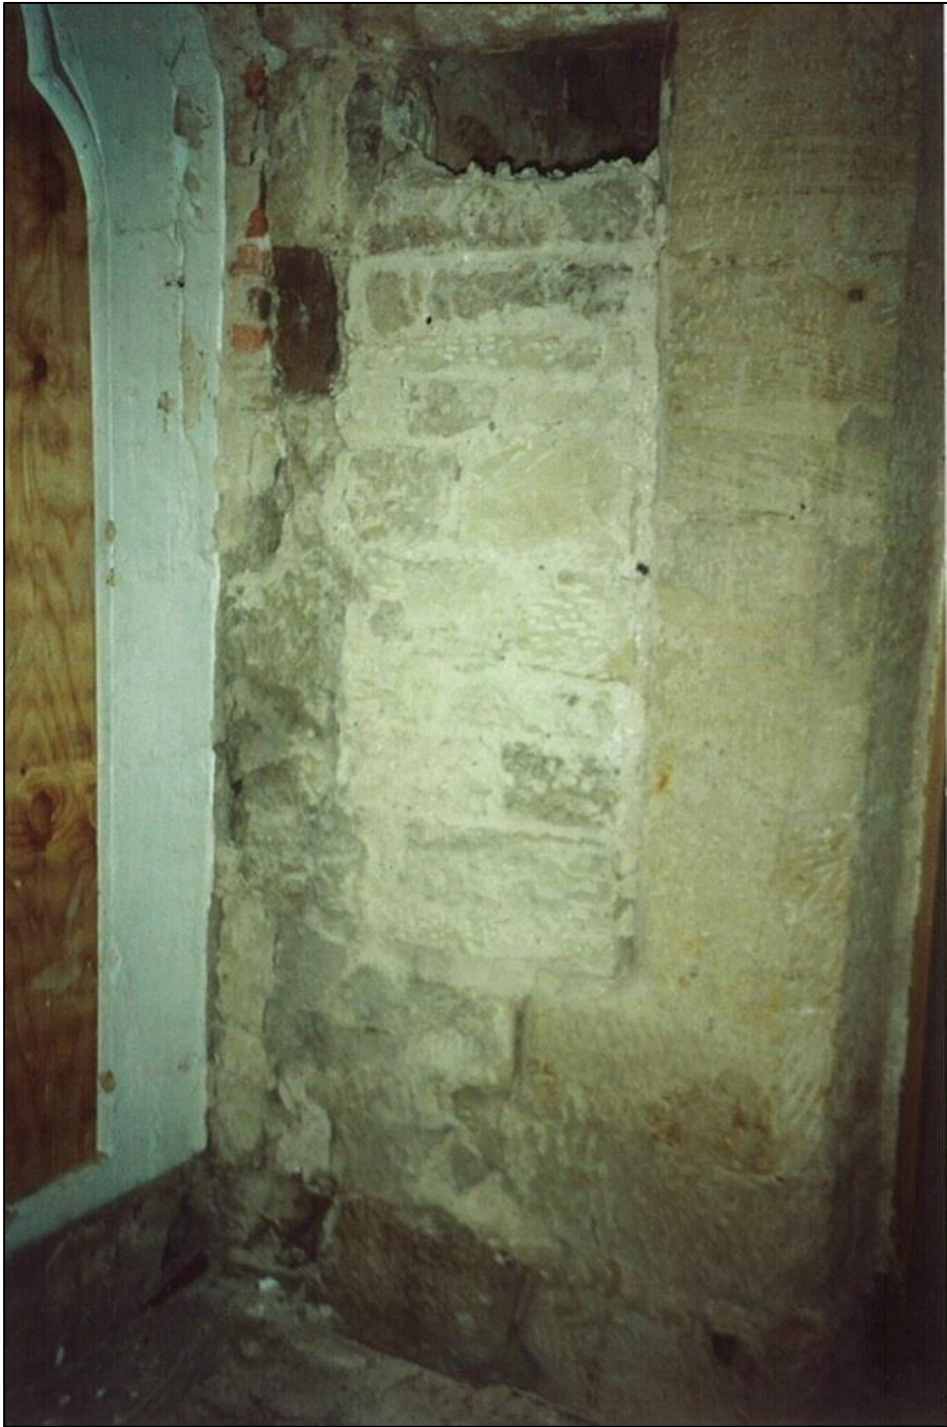
Discovering the original garderobe in the kitchen, to the right of the window.

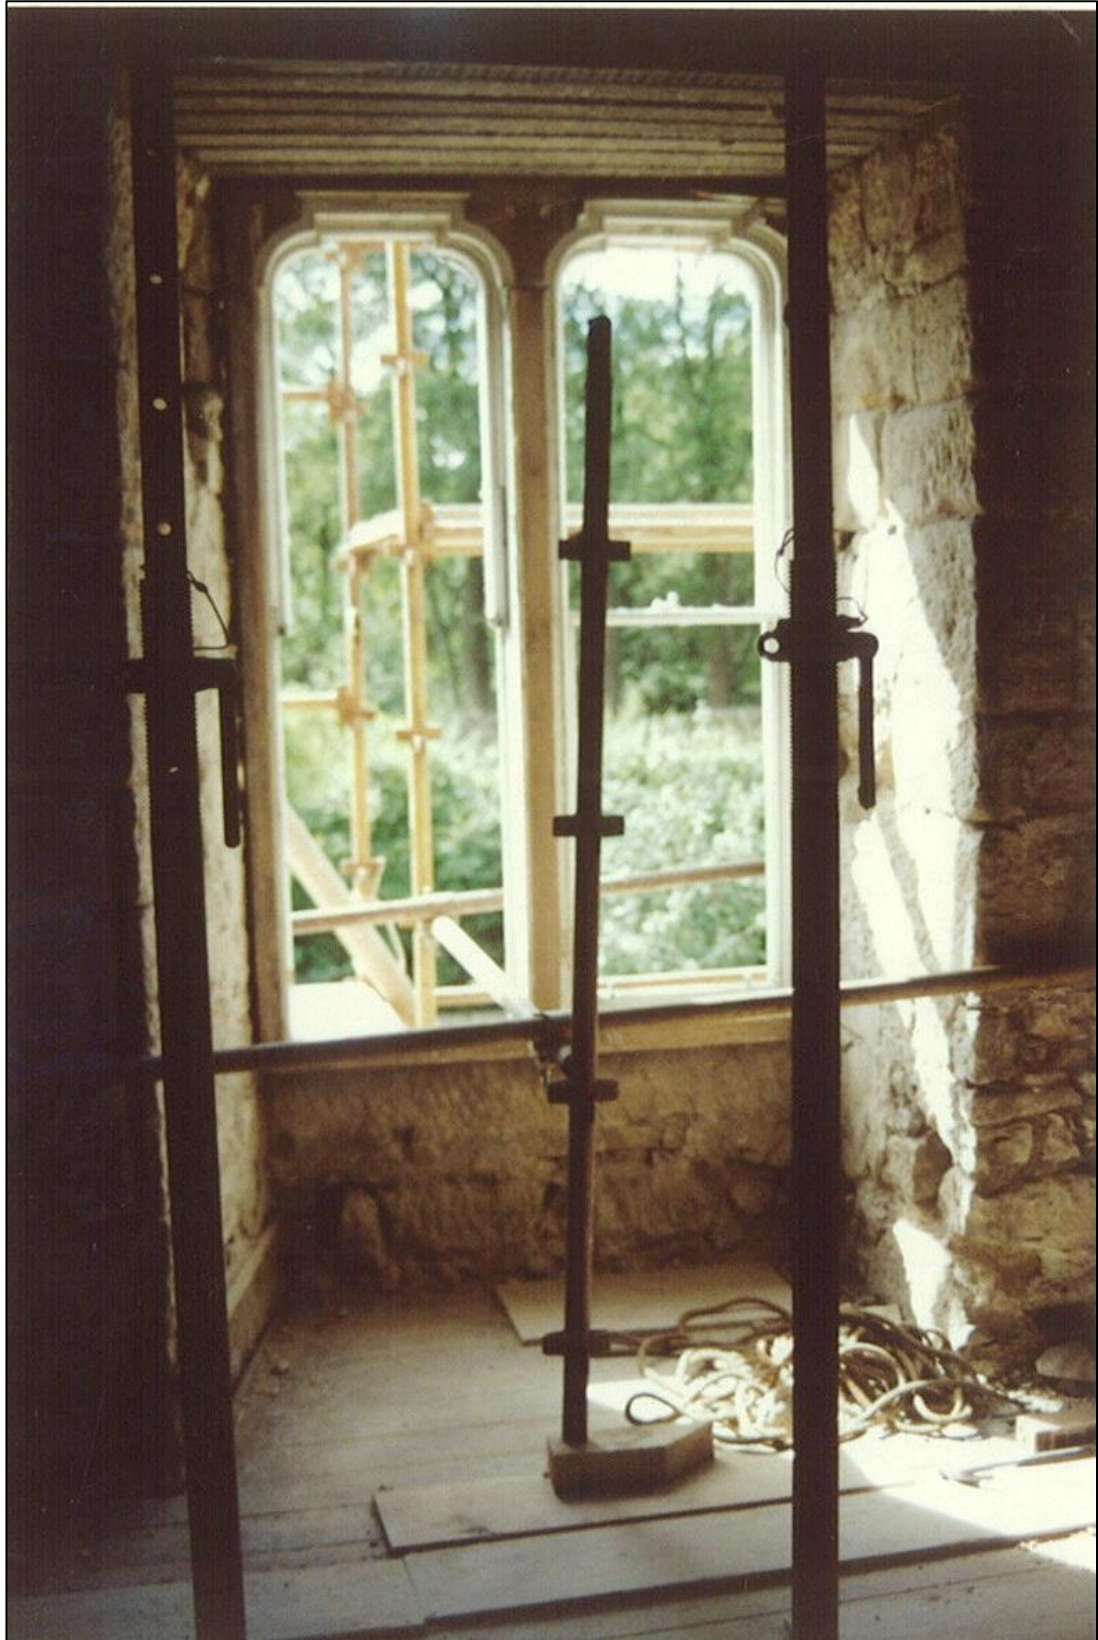
Window onto the second floor passage. The level of the original floor is shown by gaps in the stone work.

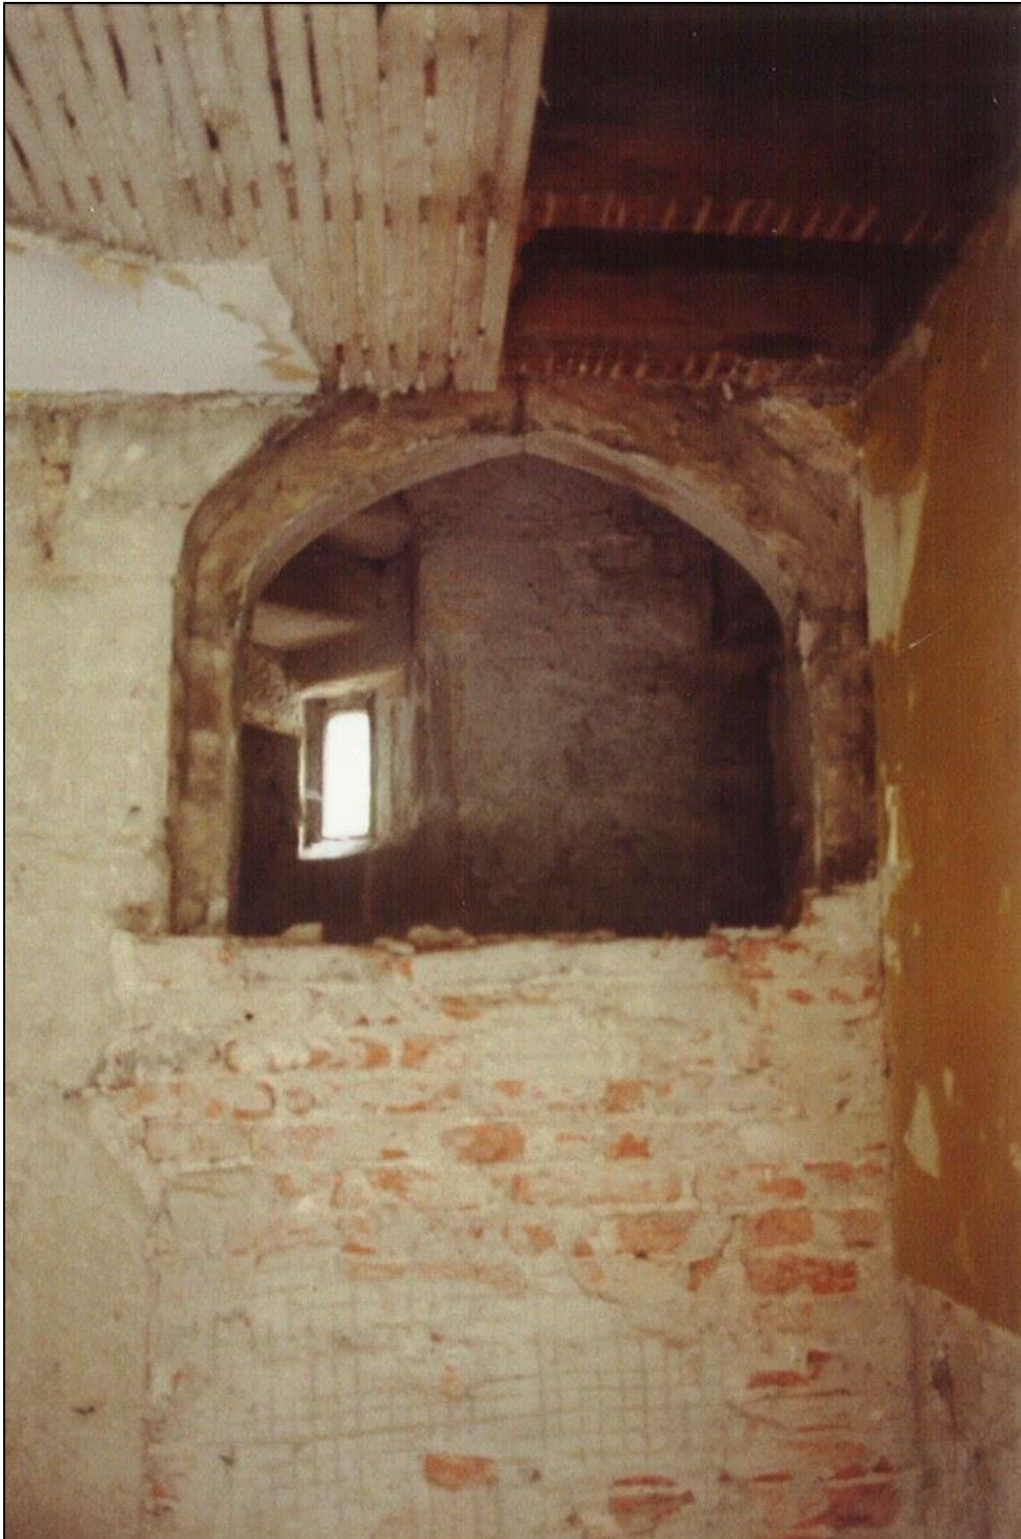
Opening the original doorway from the spiral stairs to the second floor, December 1990.

The central Victorian staircase was removed and the newel stair, which led only to the roof, was put back into commission. The medieval doorway leading from the stairs to the second floor was reopened. With the change of floor level, the threshold of the spiral stairs at the second floor was 18" higher than the level of the actual floor. Three steps now lead up to it. It was here that two shoes were discovered built into the threshold. Between the first and second floors the door leading out onto the walkway round the top of the curtain wall was replaced with a fixed door with a window, the curtain wall having crumbled, it lead out onto nothing. A new staircase was put in between the second and attic floors against the south wall, and the old one, against the east wall was removed.

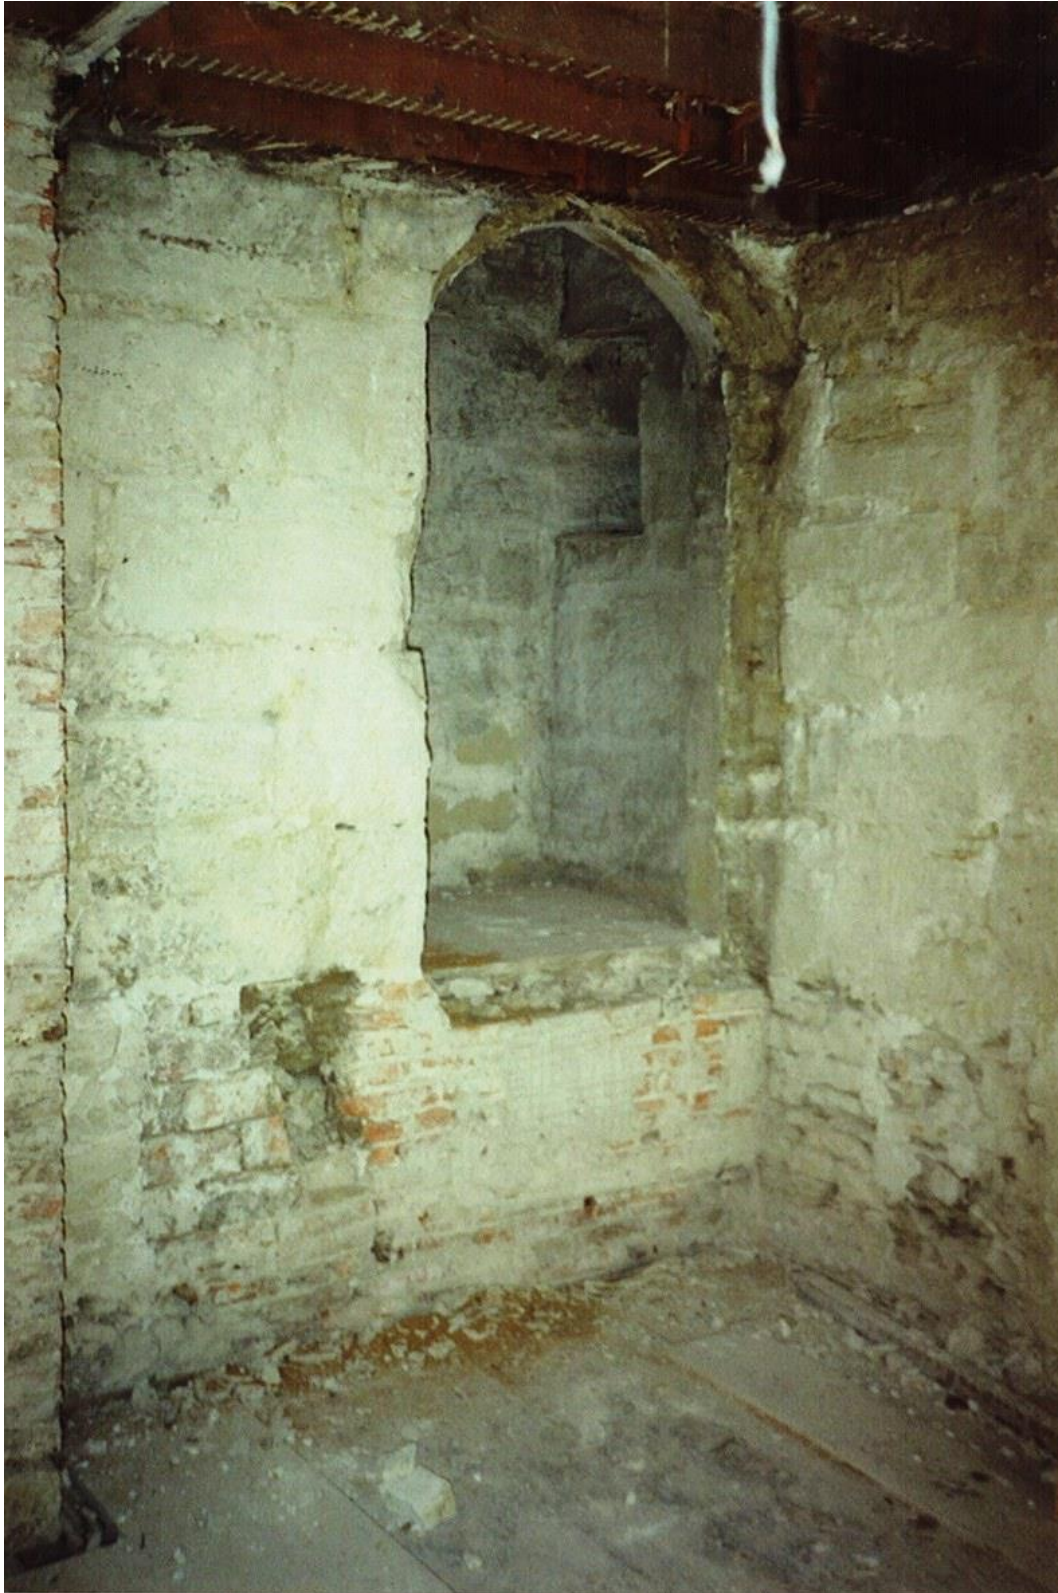
The spiral stair doorway completely open. This is where the shoes were found hidden in the threshold.

The decision to reinstate the original newel staircase caused a minor problem because either in the 17th century or in 1860, the level of the second floor had been lowered by about two feet. Landmark decided to keep to the existing, lower, floor level, so some steps had to be built to bridge the gap between it and the threshold of the medieval door. Under the threshold two 19th-century shoes were discovered.

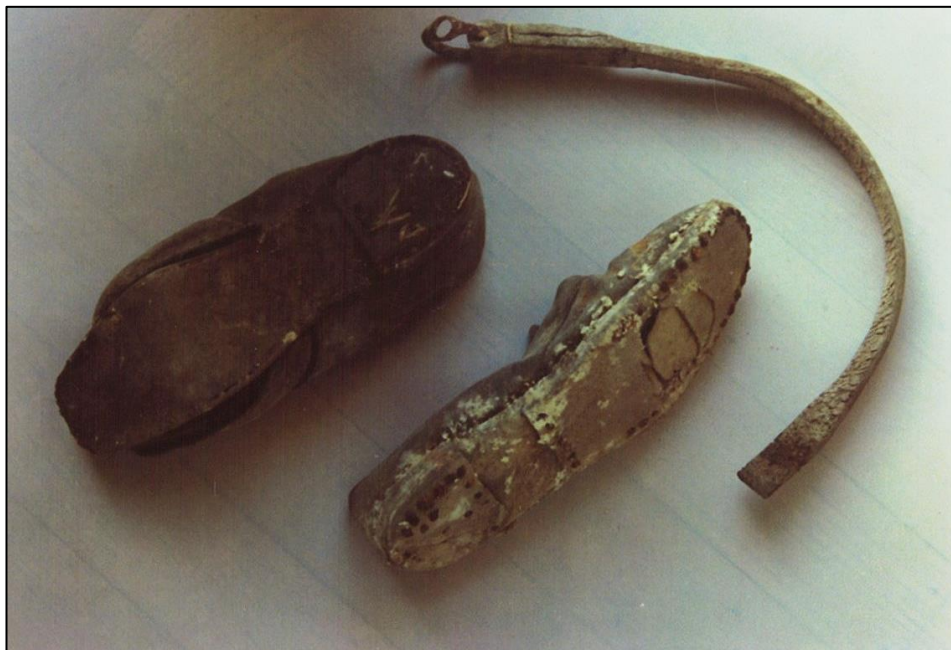
Shoe 2

Man's leather lace-up derby shoe. Once again with a square toe, a two lift heel and a half-sole repair. This shoe however is not a 'straight', it is almost certainly the left shoe.

This shoe is more in keeping with traditional concealed shoe superstitions, i.e. it is badly worn. I have already mentioned the half shoe repair (which incidentally, has been riveted) but there is also the worn down sole and heel and the hole in the vamp at the little toe joint. This tells us that the shoes have been treasured by the wearer, either for their comfort or more likely because new shoes were too expensive.
