## VILLA SARACENO

#### Vol II- The Repair of the Buildings

Charlotte Haslam, 1994

**Repairs to Villa Saraceno**

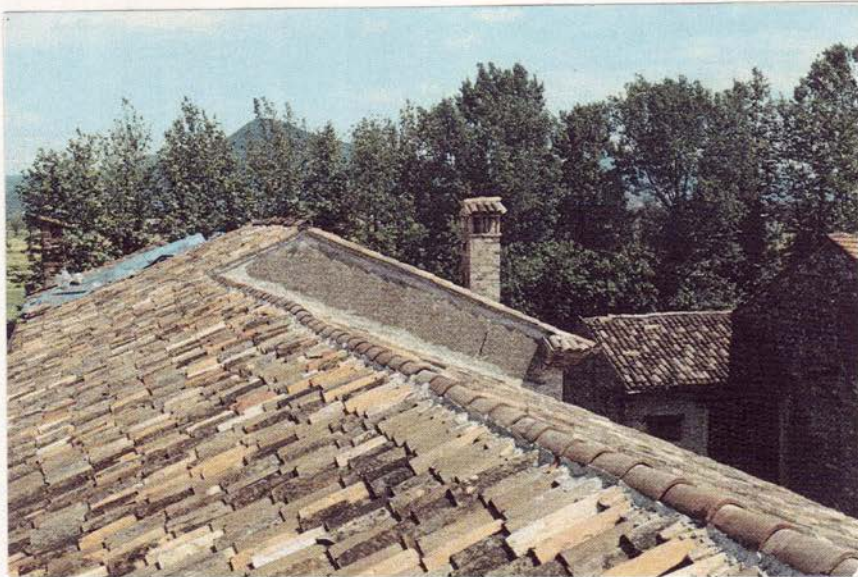
*Re Carchessa roof seen from above.*

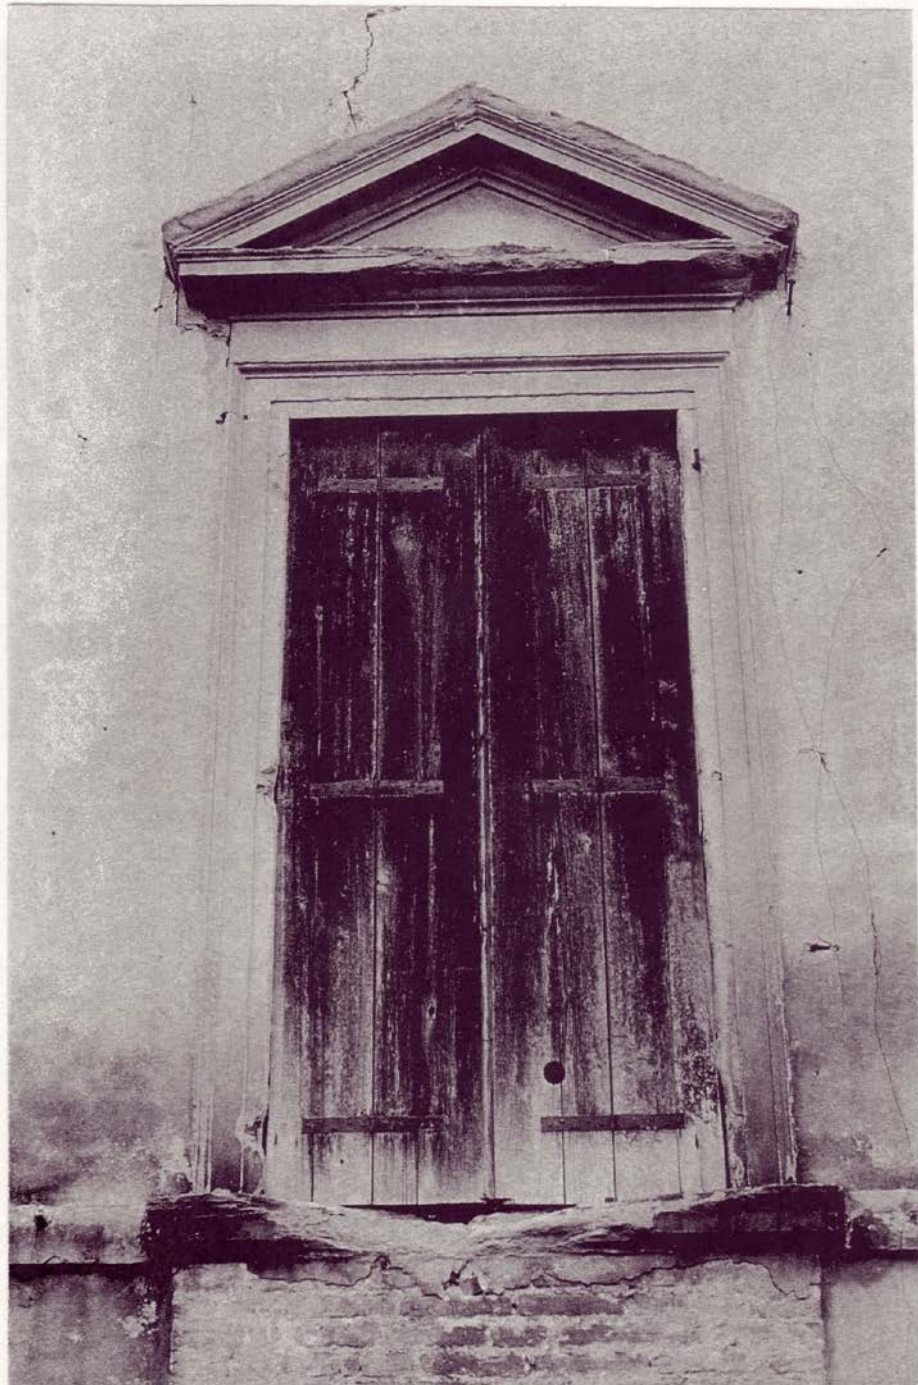
best window of south front,  
with 19<sup>th</sup> century shutters.

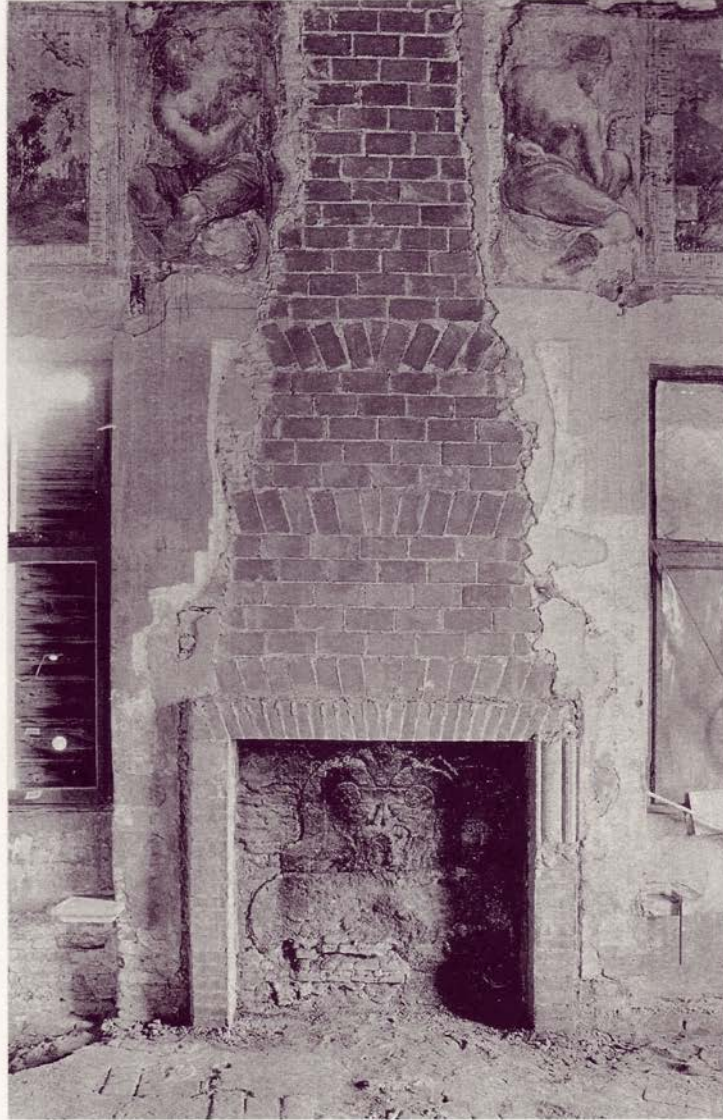
The 17<sup>th</sup> century chimney piece in the stanza maggiore, emerging (left), and half way to reconstruction (above).

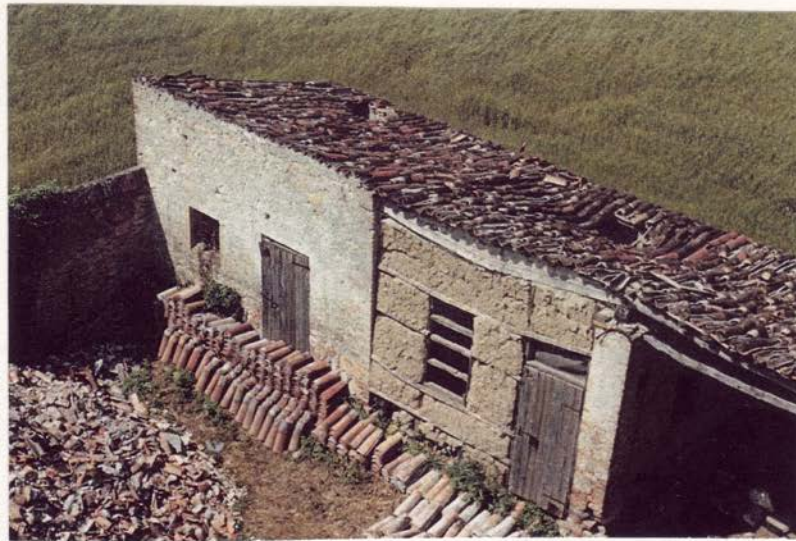
chicken houses in the north-west corner of the estate, demolished 1992.

Most of the nineteenth-century agricultural buildings were treated likewise. The next going north was left unfloored; the second and third made into a custodian's house (with new windows on the first floor to east and west) and laundry. The little pigsty was repaired, but the intrusive, if picturesque, hen houses to the west of the villa house were removed.
