# The Landmark Trust

# OLD CAMPDEN HOUSE SITE HISTORY ALBUM

East Banqueting House & West Banqueting House

# **Volume I – RESTORATION OF THE BUILDINGS**

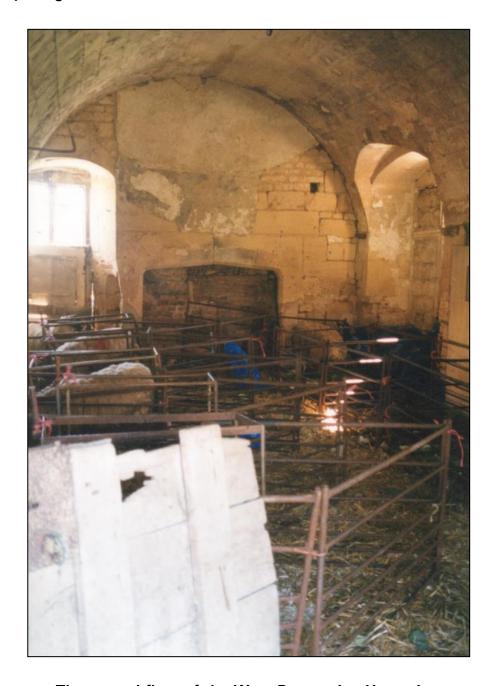
The ground floor of the West Banqueting House in April 1998 before restoration - during the lambing season!

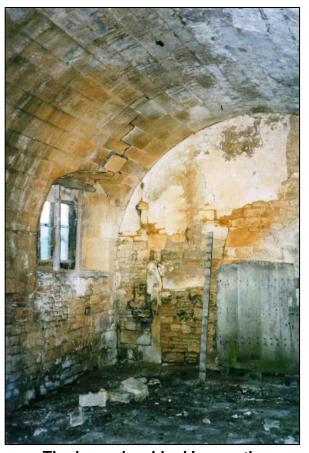
The lower level looking north.

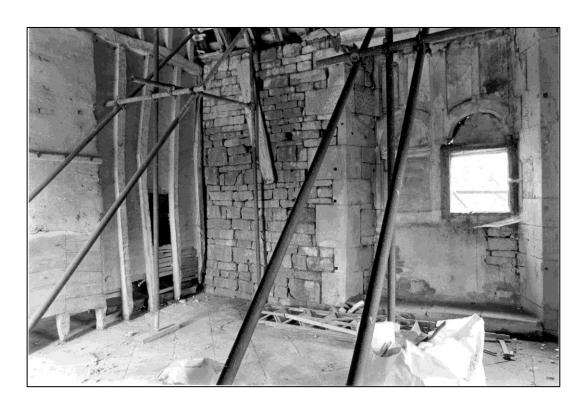
The first floor before restoration.

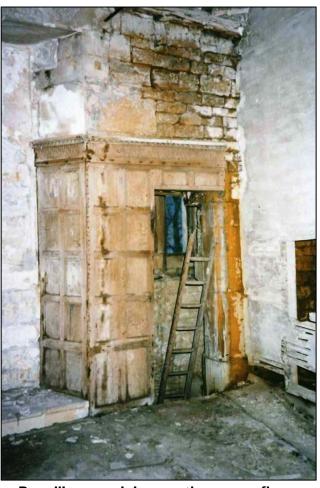
Panelling surviving on the upper floor.

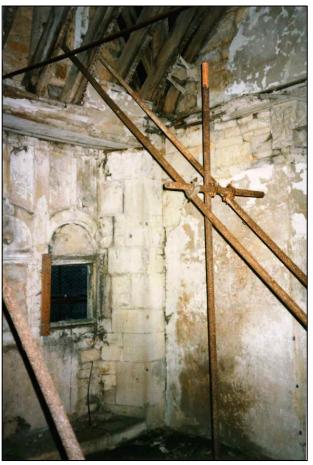
Part of the wall and roof structure of the upper level.

The east wall had also bowed significantly and rotted rafter feet above equally decaying wall-plates meant that the wall had come adrift from the roof by some 12-15cm. Metal tie beams had been inserted in the past and the wall seemed stable so, in contrast with the treatment of a similar problem at the East Banqueting House, we decided not to crank the wall back to vertical, simply replacing the metal ties. Quite how far out of true the wall has moved is easy to read from the boxed-out west cornice on the inside. The rafters were given new feet and we cast a new concrete tie beam to give them something to sit on.

Apart from the wall plates, relatively few of the roof timbers needed renewal. The new stainless steel ties across the chamber are a measure we had hoped to avoid but decided their omission was too great a risk.

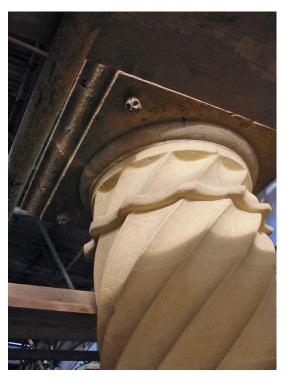
Original stone carving detail of the small *gotti* beneath the square plinths of the chimneys.

Also at roof level, two chimneys were found to be beyond repair and had to be replaced. The work was done on-site in a traditional stonemason's bankers' shed. The shafts were carved in two halves, each divided into several slices and the

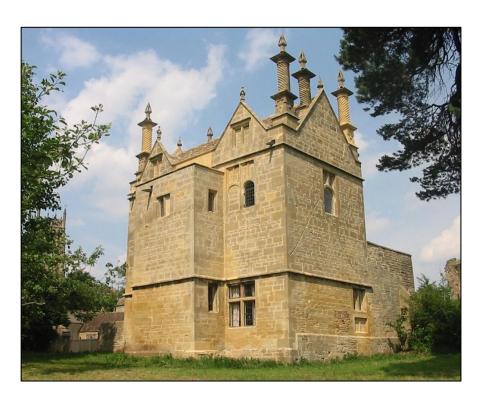
The view of the south-west elevation after restoration showing the unblocked west window and the re-blocked lower half of the window on the south.

Stone blocks had dropped in the vaulting above the window over the sink and over the stairwell. These were re-pinned, in preference to dismantling and reconstructing them. The lower part of the other, larger window on this west wall in the kitchen had been blocked up to transom height and at first we planned only to re-glaze part of it, and to form a double height window of the top half of a doorway and its fanlight to the left of the fireplace on the southern wall. (This doorway must once have led into the extension built onto this south wall, whose shadow can still be read on the exterior).

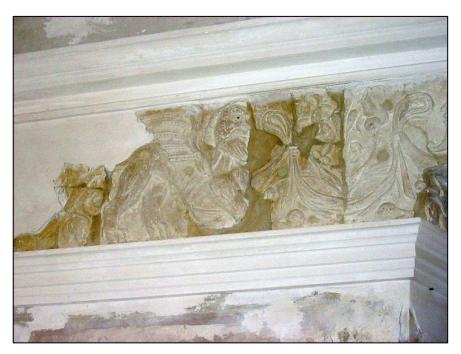
The blackened eye of the winged grotesque was the only evidence of colour that remained and which we have reinstated.

The ceiling on the first floor still had its original barrel vault (unlike the East Banqueting House where the Earl of Gainsborough had once again intervened). Unfortunately it was so decayed that it had to be replaced with new lathes and 3-coat lime plaster. The patchy plaster in the rest of the room is largely as we found it, limewashed over. The decorative frieze that runs around the cornice has been pieced together from pieces picked up off the floor or stored in boxes in the Fellowes' attic by conservator Ned Schaerer. The fashion of the day was for such plaster to be brightly painted, although the only evidence of colour that remained here was blackening of the winged grotesque's eyes, which we have reinstated. The cornice moulding is based on sections found on the floor.

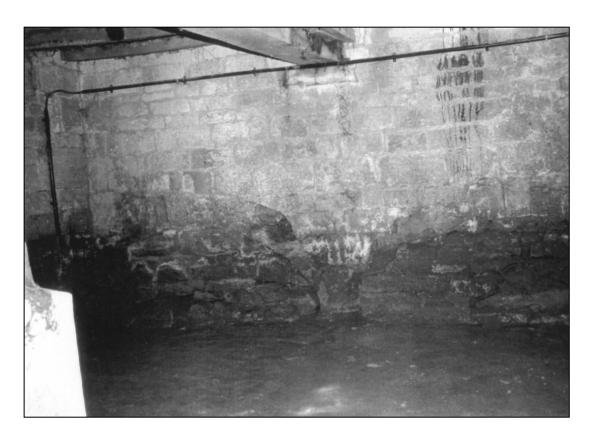
The cellar of the Almonry, showing the possible conduit arches built into the wall (now blocked) and drainage channel down the centre.

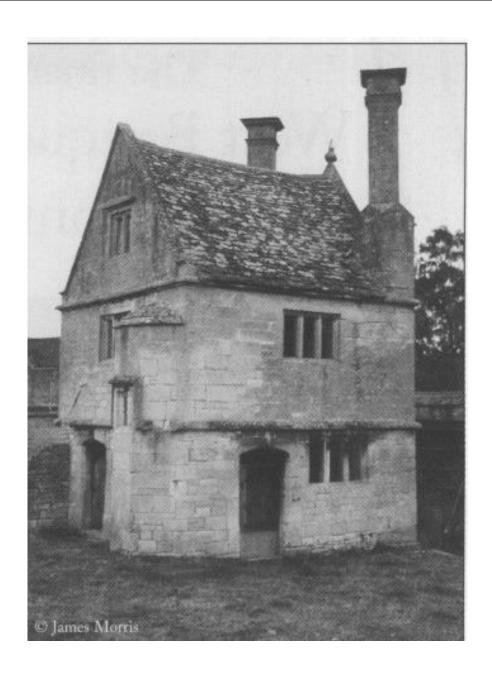
The decay of the roof structure from walls had again led to walls bowing outward, especially on the west, where a stress crack ran from top to bottom. Slips of new stone have been inserted and we hope the problem has now stabilised.

The Almonry before restoration.

Largely as a result of Griggs' repairs, the Almonry was relatively sound structurally when it came to us. Even so, it still needed a thorough overhaul of its fabric and so was shrouded in scaffolding for much of 2002, just like the West Banqueting House.

Its rafter feet had also decayed so that it required re-roofing, in the course of which we discovered that the building originally had parapets which, on its politefacing east elevation at least, possibly carried strapwork similar to that on the banqueting houses. This suggested that the building had once been of higher status and also that it had been re-rooved in the past. It also explained the current, rather uneasy relationship between the roof and the eaves: there is no longer an internal gutter, merely a hole on the north wall to show where one once egressed. Sufficient tilestones were available from the banqueting house to re-roof the Almonry.

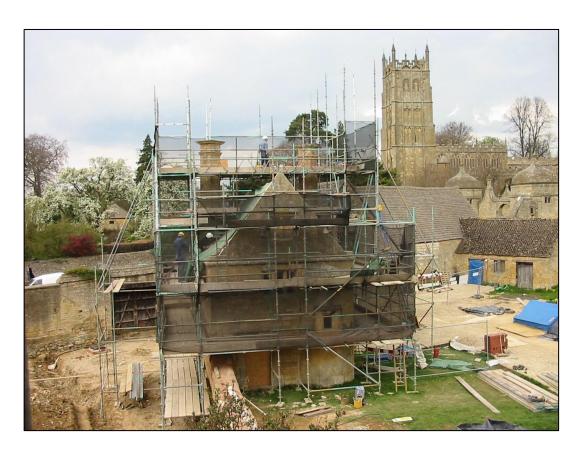
The Almonry viewed from West Banqueting House during repair in April 2002.

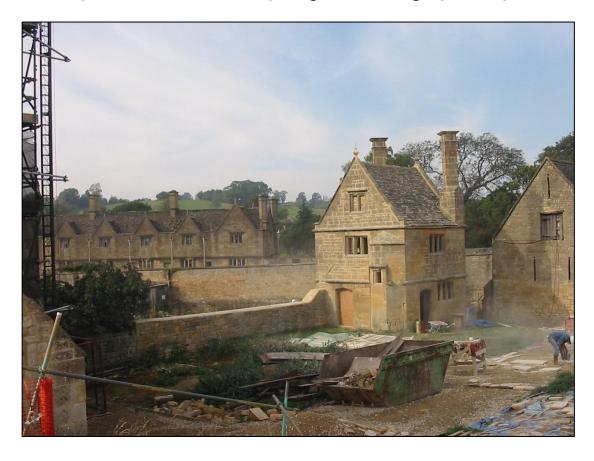
Looking towards the SW corner of the Almonry.
