The Landmark Trust

THE PARISH HOUSE

History Album

The Parish House

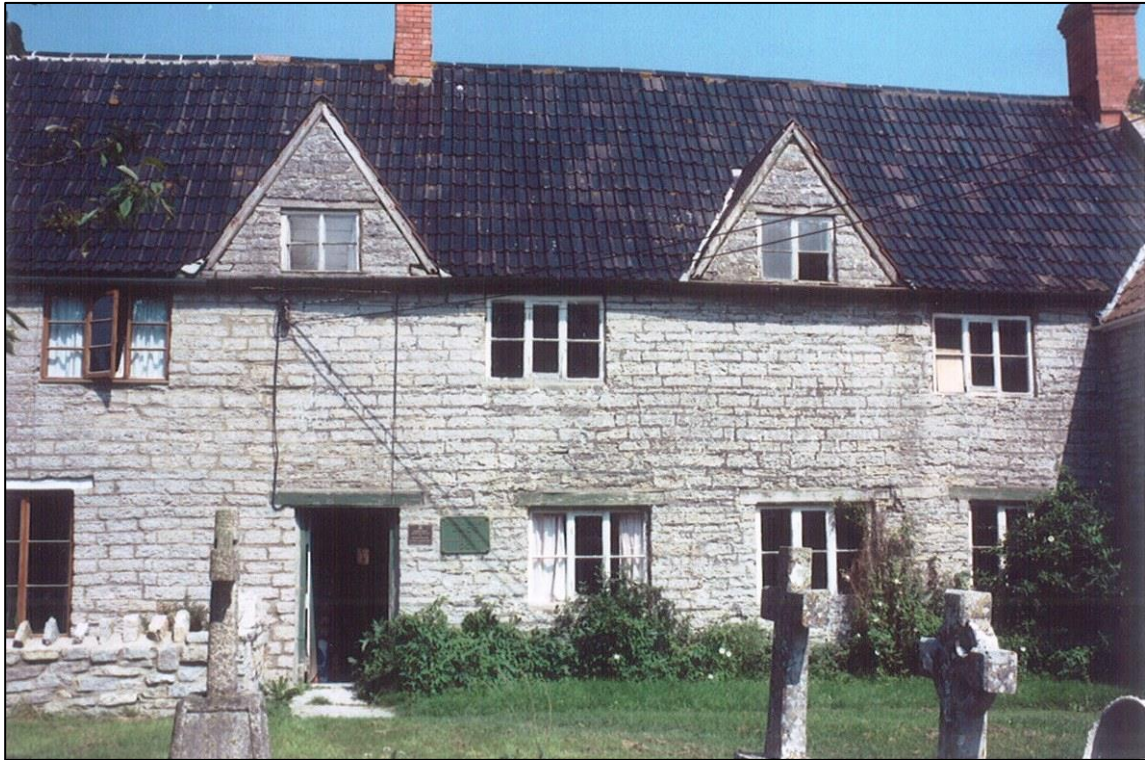
The wirescape was removed and placed underground.

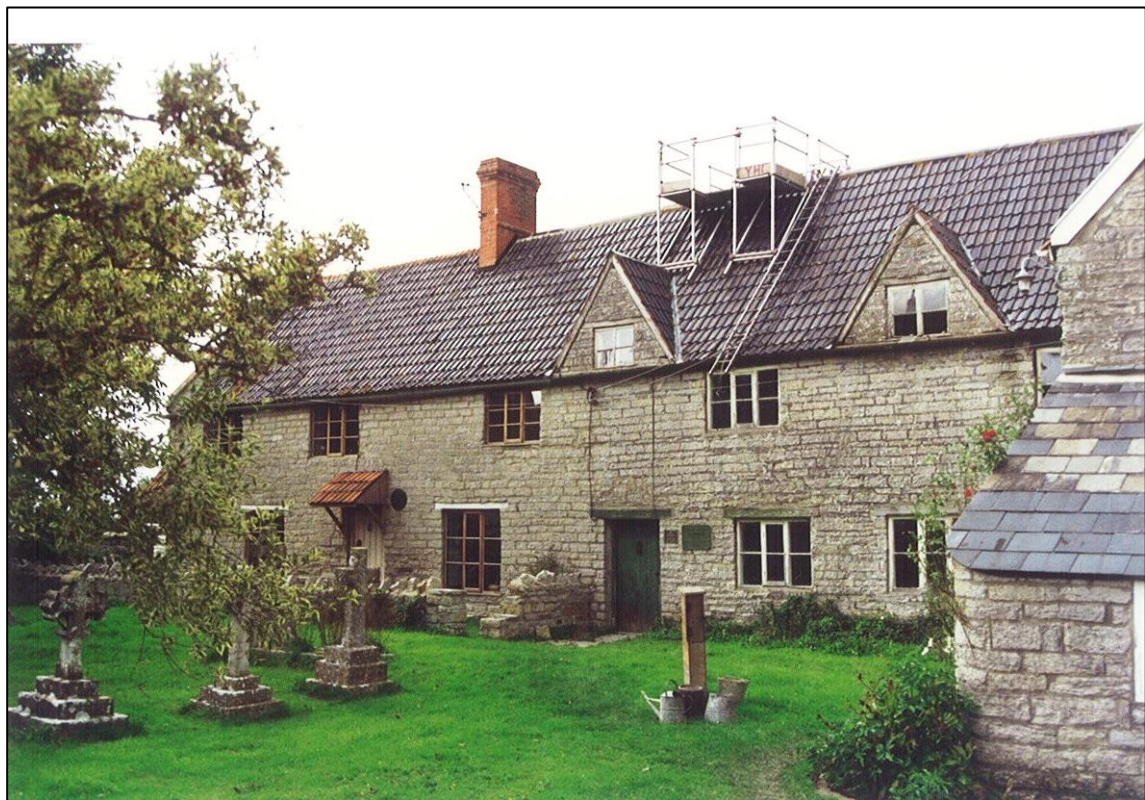
The central chimney, the low wall and the red tiled porch were all removed.

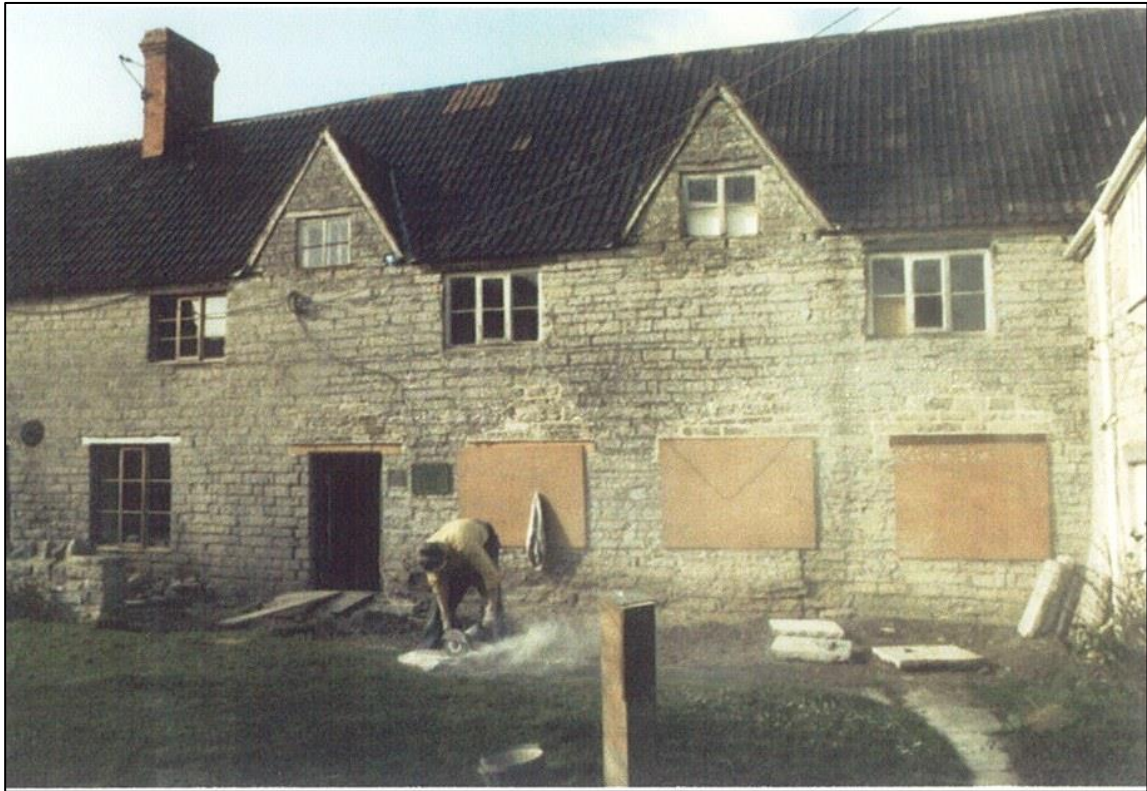
The windows on the ground and first floors were rotten and had to be replaced.

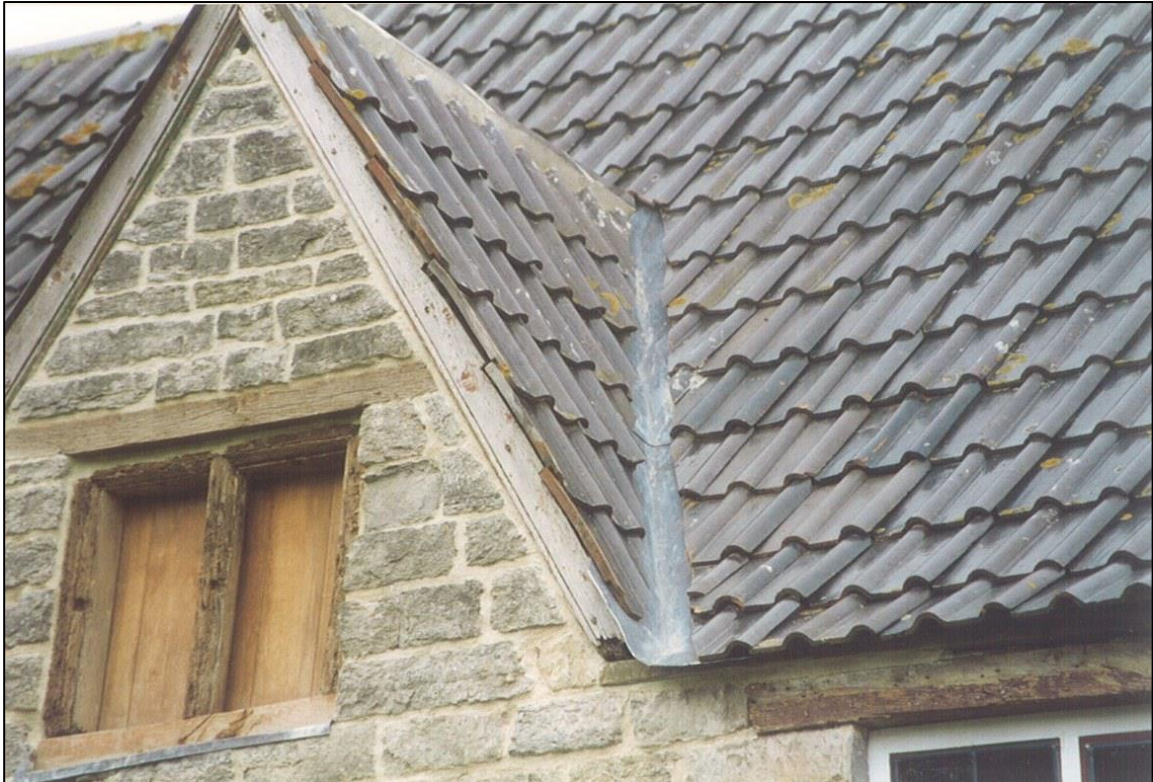
The attic windows were repaired and then boarded up.

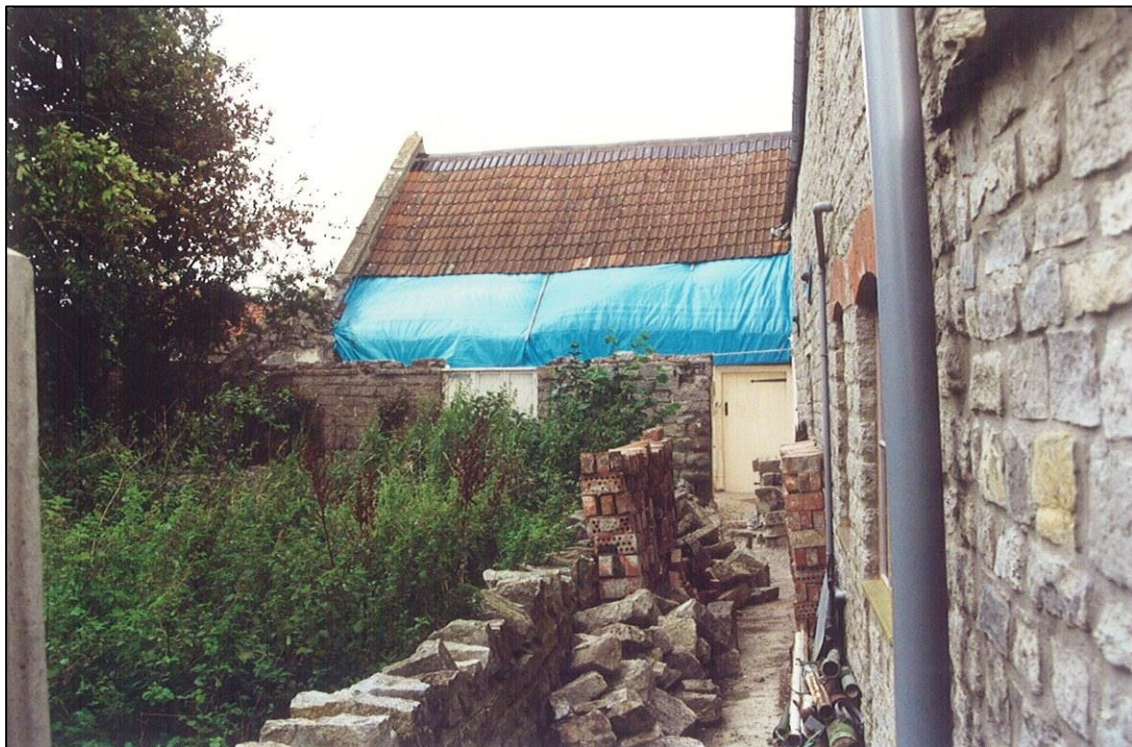
The roof of the lean-to was removed.

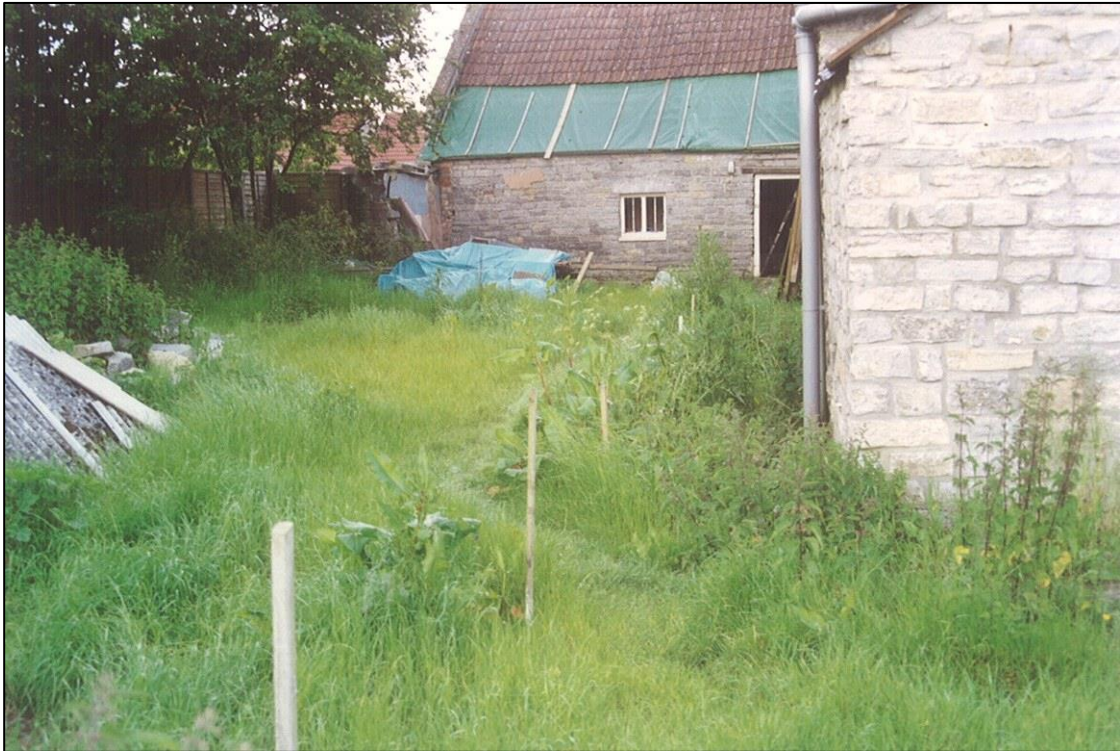
The original wall and window were repaired. On the right the Church View garden is staked out.

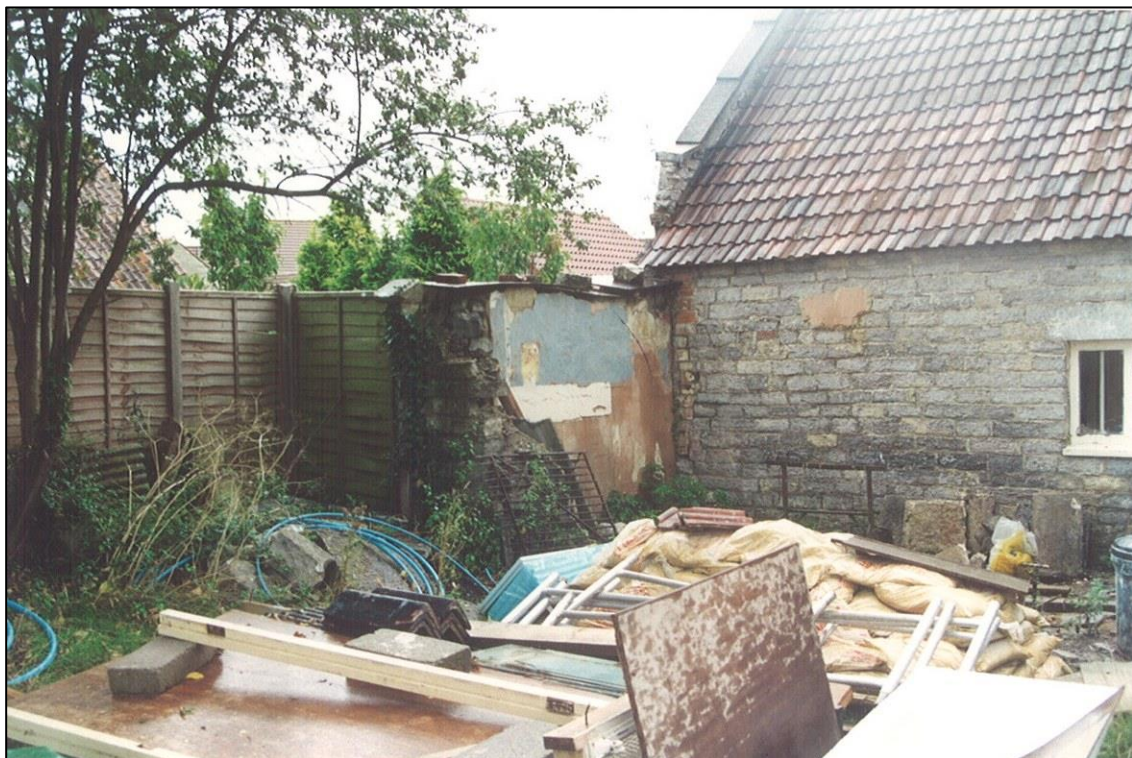
The roof was restored to its pre lean-to shape and the coping replaced.

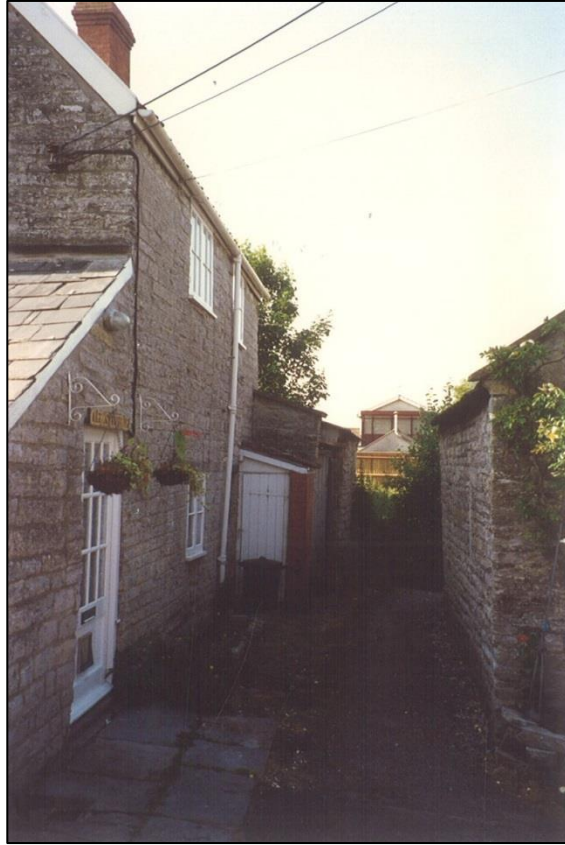
The East end. The back of Clerks Cottage and the old lean-tos.

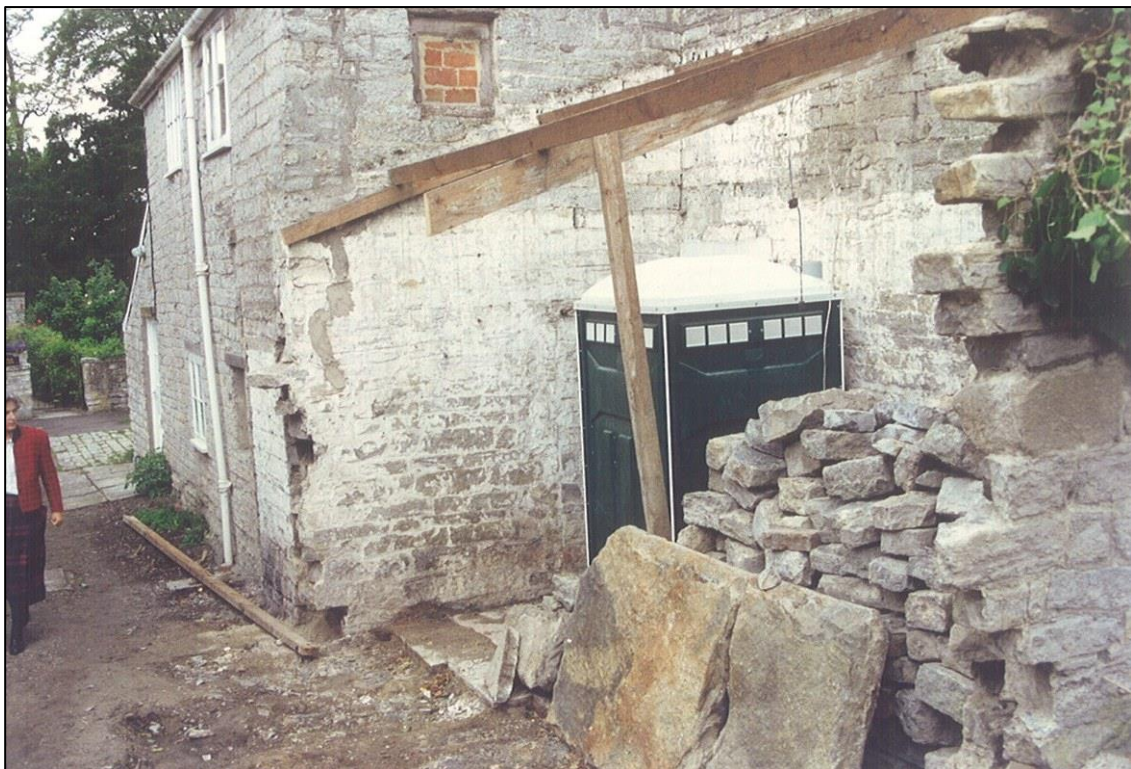
The lean-tos were demolished. Note the blocked up early window.

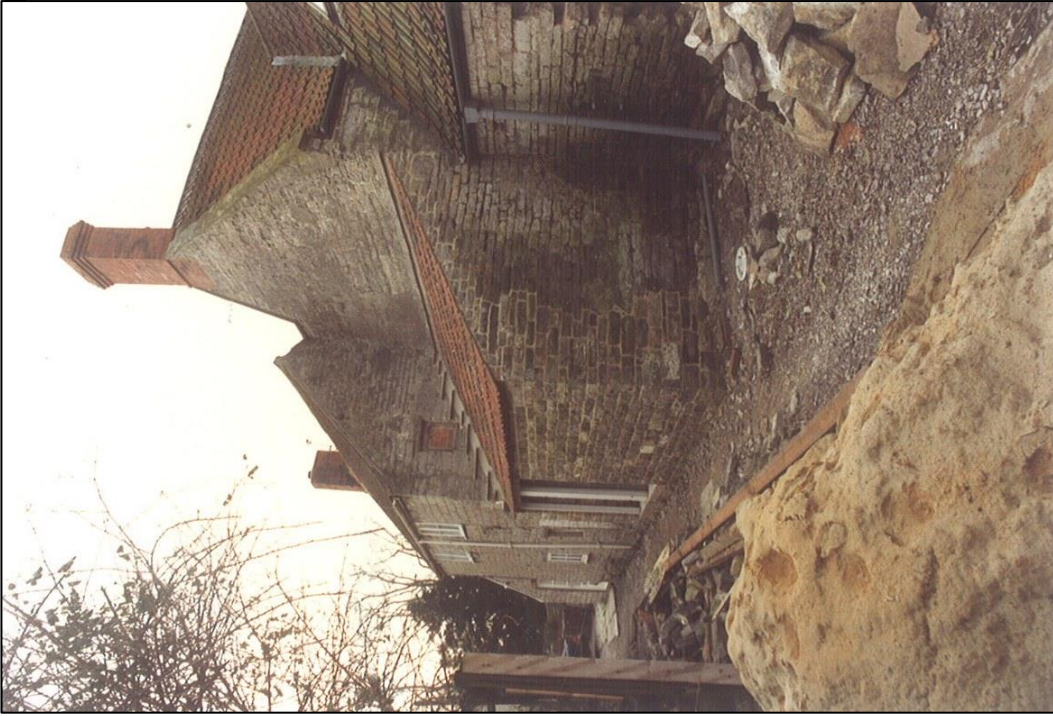
The new lean-to and on the far right the opening for the new front door is begun.

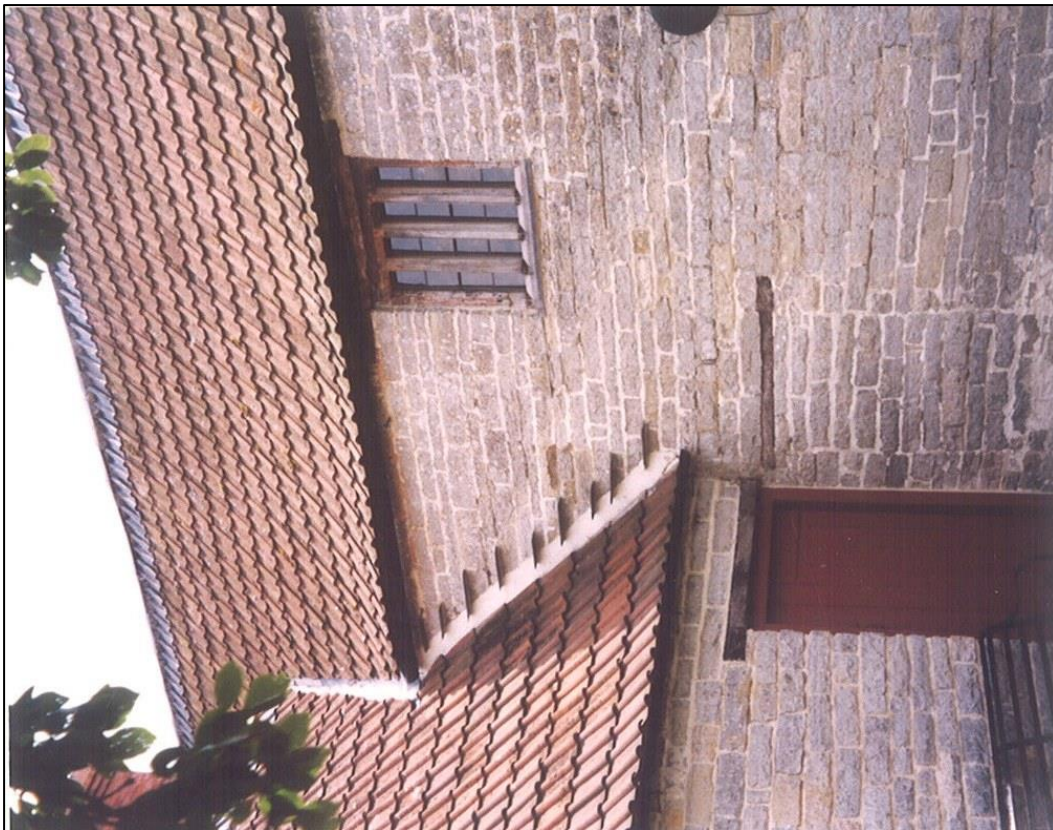
The door from the parish room into the old lean-to was blocked up

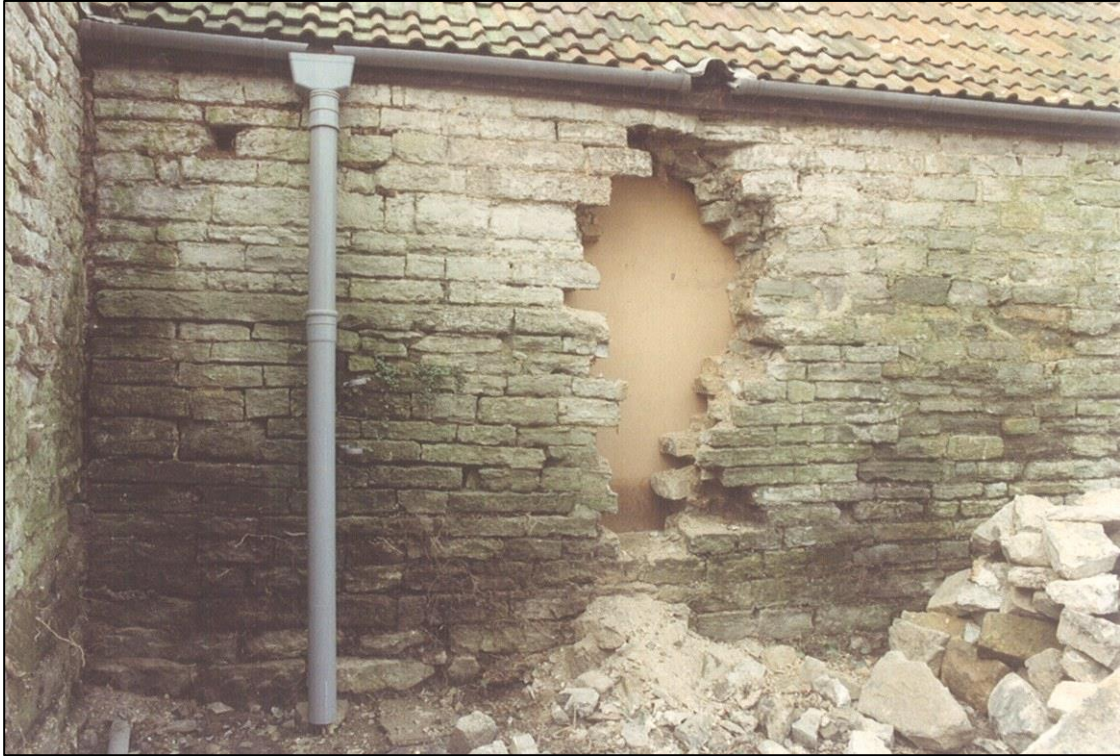
The opening for the front door.

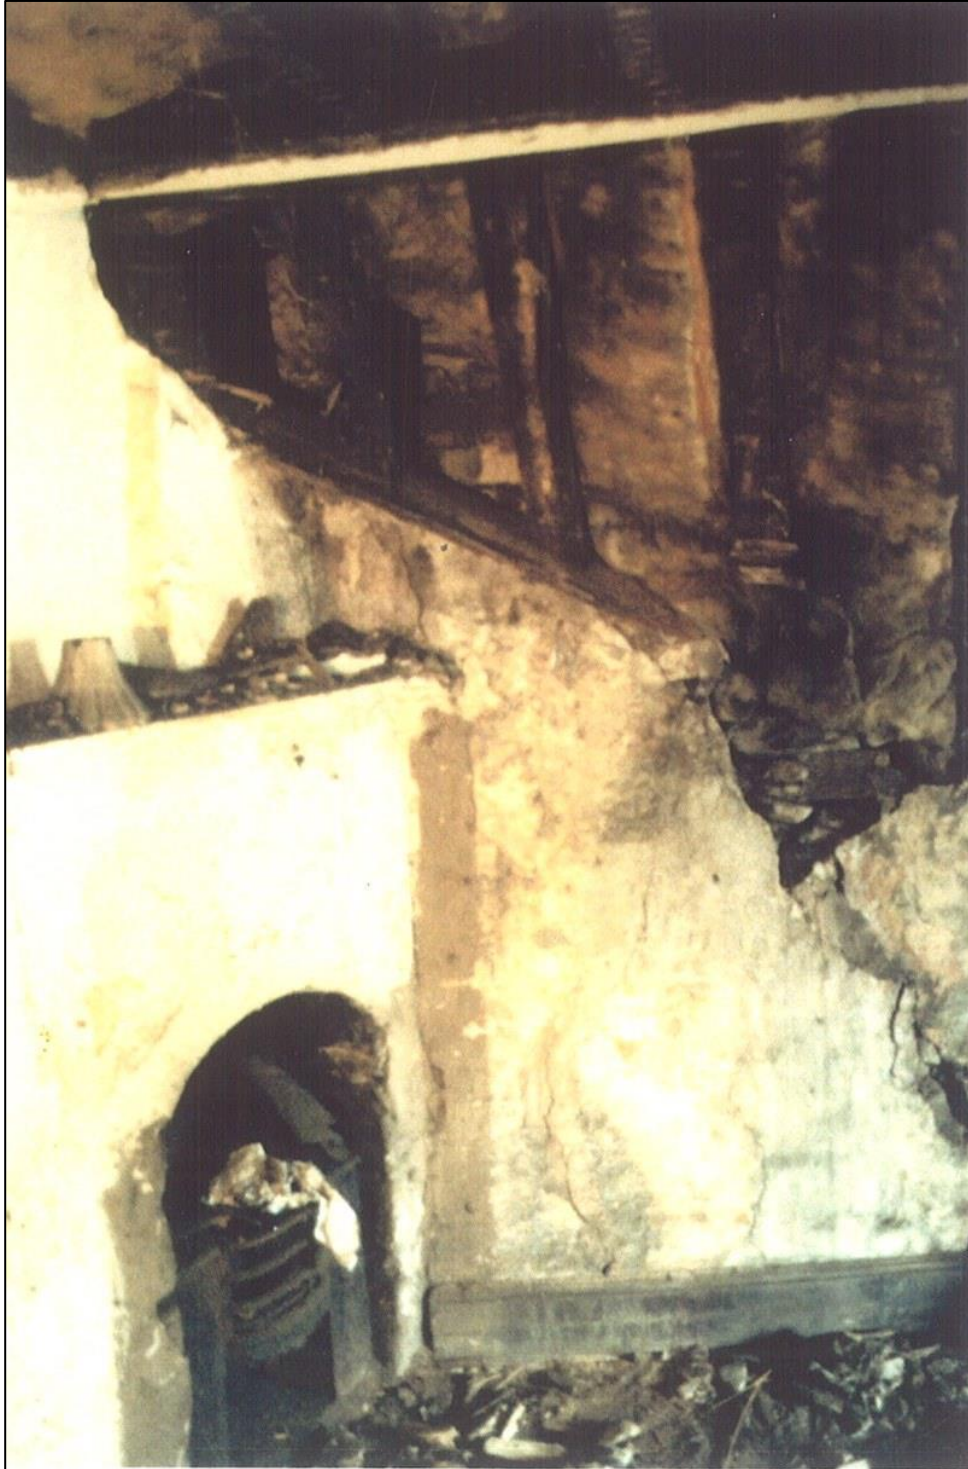
The fireplace in the SW corner of the present parish room was removed.

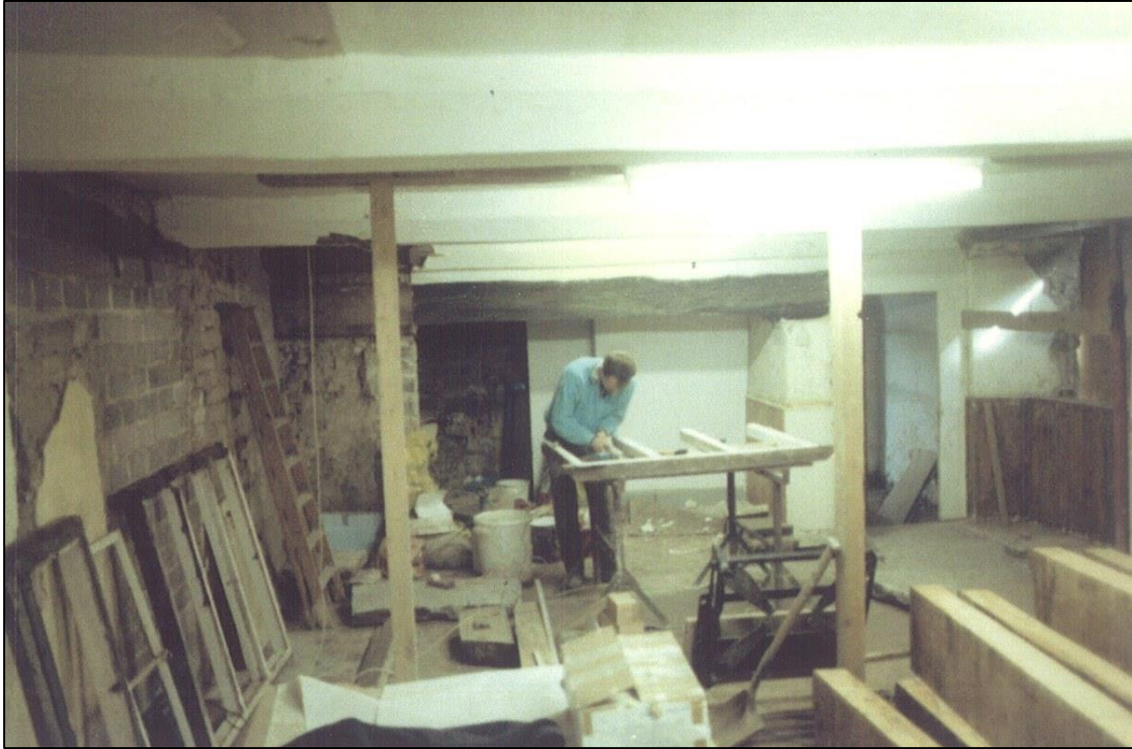
**Andy Coward at work on a window in the parish room.
The blocked up door to the north wing is behind.**

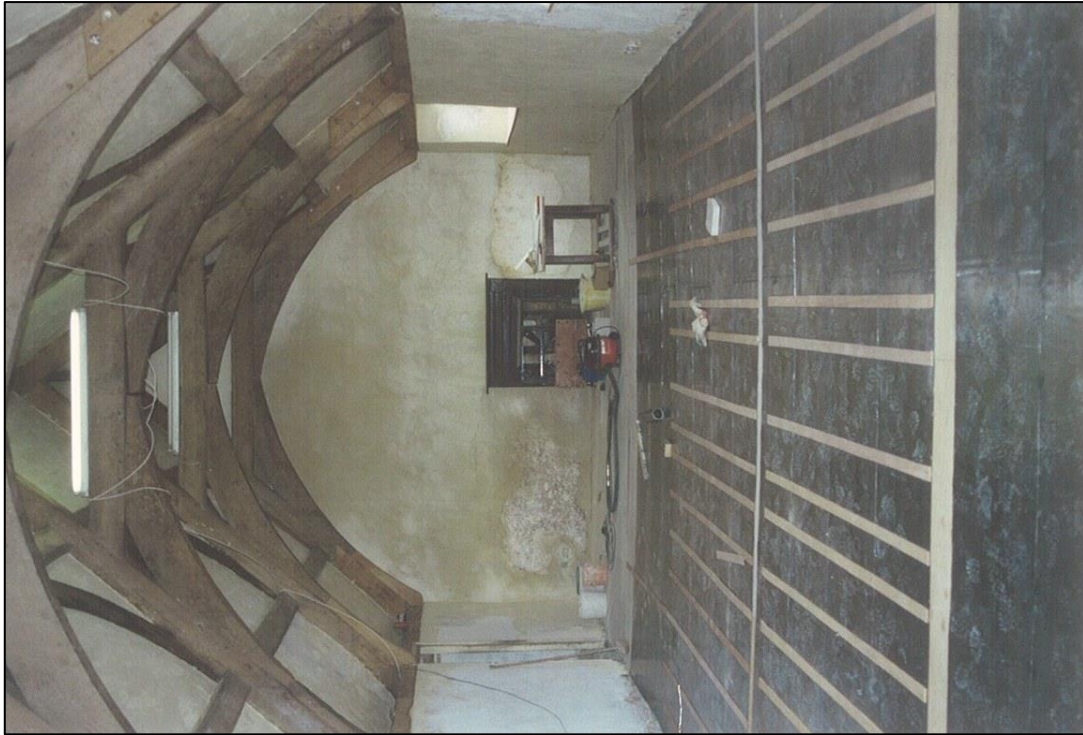
Looking east before the partition went in. The fire surround was removed.

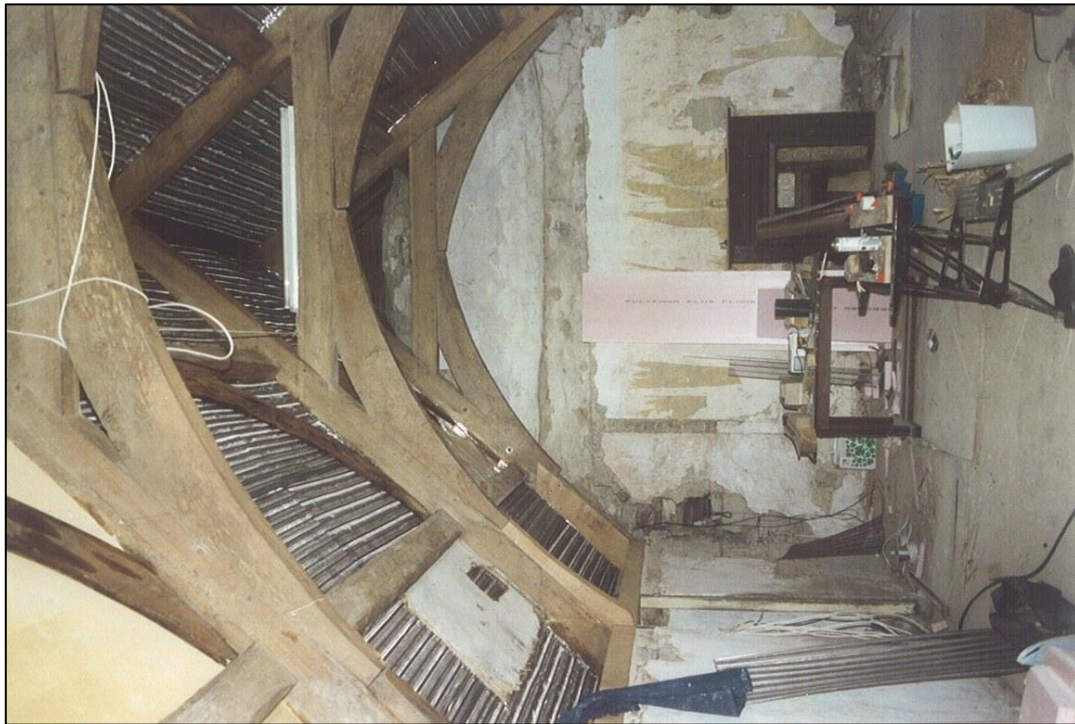
Looking east. Missing braces were restored, rotten and mutilated feet of the principal rafters were repaired and there were extensive repairs to the wall plates

When the Landmark Trust took over the building the first priority was to regain the experience of entering the original Church Room. To achieve this, the 17th-century ceiling was removed. The dormer windows remained, blocked up, but the attic went and the fine medieval roof could be enjoyed once more. The trusses were intact but they needed re-pinning and repair and Leonard Hardy, who has worked on several Landmark buildings in the West Country, put a lot of work into them. They and the wall plates were cut about especially where the dormers were inserted and in those areas, as you can see, there is new work and a new wall plate on the south side.

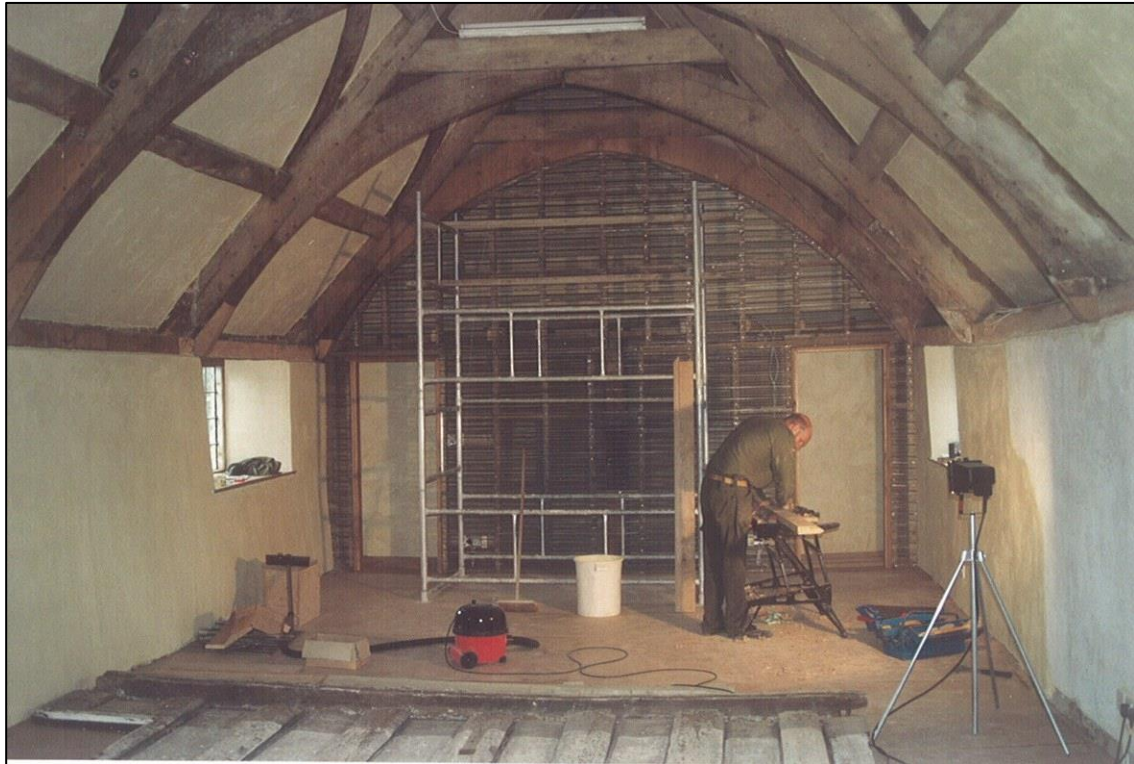
The 17th-century screen on the floor being repaired.

The Landmark Trust by this time had bought Church View and it was possible to extend the first floor of Parish House into it, taking down the wall between the two and rebuilding it further west, so that all the trusses except for the one that was pulled down when the old Church House became two cottages, are now in the Parish house. On the ground floor the party wall remained where it was before. The partitions and passages which had accumulated during its life as a cottage were removed except for one original 17th-century wooden screen on the first floor, found within later plaster-work. It was repaired and now divides the sitting room from the main bedroom.

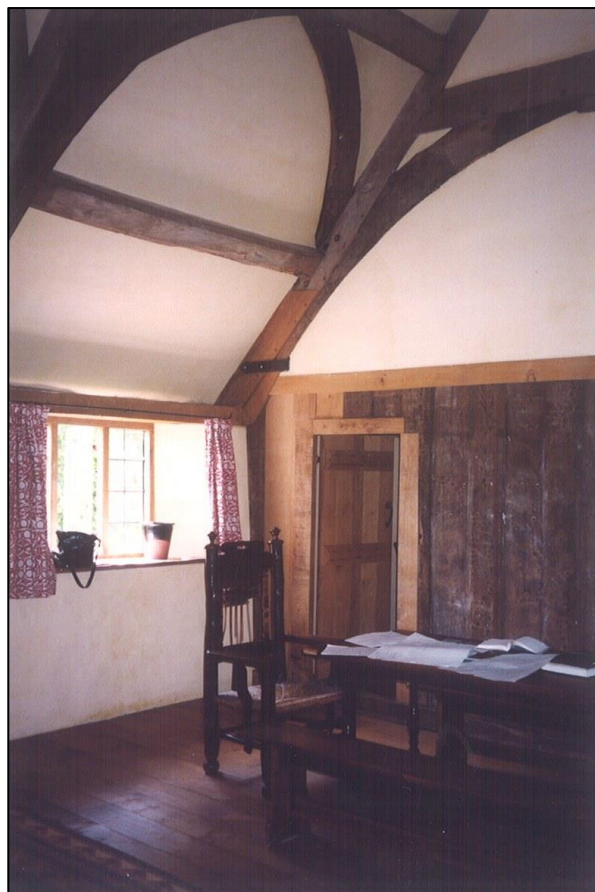
The repaired screen in its new position.

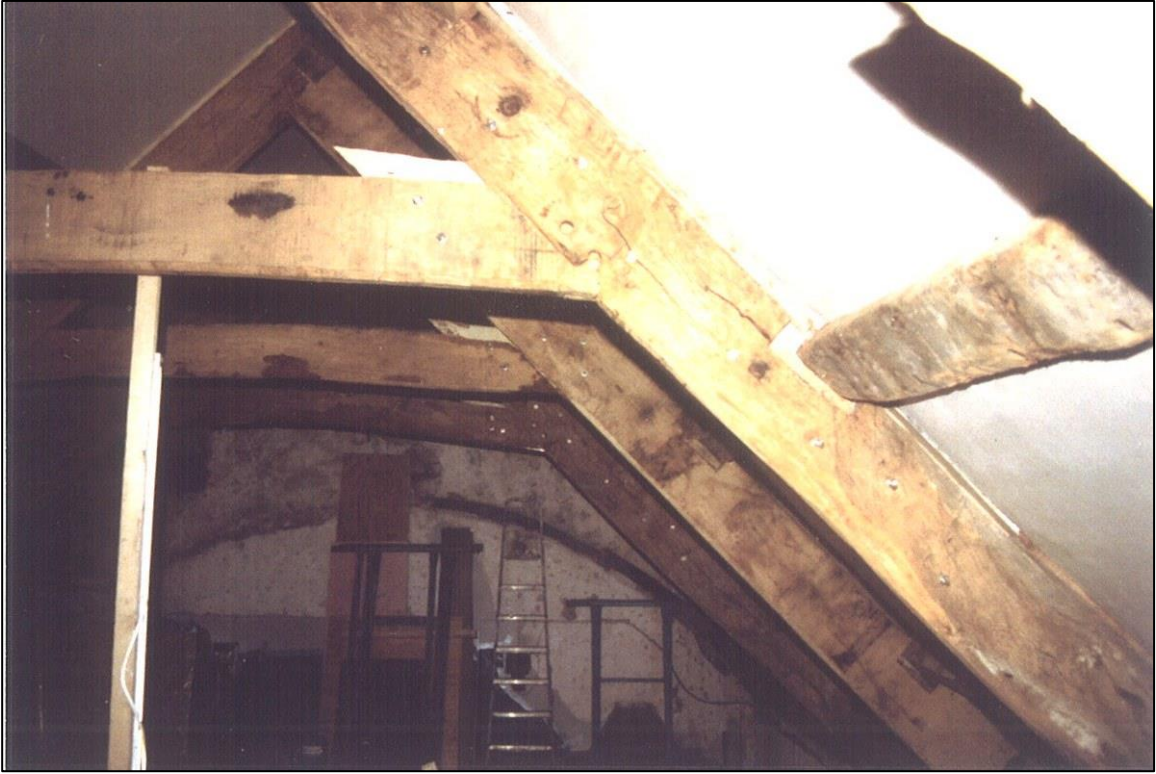
The roof of the north wing needed repairs.

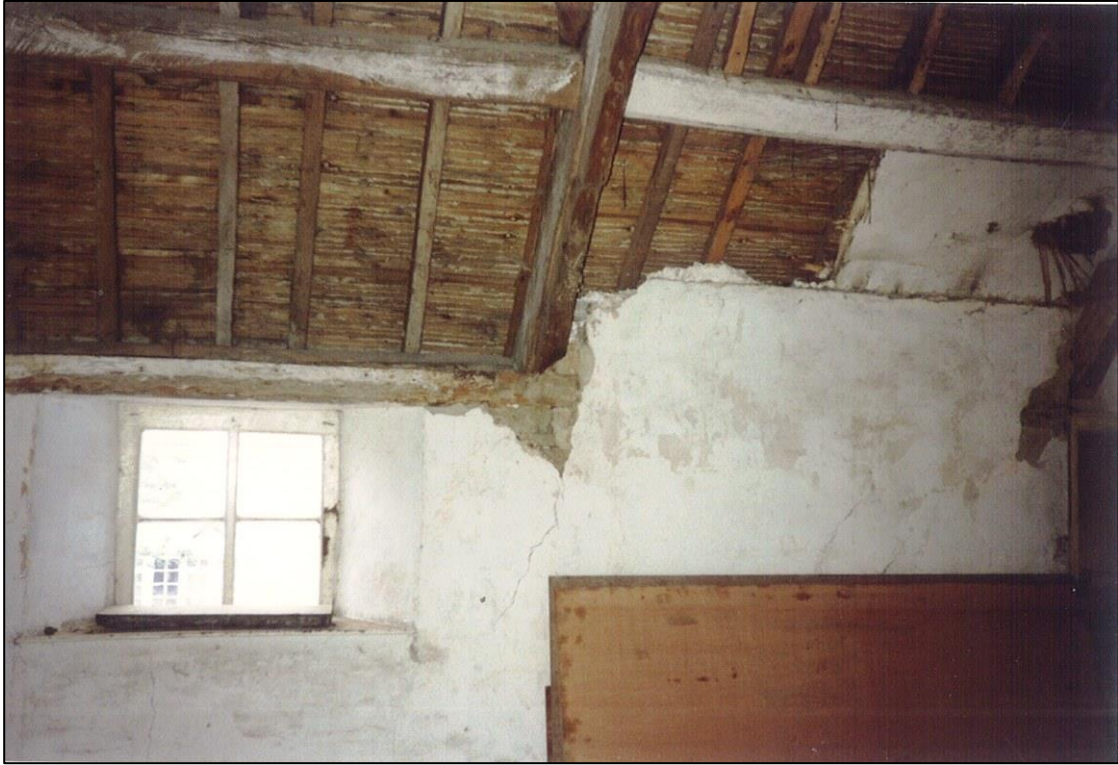
The old west facing window in the kitchen previously hidden by the lean-to.

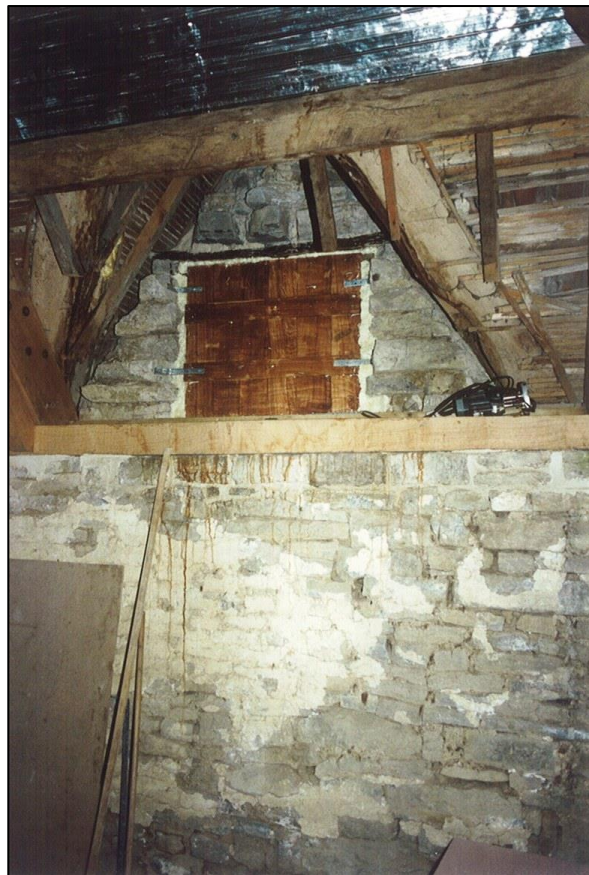
One of the blocked up dormers. The wall plate, damaged when the attic floor was put in, has been replaced.
