## VILLA SARACENO

#### Vol II- The Repair of the Buildings

Charlotte Haslam, 1994

**Repairs to Villa Saraceno**

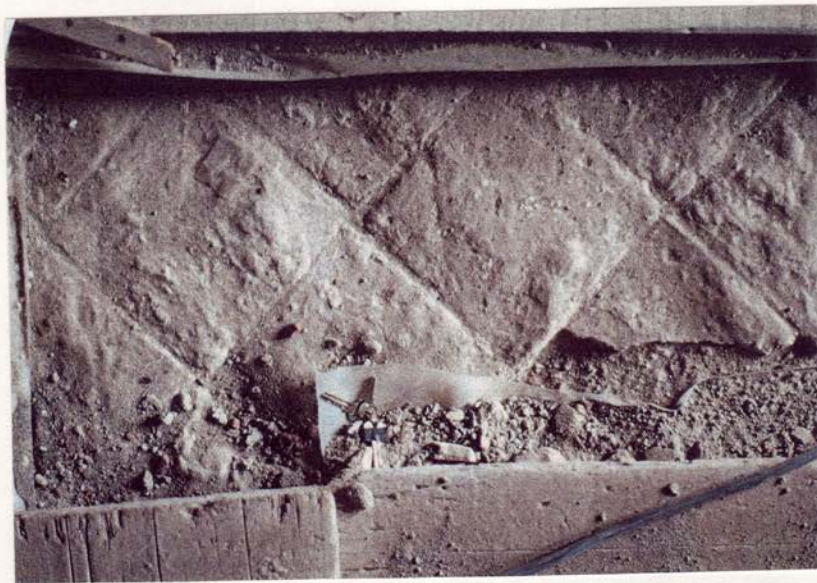
Imprint of the 16<sup>th</sup>-century tiled floor.

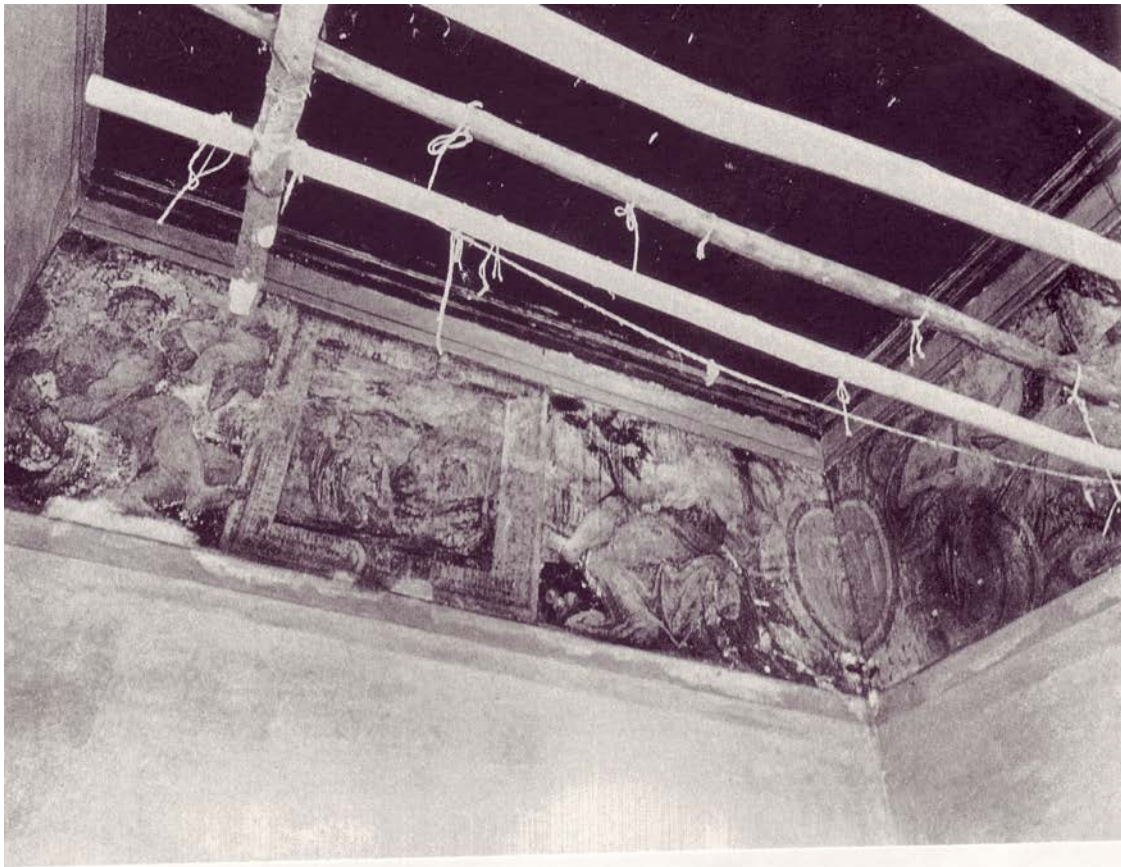
Mythological scenes in the stanza mezzana  
(great chamber) where had to compete with  
the drying of agricultural produce.

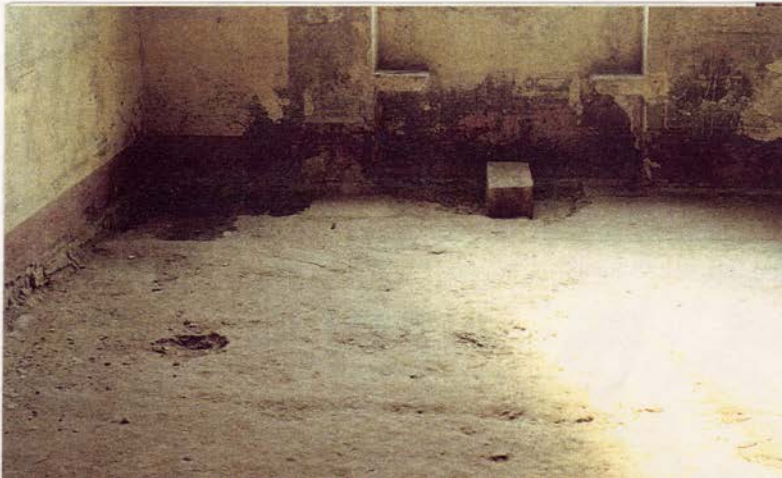
This view of  
the stanzza  
maggiora after  
renovation of  
the two halves,  
and before the  
red clay / marmorino  
has scraped off  
the early plaster  
(arintoneco).

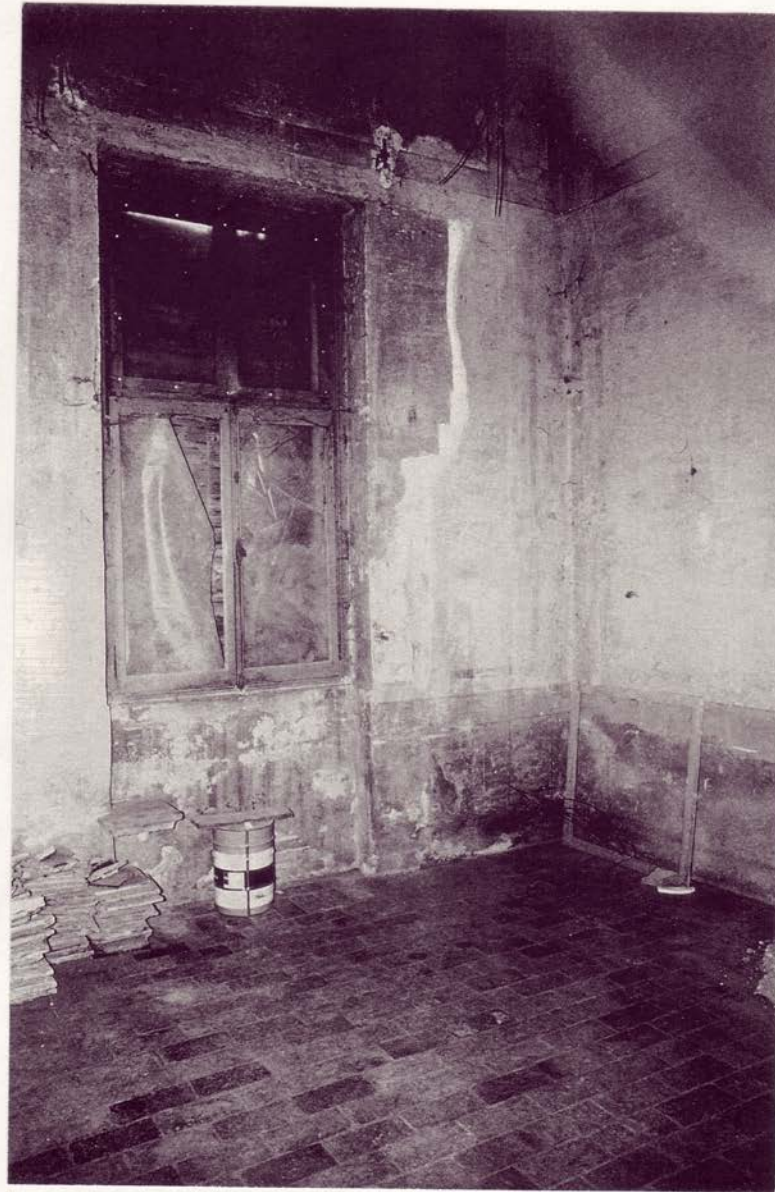
One of the two 17<sup>th</sup>-century window frames  
in the stanza maggiore, which provided  
the model for the rest of the house.

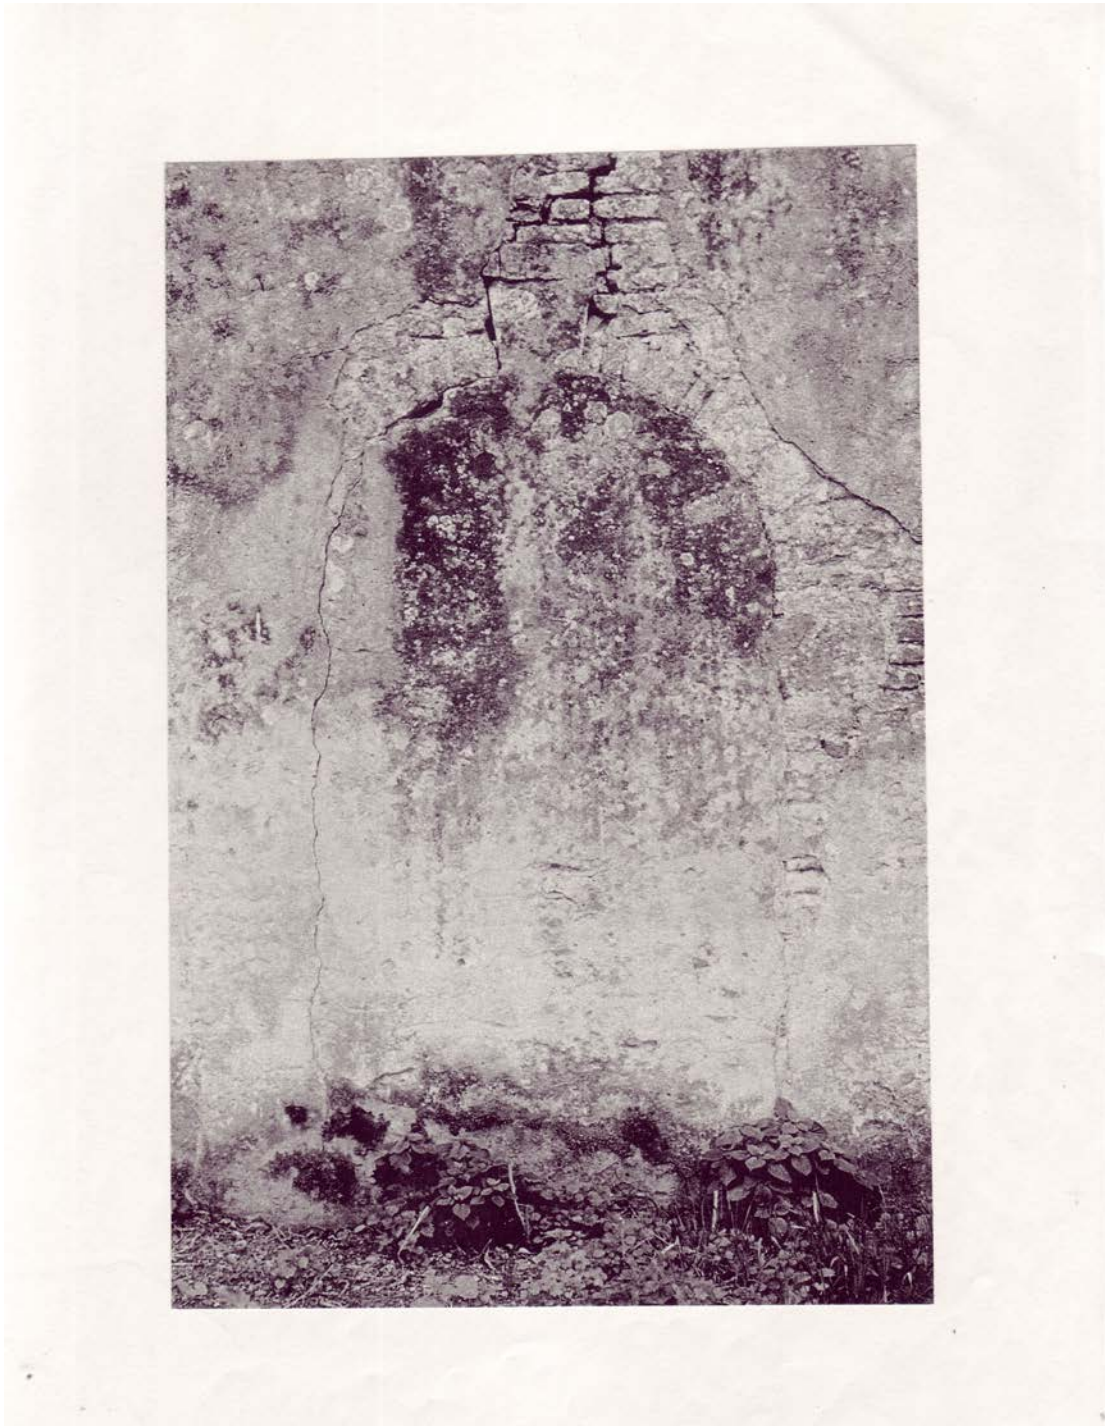
Blocked 17<sup>th</sup>-century doorway to the *brolo* in the north wall.

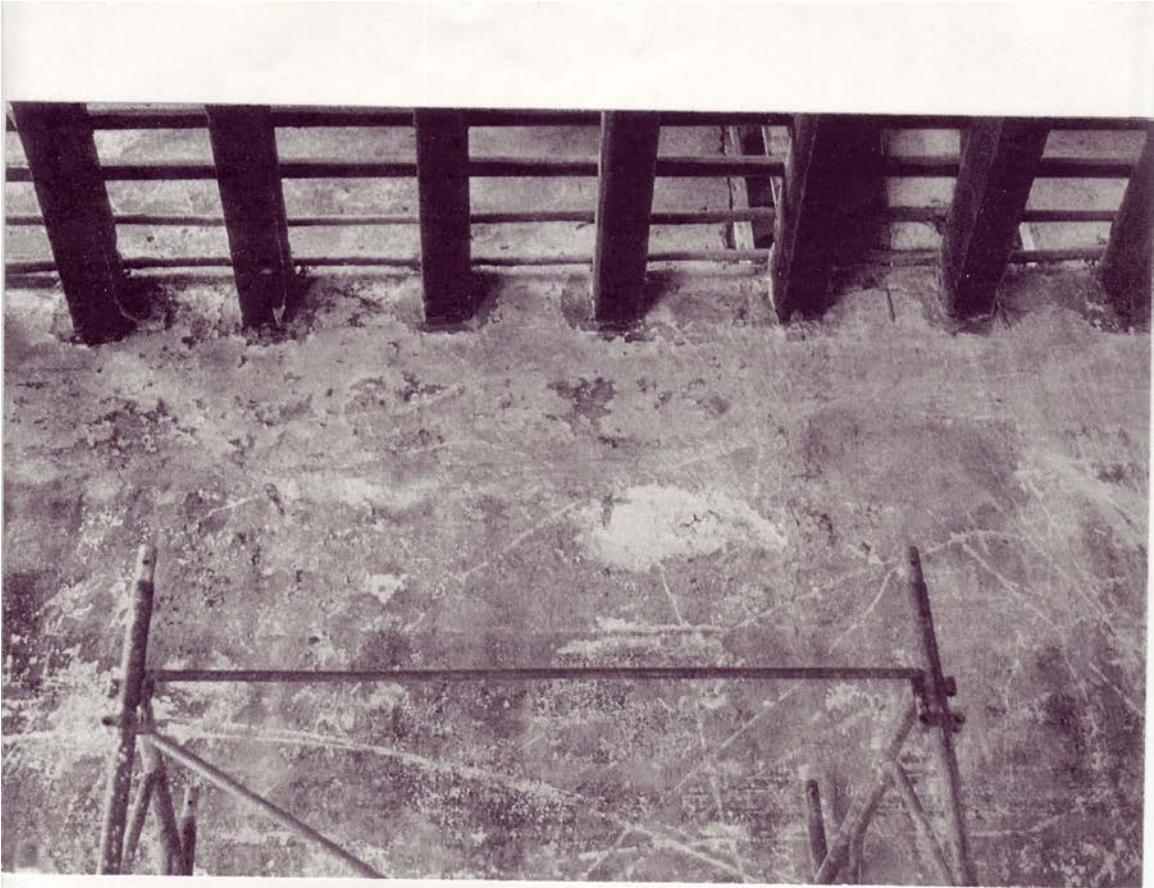
Looking for the fresco frieze, visible  
now in the bedrooms.

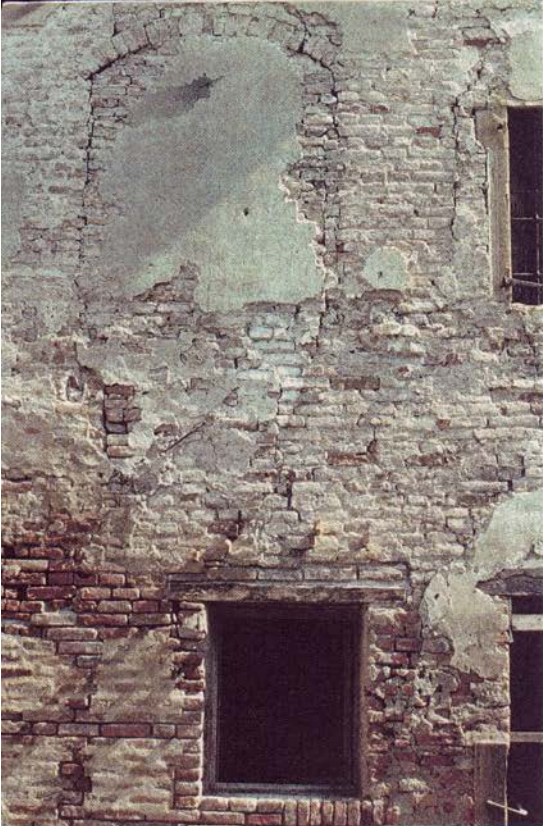
The opening in the  
first-floor brickwork  
for a medieval window,  
looking south.

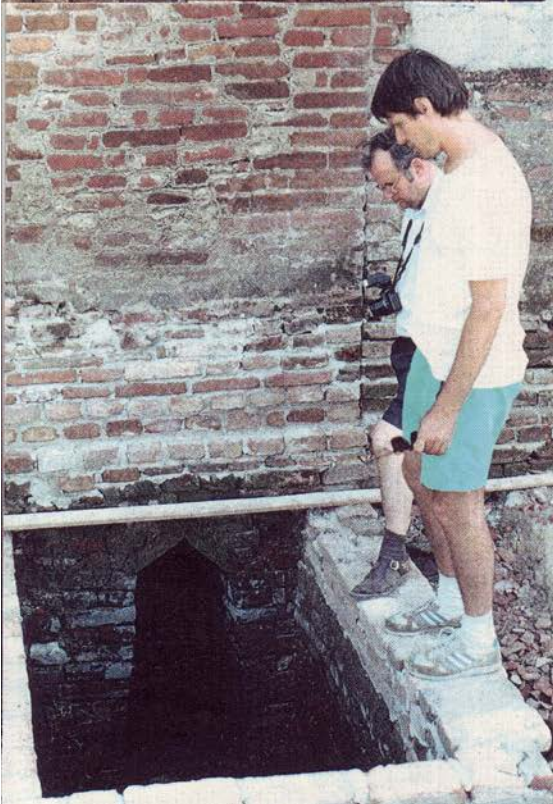
Architects looking  
at the medieval  
cess-pit.

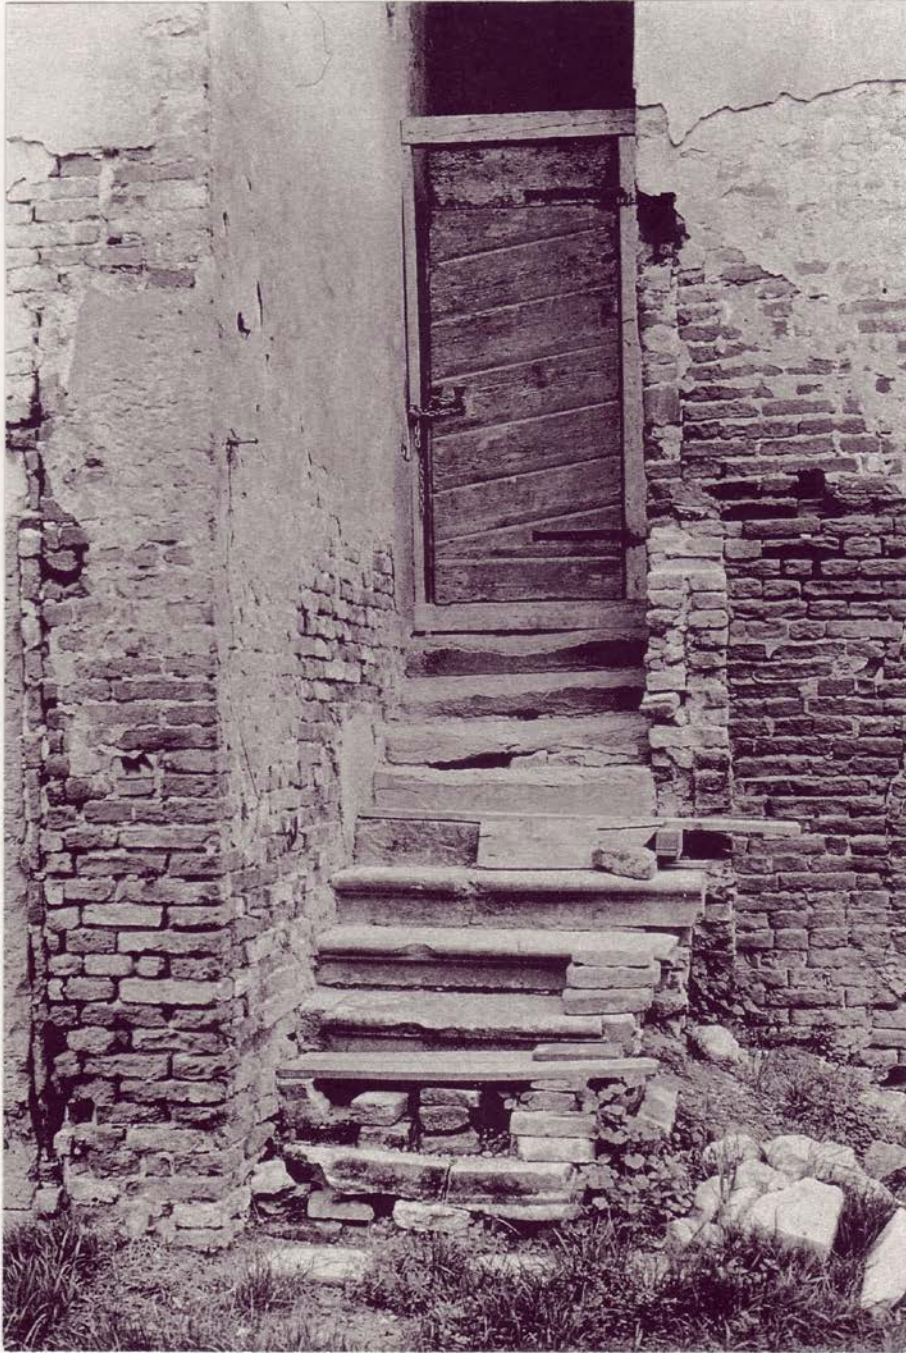
Steps from the cave to the first floor.  
an archaeological record.
